**Technical Service
Information Bulletin**

Title:
PAINT STAINS UNDER RAPGARD™
Models:
'02 - '06 All Models

REVISÉD
PA001-03
PAINT

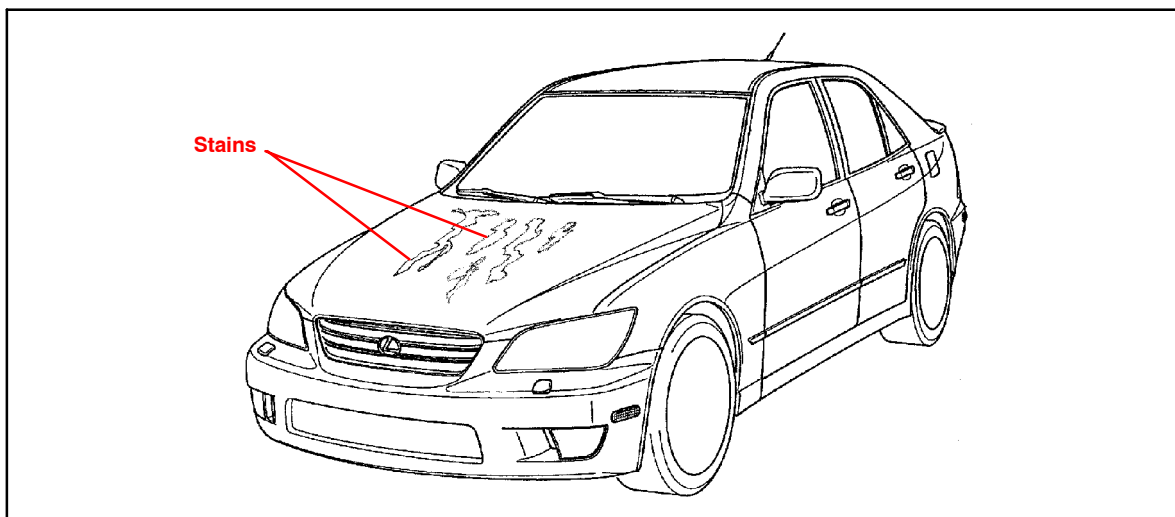
On some vehicles, when Rapgard™ is removed, the paint may have a stained appearance under the clear coat. These stains should not be considered a defect in the paint (clear coat or color coat). Wrinkles in the Rapgard™ sometimes trap water and cause the paint to stain from the trapped moisture, especially on horizontal surfaces, such as the hood, roof, and trunk. Stains can be removed by heating the stained surface to remove the trapped moisture.

1. Use the aluminum foil or damp cloth to cover plastic/rubber parts that are near the stain.
2. Apply heat to the stain using an infrared lamp or heat gun.

Apply heat for 5 - 10 minutes at 158°F - 176°F (70°C - 80°C). Do NOT allow the surface to become hotter than 176°F (80°C). Measure the temperature with a thermometer.

3. After applying heat for 5 minutes, examine the area to determine if the stain has been removed. If the stain still exists, continue to apply heat and re-examine the stain 5 minutes later.
