TECHNICAL SERVICE INFORMATION

REF: SUSPENSION
NO: SU005-96
DATE: NOVEMBER 29, 1996
MODEL: ES 300

KNOCKING NOISE UNDER FLOOR IN REAR

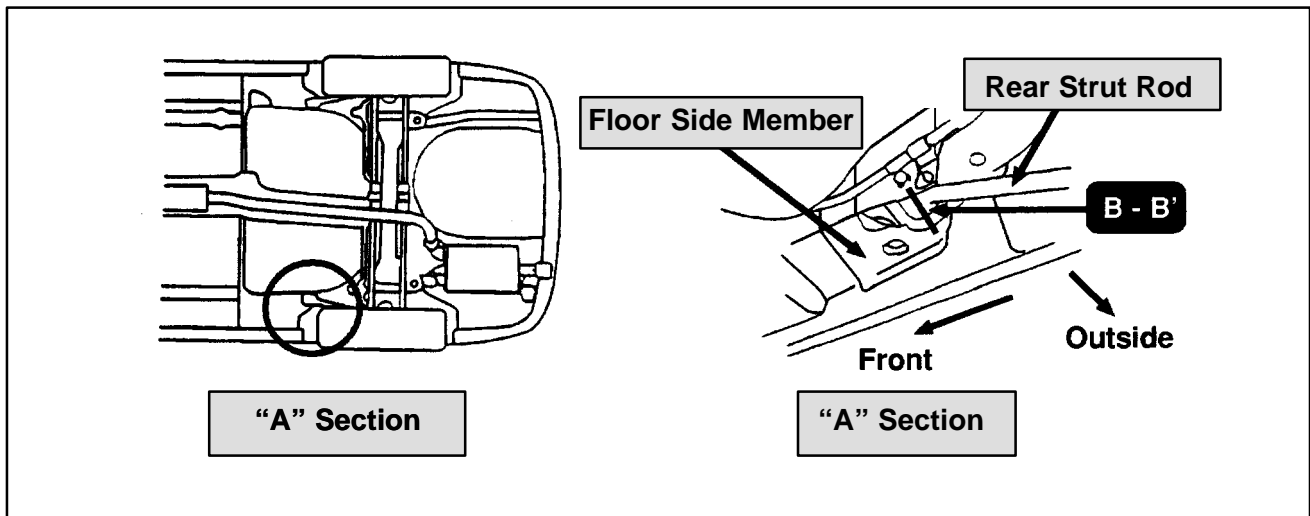
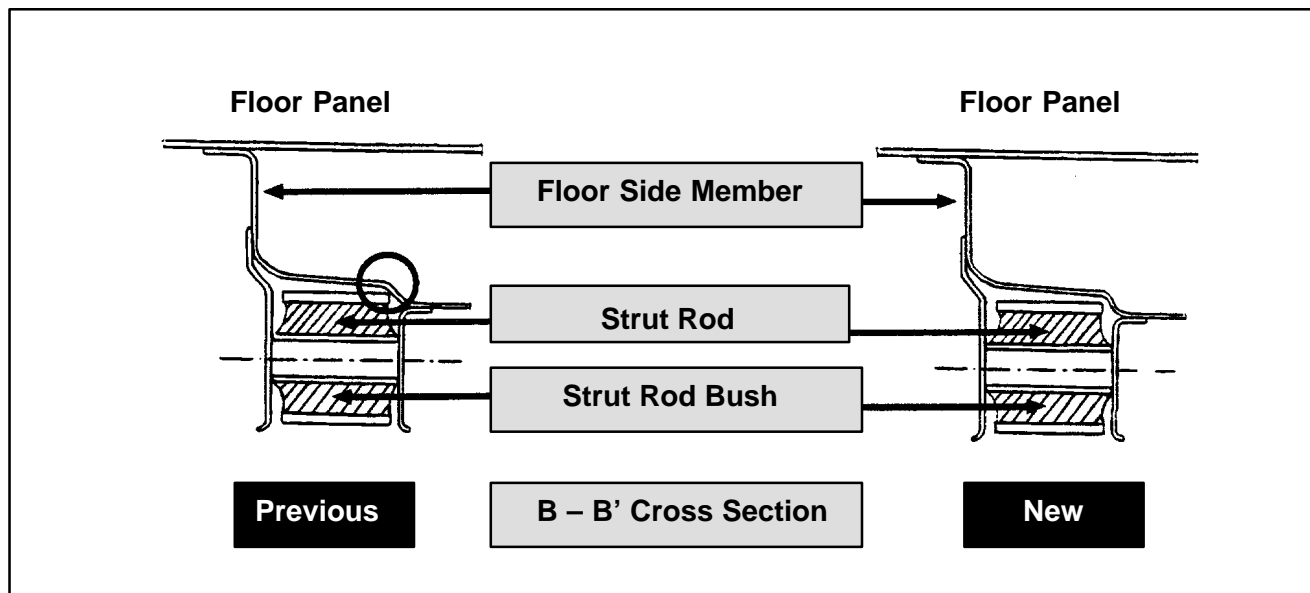
To eliminate a knocking noise heard under the floor in the rear, caused by interference between the rear floor side member and the front end of the rear strut rod, the clearance between the side member and the rear strut rod has been increased.
