2000 Lexus ES 300 V6-3.0L (1MZ-FE)

Suspension - Knocking Noise Under Floor In Rear

NO.: SU005-96

MODEL: ES 300

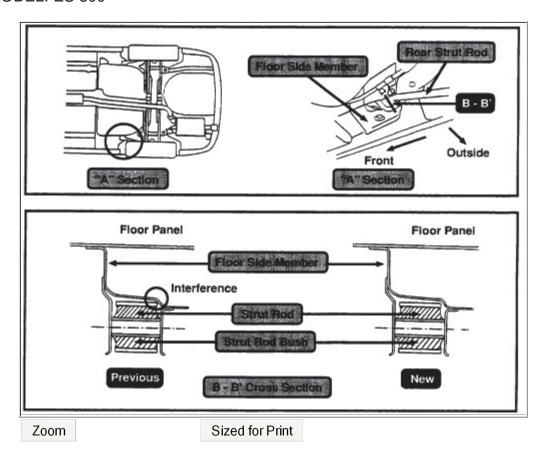
To eliminate a knocking noise heard under the floor in the rear, caused by interference between the rear floor side member and the front end of the rear strut rod, the clearance between the side member and the rear strut rod has been increased.
