**Repair
Procedure**

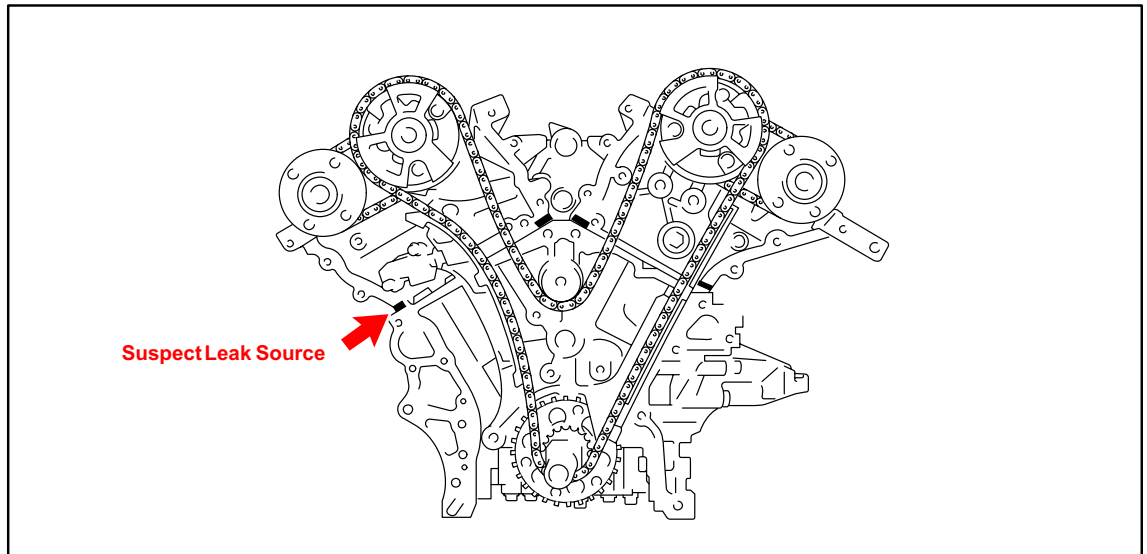
1. Inspect the location where the Bank 1 cylinder head, engine block, and timing cover meet for signs of an oil leak.
2. Use an oil dye to confirm the source of the oil leak.

3. Remove and reseal the timing cover if confirmed leaking.
Refer to the Technical Information System (TIS), 2007 model year ES 350 Repair Manual:
 - *Engine/Hybrid System – Lubrication – “2GR-FE Lubrication: Oil Pump: Removal”*
 - *Engine/Hybrid System – Lubrication – “2GR-FE Lubrication: Oil Pump: Installation”*
4. Confirm that the repair corrected the condition.
