Repair Manual Supplement: Vehicle Pulling to One Side

Service Category Steering

Section Steering Gear/Linkage

TSIB SUPERSESSION NOTICE

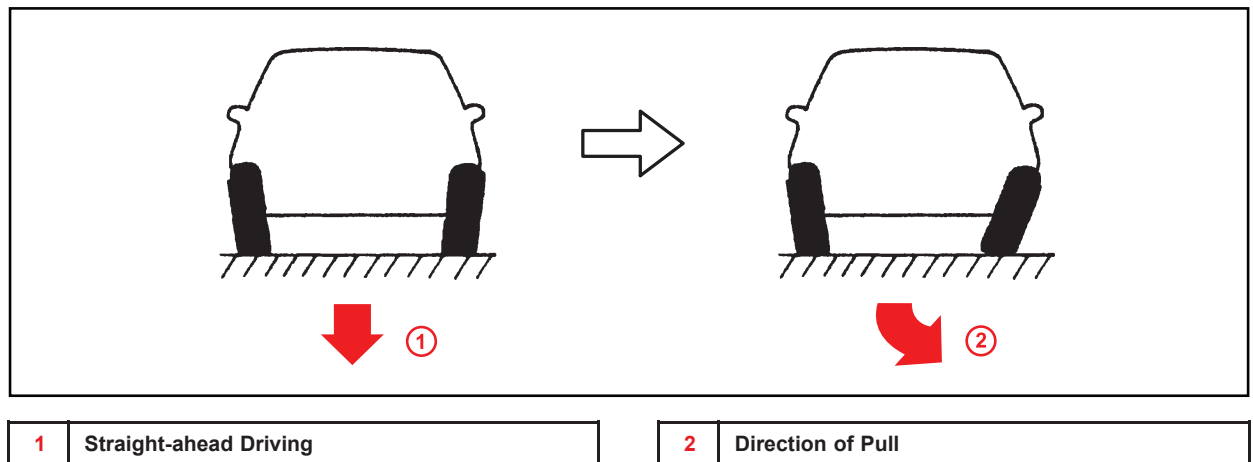
Figure 1. Camber

When the cross camber or caster of the front wheel alignment is large, it can cause vehicle pulling.

WHEEL ALIGNMENT	DIRECTION OF VEHICLE PULLING
Camber	Vehicle Pulls in Direction of Wheel with Large Camber Value (See Figure 1)
Caster	Vehicle Pulls in Direction of Wheel with Small Caster Value (See Figure 2)

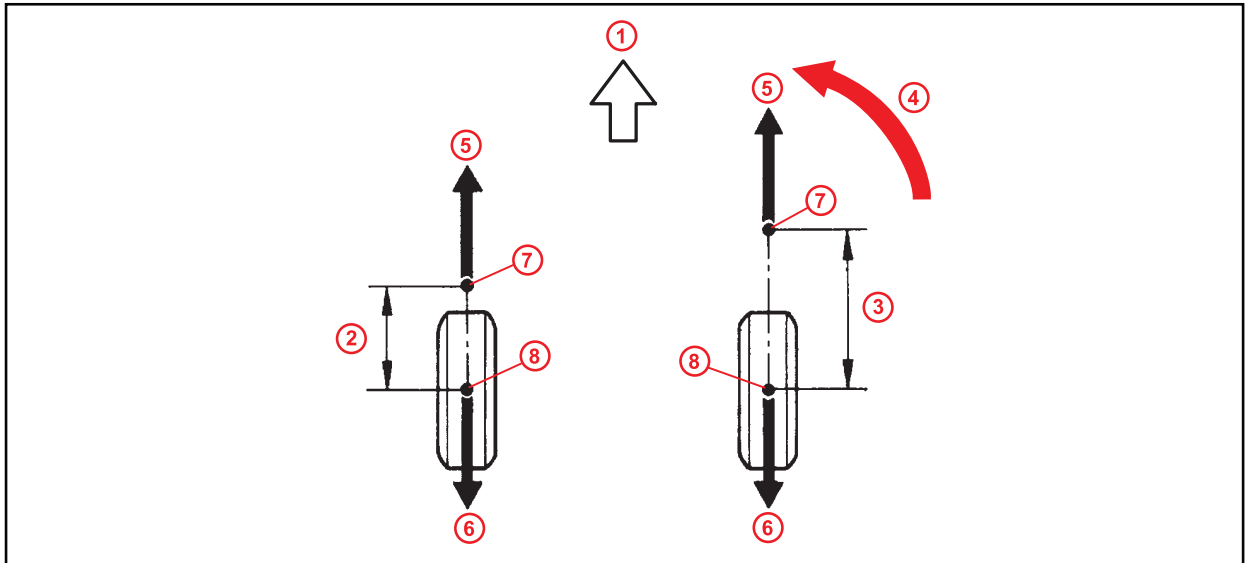
Figure 2. Caster

If the cross camber or caster is within the specified range (30' or less), noticeable vehicle pulling will not occur due to side-to-side differences in camber or caster.

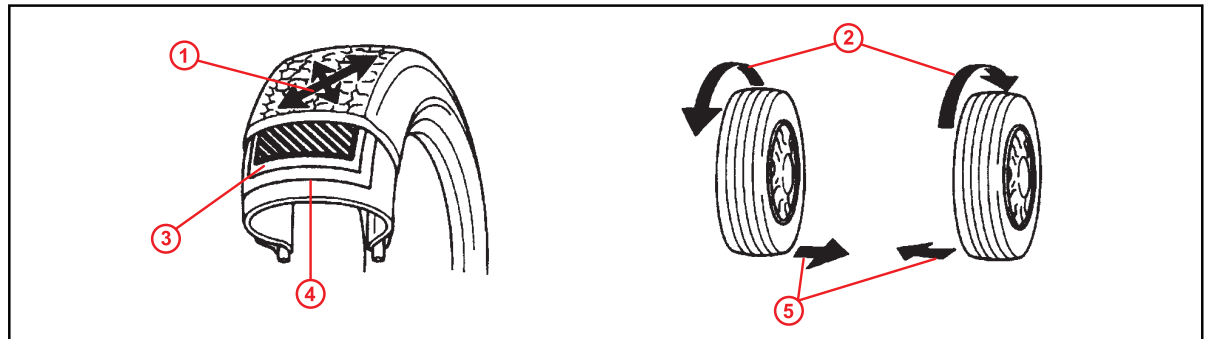
Figure 3.

Lateral force due to ply-steer is produced by the construction of the belts inside the tire tread. With radial tires, the wire of the belt is slanted as shown in the illustration below. Thus, it is in the lateral direction that tire tread easily changes shape (stretches), and lateral force is generated between the tire and the road surface in the lateral direction.

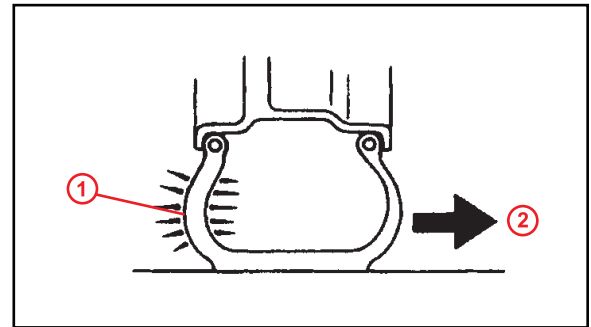
Figure 4.

Conicity is lateral force resulting from uneven formation of the left and right sides of the tire. The direction the lateral force is exerted depends on the hardness of the side walls and the difference in height between the left/right sides of the tire.

- In the case of vehicle pulling caused by tires, the lateral force which is exerted as a result of conicity has the greatest effect. On a flat road, if the steering wheel is held without exerting steering effort for 109 yards (100 m) when traveling at 62 mph (100 km/h), the vehicle may drift as much as 5 feet (1.5 m).
- When vehicle pulling is due to conicity, the amount of drift can be reduced and the direction of drift can be changed by changing the location of the tire or reversing the tire when installing it on the wheel.

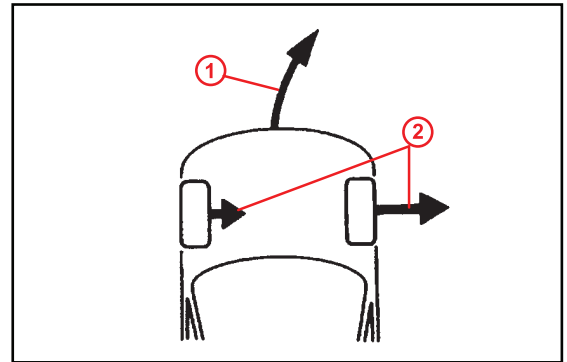
Figure 6. Original Tire Positions

- The direction of lateral force from tire conicity becomes reversed when the left and right tires are switched. Therefore, if the pulling direction changes when the tires are switched, it can be concluded that vehicle pulling is caused by tire conicity.
 - The vehicle is pulled to the right by the lateral force exerted to the right.

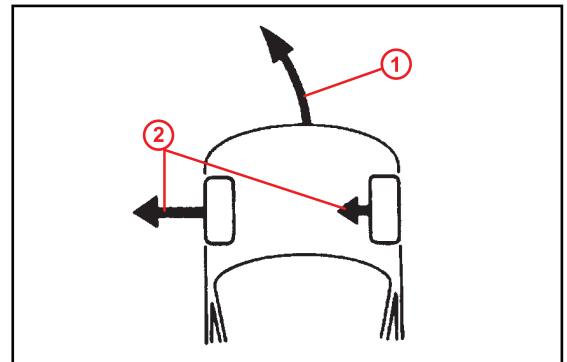
Figure 7. Tires Switched

- The direction of the tires which exerted lateral force to the right has been changed, so the tires now exert lateral force to the left and the vehicle now pulls to the left.

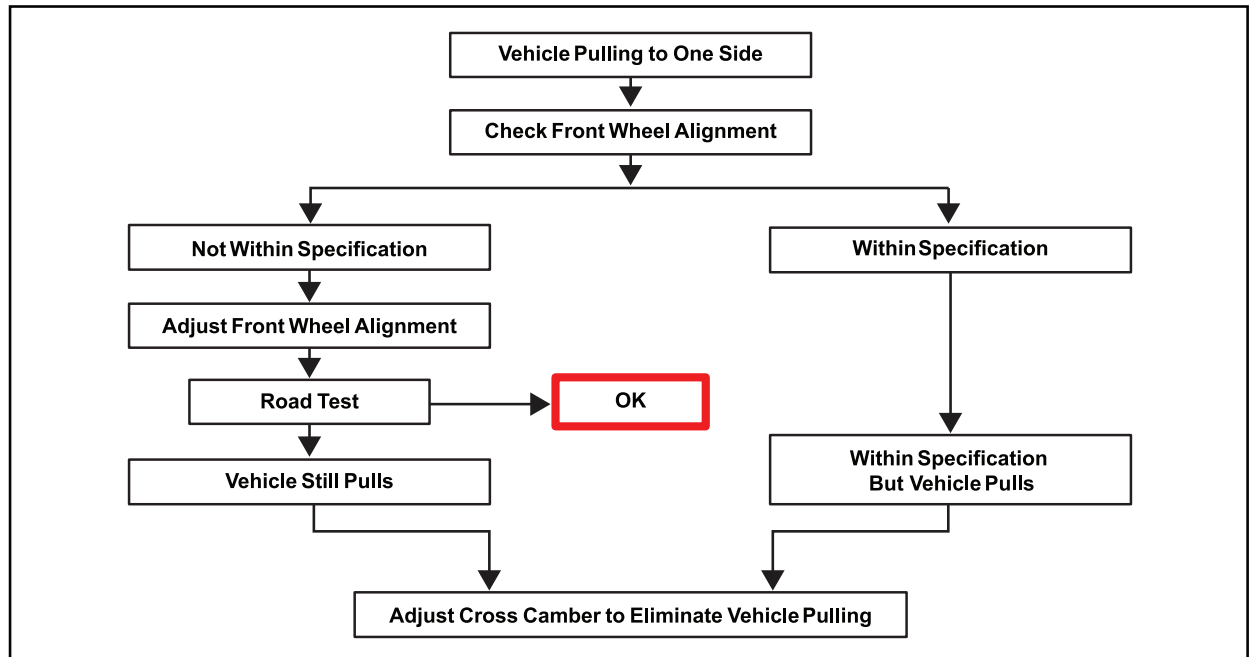
Figure 8.

When it is determined by troubleshooting that the vehicle pulling to one side is caused by wheel alignment, perform repairs according to the following procedure.

WHEN VEHICLE PULLS TO LEFT	WHEN VEHICLE PULLS TO RIGHT
Increase right front camber and decrease left front camber until vehicle pulling is eliminated	Increase left front camber and decrease right front camber until vehicle pulling is eliminated

- Keep the cross camber within 1° or less.
- Keep the camber of each wheel within specifications (+/-45' of center value).
- If adjustment exceeds the specifications, uneven tire wear will result.

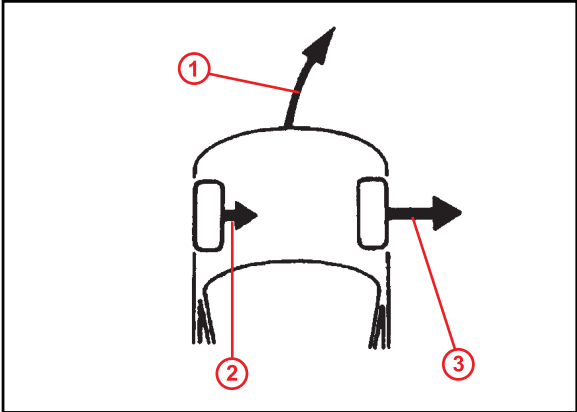
Figure 9. Original Tire Positions

The lateral force generated by the right front tire is greater than the left tire, so the vehicle is pulling due to the lateral force of the right tire.

- A. Remove the front left tire from the wheel and reverse the tire. Then perform a road test and check for change in the pulling direction.
