Repair Manual Supplement: Vehicle Pulling to One Side

Service Category Steering

Section Steering Gear/Linkage

TSIB SUPERSESSION NOTICE

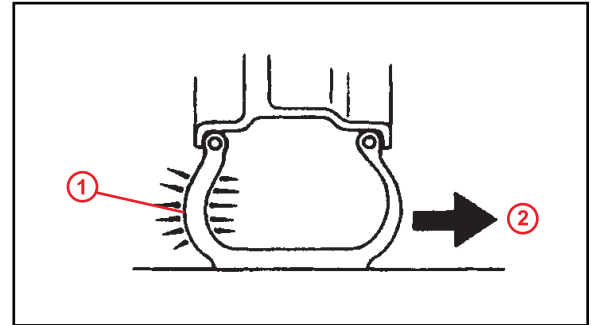
Figure 4.

Conicity is lateral force resulting from uneven formation of the left and right sides of the tire. The direction the lateral force is exerted depends on the hardness of the side walls and the difference in height between the left/right sides of the tire.

- In the case of vehicle pulling caused by tires, the lateral force which is exerted as a result of conicity has the greatest effect. On a flat road, if the steering wheel is held without exerting steering effort for 109 yards (100 m) when traveling at 62 mph (100 km/h), the vehicle may drift as much as 5 feet (1.5 m).
- When vehicle pulling is due to conicity, the amount of drift can be reduced and the direction of drift can be changed by changing the location of the tire or reversing the tire when installing it on the wheel.

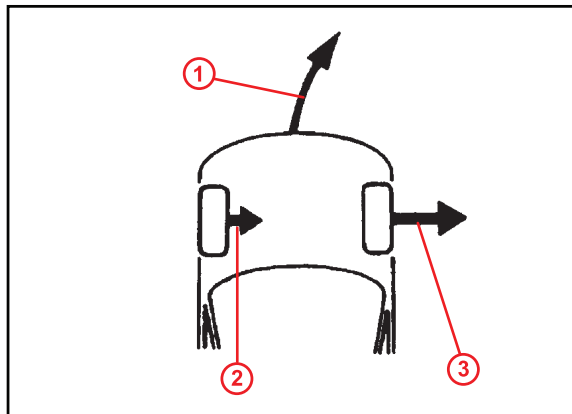
Figure 9. Original Tire Positions

The lateral force generated by the right front tire is greater than the left tire, so the vehicle is pulling due to the lateral force of the right tire.

If Vehicle Pulls in the Same Direction: Go to step 3B.

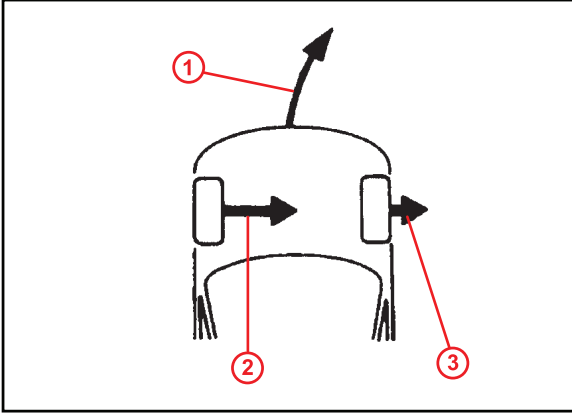
Figure 11. Original Tire Positions

The lateral force generated by the left front tire is greater than the right tire, so the vehicle is pulling due to the lateral force of the left tire.

If Vehicle Pulls in the Opposite Direction: Go to step 3B.
