Introduction

L-SB-0016-10 February 8, 2010 Page 2 of 10

HVAC Evaporator Drain Blockage

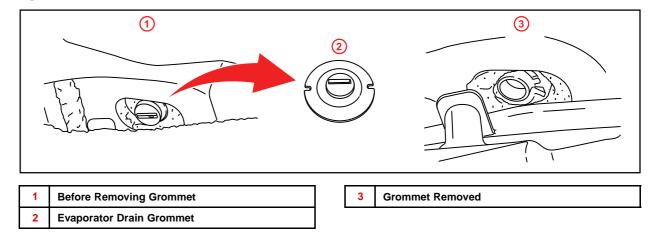
Figure 13.

11. Take a long pair of needle nose pliers and gently pull out the evaporator drain grommet (see Figure 13). Confirm that there is NO foam blocking the evaporator drain port. If foam is blocking the drain port, trim only the foam that is blocking the port.

Confirm that you are ONLY pulling on the evaporator drain grommet. There is foam located behind the grommet that should not be pulled on.
