Instrument Panel Rattle

YEAR(S)	MODEL(S)	ADDITIONAL INFORMATION
2006 – 2007	GS300, GS350, GS430, GS450H

Some customers may complain of rattle noises coming from the front of the instrument panel at the base of the windshield. The following procedures have been developed to improve this condition.

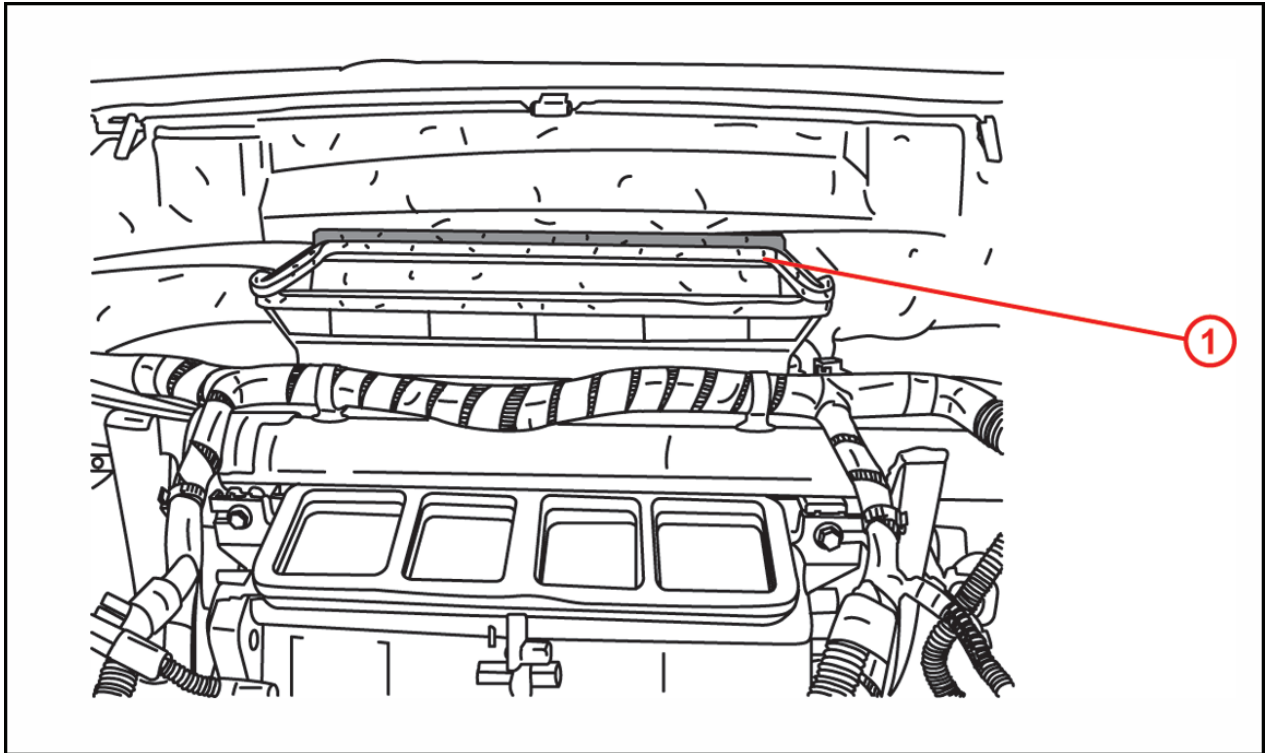
1	Felt Location
----------	---------------

4. Apply felt along the defroster nozzle lip as shown in Figure 2.

Felt Size:

Length: 29 cm (11.42 in.)

Width: 14 mm (0.55 in.)

Thickness: 0.5 mm (0.02 in.)

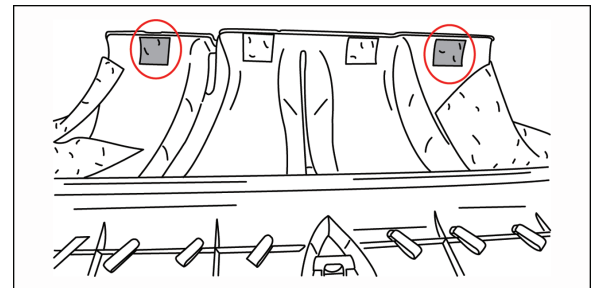
NOTE
Instrument panel pad is shown upside down.

5. Apply foam to the instrument pad HVAC duct as shown in Figure 3.

Foam Size:
Length: 30 mm (1.18 in.)
Width: 30 mm (1.18 in.)
Thickness: 5 mm (0.20 in.)

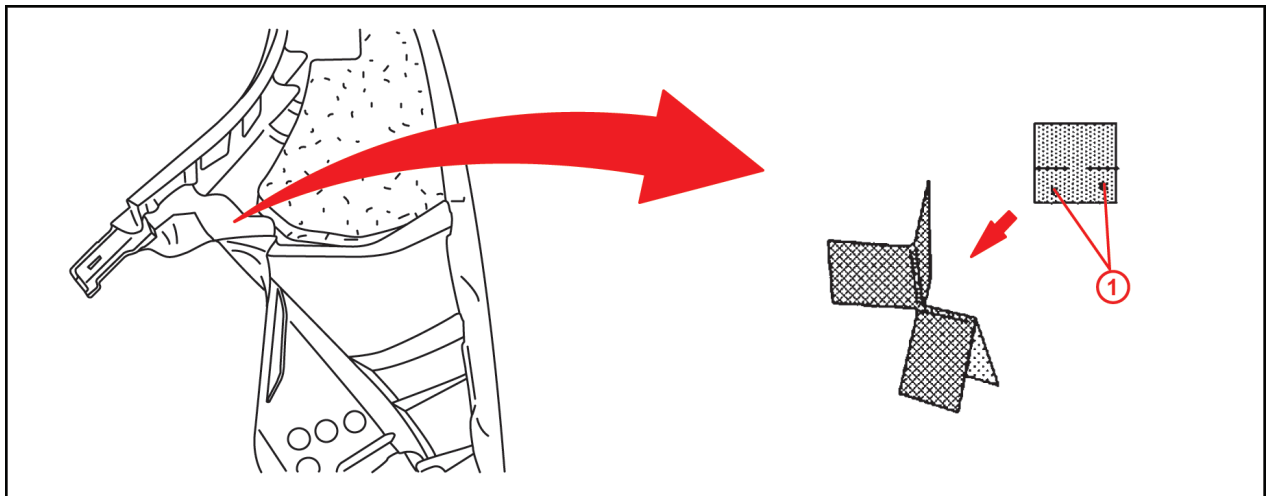
1	Slit
----------	-------------

1. Add felt to the "A" pillar garnish ribbing as shown in Figure 4.

Felt Size:

Length: 10 mm (0.39 in.)

Width: 10 mm (0.39 in.)

Thickness: 0.5 mm (0.02 in.)

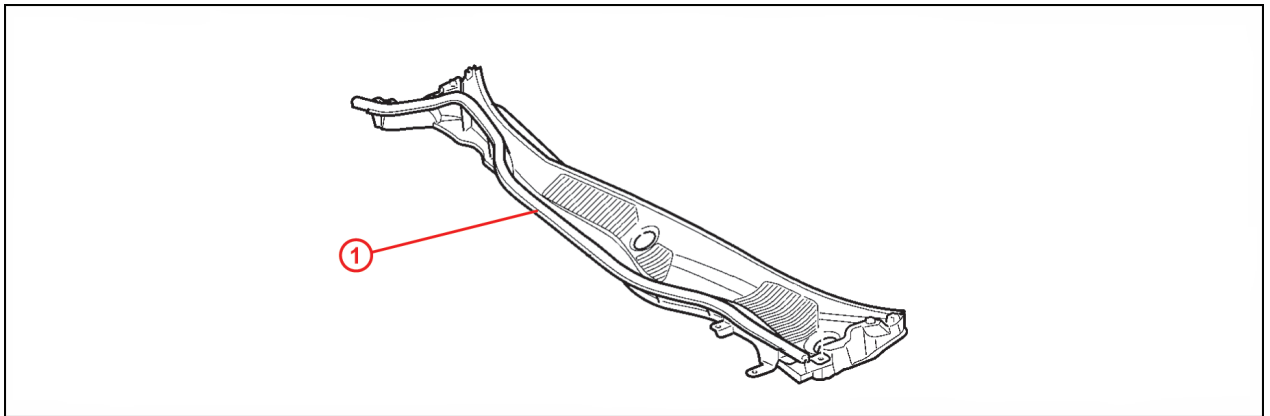
Figure 5.

1	Cowl Top Ventilator Louver Sub-assembly
---	---

2. Replace the cowl louver with an updated part (P/N 55708–30100).
