DIY – How to replace GX470 Rear Drive Shaft Propeller – for Clunk / Thump Noise.

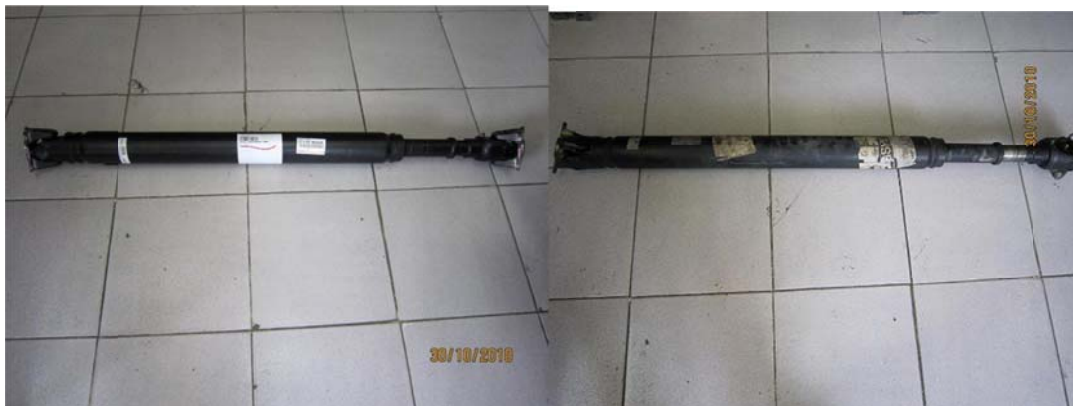
A View of both Old Shaft and New Shaft

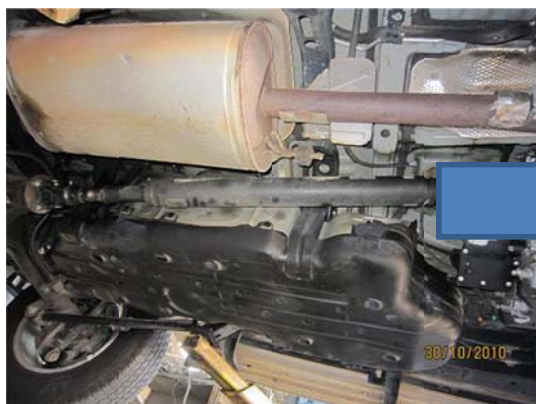
Location of the Propeller Shaft : (For Non Tech Guys)

The shaft location is simple, located on the Rear between the Transfer and the Rear Wheel parallel to the Canister.. **Here is what you need to replace**, if required. An image for more visibility.

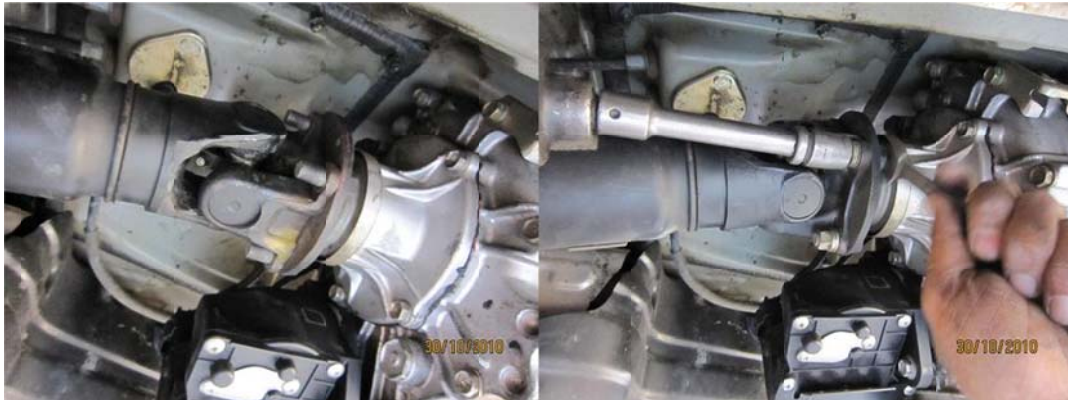
Removal Method:-First Place Notch marks on the Propeller Shaft, Yoke and the Transfer Flange. The Existing Old Shaft had already a notch which has a Yellow Paint Mark for the front and Pink for the Rear Image of the Notch Mark Sample. This was done by the Previous TSB carried out by the dealer during warranty.

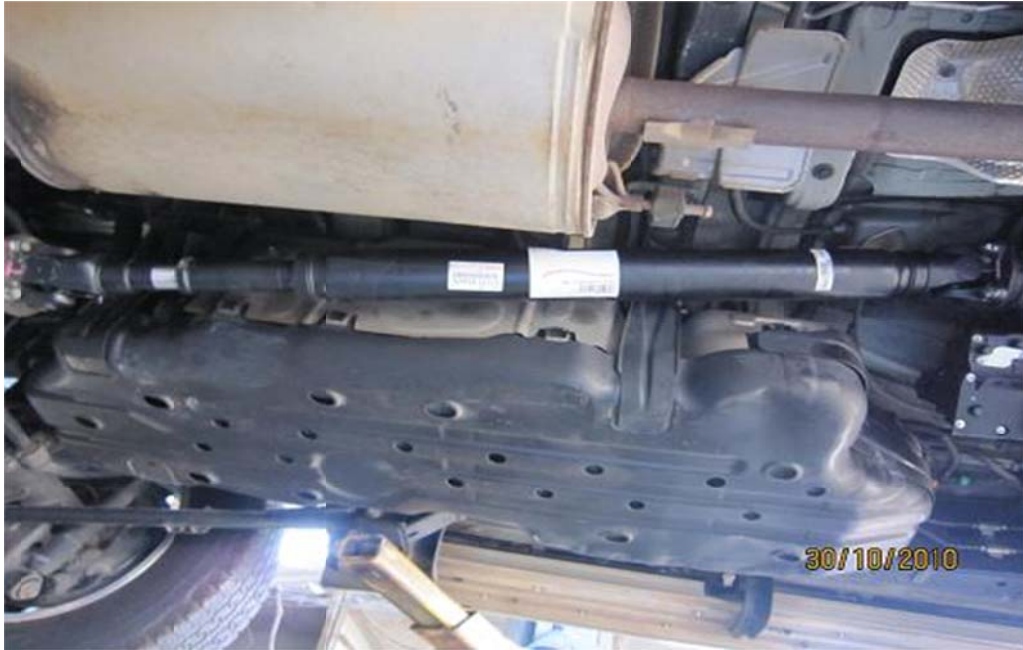
Here is the Complete Installed View

The Drive has been really smooth, more response at the Start on throttle , took a long drive, again real difference on the acceleration part, braking, no more thumps, bumps on the rear.
Hope this helps to all.
