Rear Driveshaft/Propeller Shaft Clunk/Thump Noise

TSIB SUPERSESSION NOTICE

The information contained in this TSIB supersedes TSIB No. DL002-07.

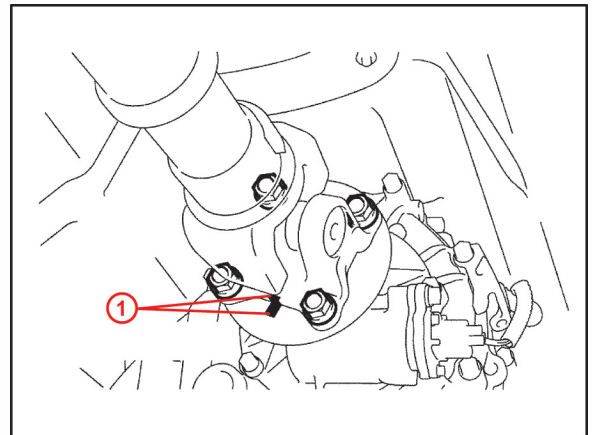
Figure 1.

1	Matchmarks
----------	-------------------

- (1) Remove the 4 nuts and 4 washers (propeller shaft to transfer flange).

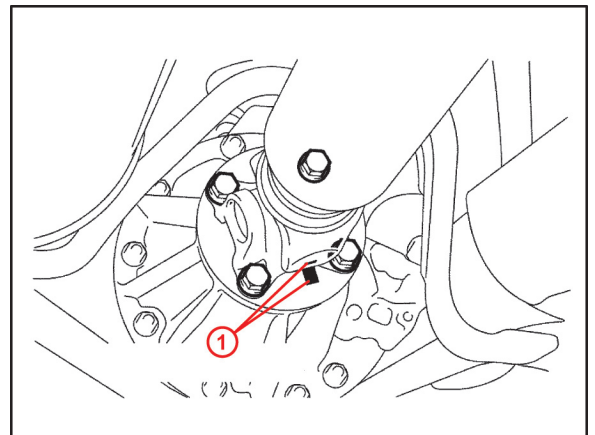
Figure 2.

1	Matchmarks
----------	-------------------

- (2) Remove the 4 nuts, 4 bolts, and 4 washers and then the propeller shaft assembly (propeller shaft to differential flange).

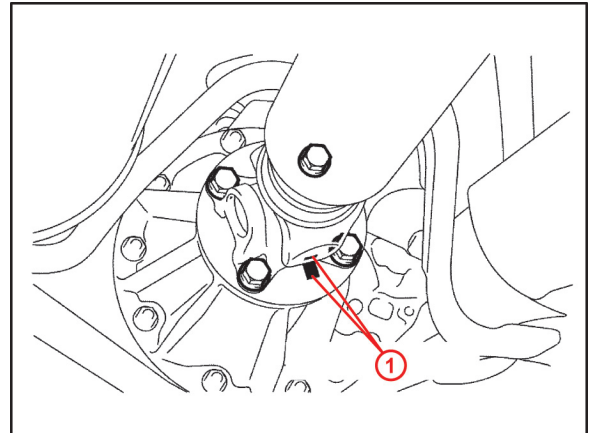
Figure 3.

1	Matchmarks
----------	-------------------

- (1) Align the matchmarks on the yoke and the differential flange.

- (2) Install the propeller shaft assembly with the 4 bolts, 4 nuts, and 4 washers.

Torque: 88 N*m (898 kgf*cm, 65 ft*lbf)

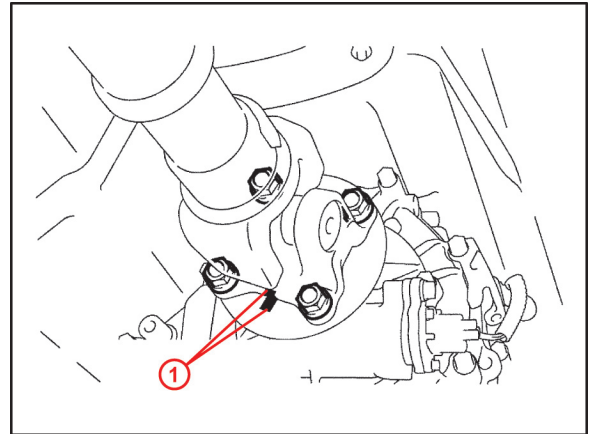
Figure 4.

1	Matchmarks
----------	-------------------

- (3) Align the matchmarks on the yoke and the transfer flange.

- (4) Install the propeller shaft assembly with the 4 nuts and 4 washers.

Torque: 88 N*m (898 kgf*cm, 65 ft*lbf)
