# MIL "ON" DTC P2440/P2442

## Applicability

YEAR(S)	MODEL(S)	ADDITIONAL INFORMATION
2014 - 2016	GX460

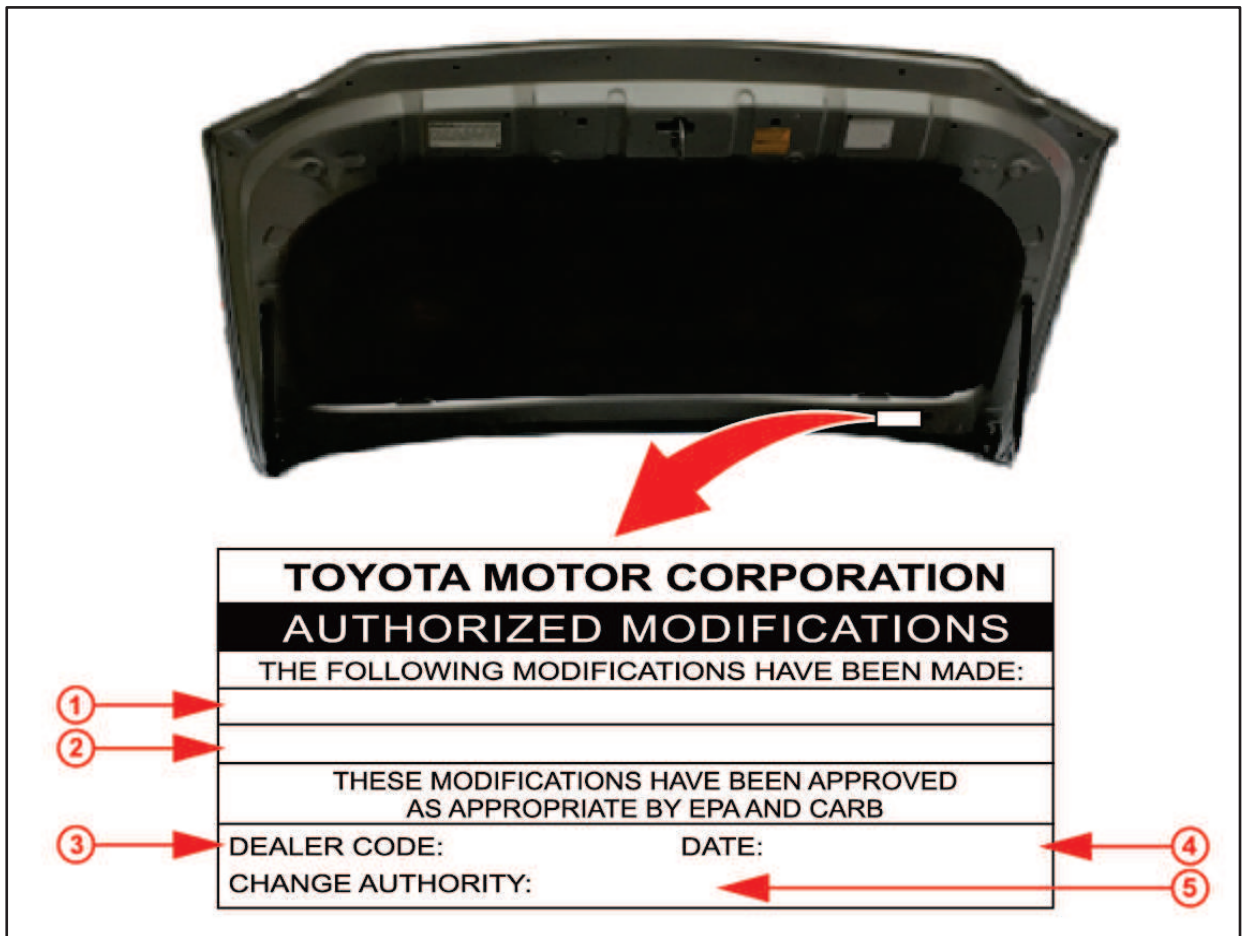
**Figure 1. Location of Authorized Modification Label for 2014 – 2016 GX 460**

2. Check for the Authorized Modification Label affixed to the vehicle in the location shown below. Confirm the ECM (PCM) calibration has been updated.

- Install the Authorized Modifications Label.
  - Using a permanent marker, enter the following information on the label:
    - ECM part number [*Refer to the **Parts Information** section for the **NEW PART NUMBER***]
    - Calibration ID(s) [*Refer to the **Calibration Information** section for the **NEW CALIBRATION ID***]
    - Dealer Code
    - Repair Date
    - Change Authority [**This bulletin number**]
  - Affix the Authorized Modifications Label to the vehicle at the location shown in Figure 1. The Authorized Modifications Label is available through the MDC, P/N 00451-00001-LBL.
- Test drive the vehicle to confirm proper vehicle operation.
