**Technical Service
Information Bulletin**

Title:
**UPPER/LOWER WINDSHIELD
TICK NOISE**

Models:
'03 - '07 Lexus

**REVISI
ED**
NV005-06
NVH

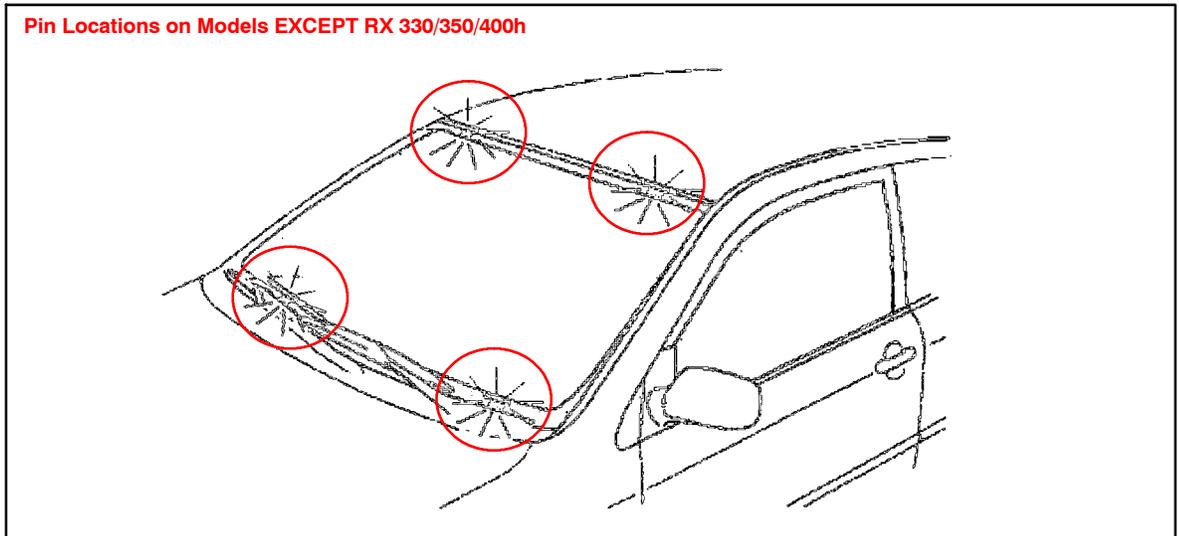
Pin Locations on Models EXCEPT RX 330/350/400h

If a creak, tick, or rattle noise is heard at the top or bottom of the windshield, the source of the noise may be the two windshield stoppers bonded to the top of the windshield or the windshield retainers bonded to the lower edge of the windshield. This bulletin provides the recommended repair procedure to eliminate these types of noises from the windshield area.

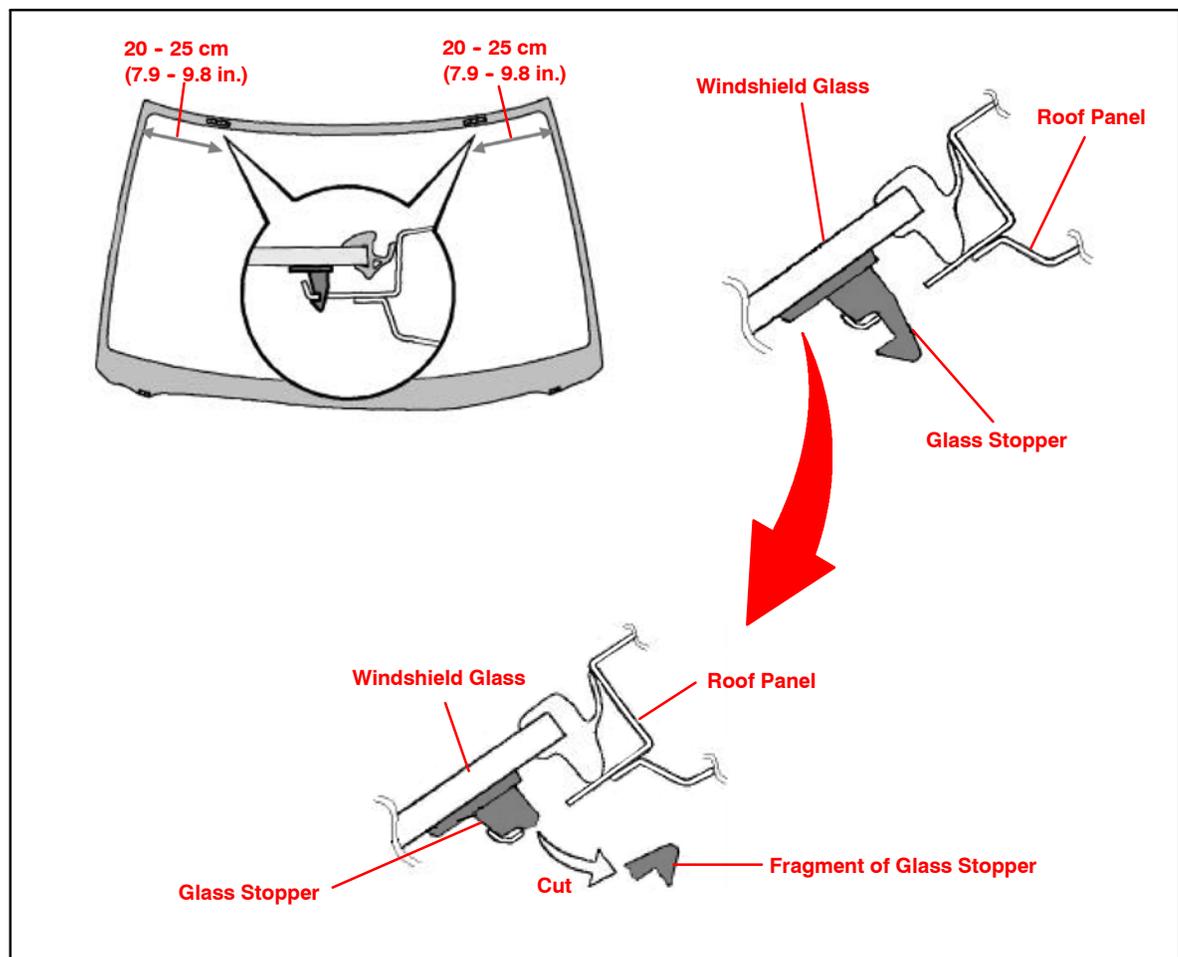
The stoppers are located on the inside of the passenger compartment behind the windshield glass blackout section (near the top front edge of the metal roof opening). The stoppers are typically located 20 - 25 cm (7.9 - 9.8 in.) inboard of the top corners of the windshield glass.

2. Cut OFF the tip of the plastic stopper as shown in the illustration.

It is sometimes necessary to bend the metal body tab down to gain access to the shaft of the stopper.

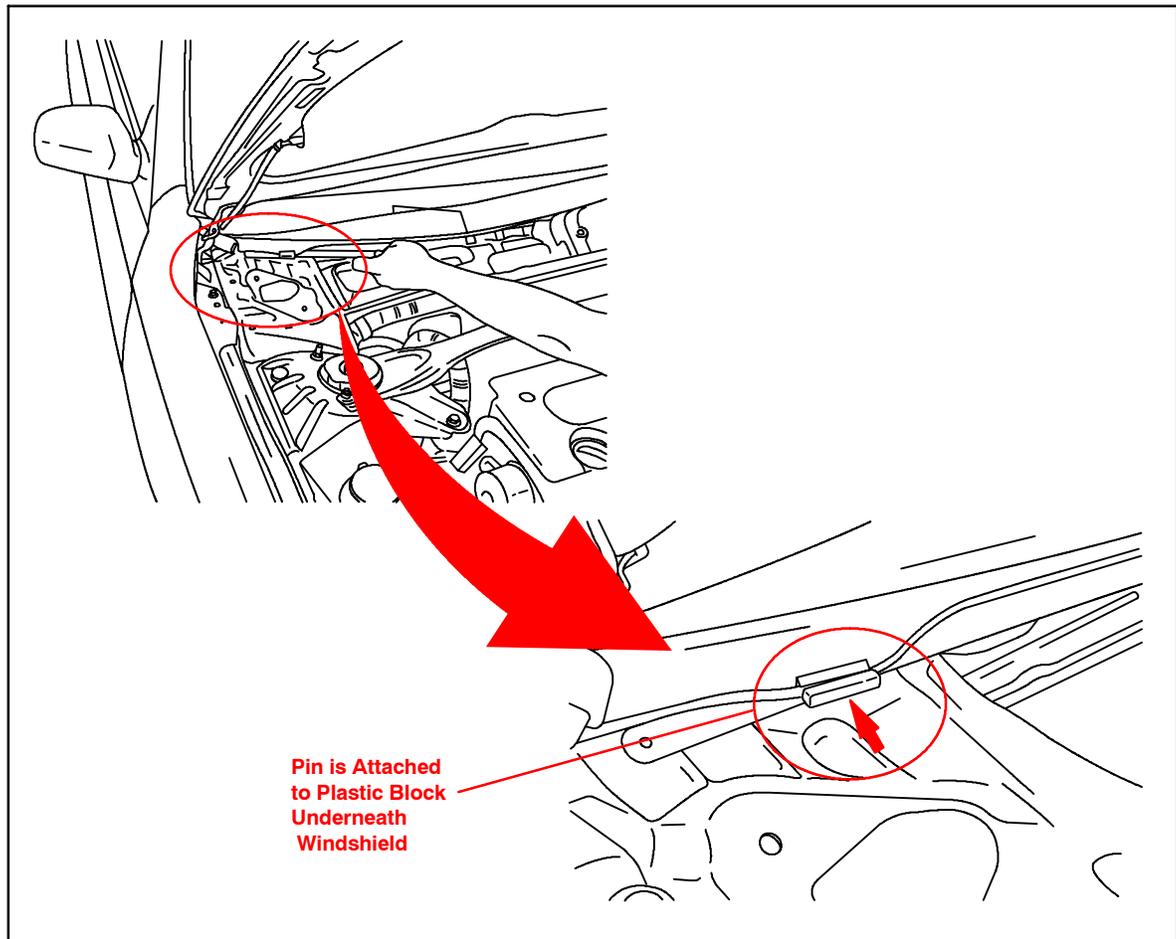
The retainers are typically located 140 - 200 mm (5.5 - 7.9 in.) inboard of the lower corners of the windshield. The flat portion of the retainer is adhered to the backside of the windshield with double-sided, foam-backed tape.

2. Locate the lower windshield retainers.
