**Technical Service
Information Bulletin**

Title:
INSTRUMENT PANEL RATTLE

Models:
'06 IS 250 & IS 350

REVISED
NV003-06
NVH

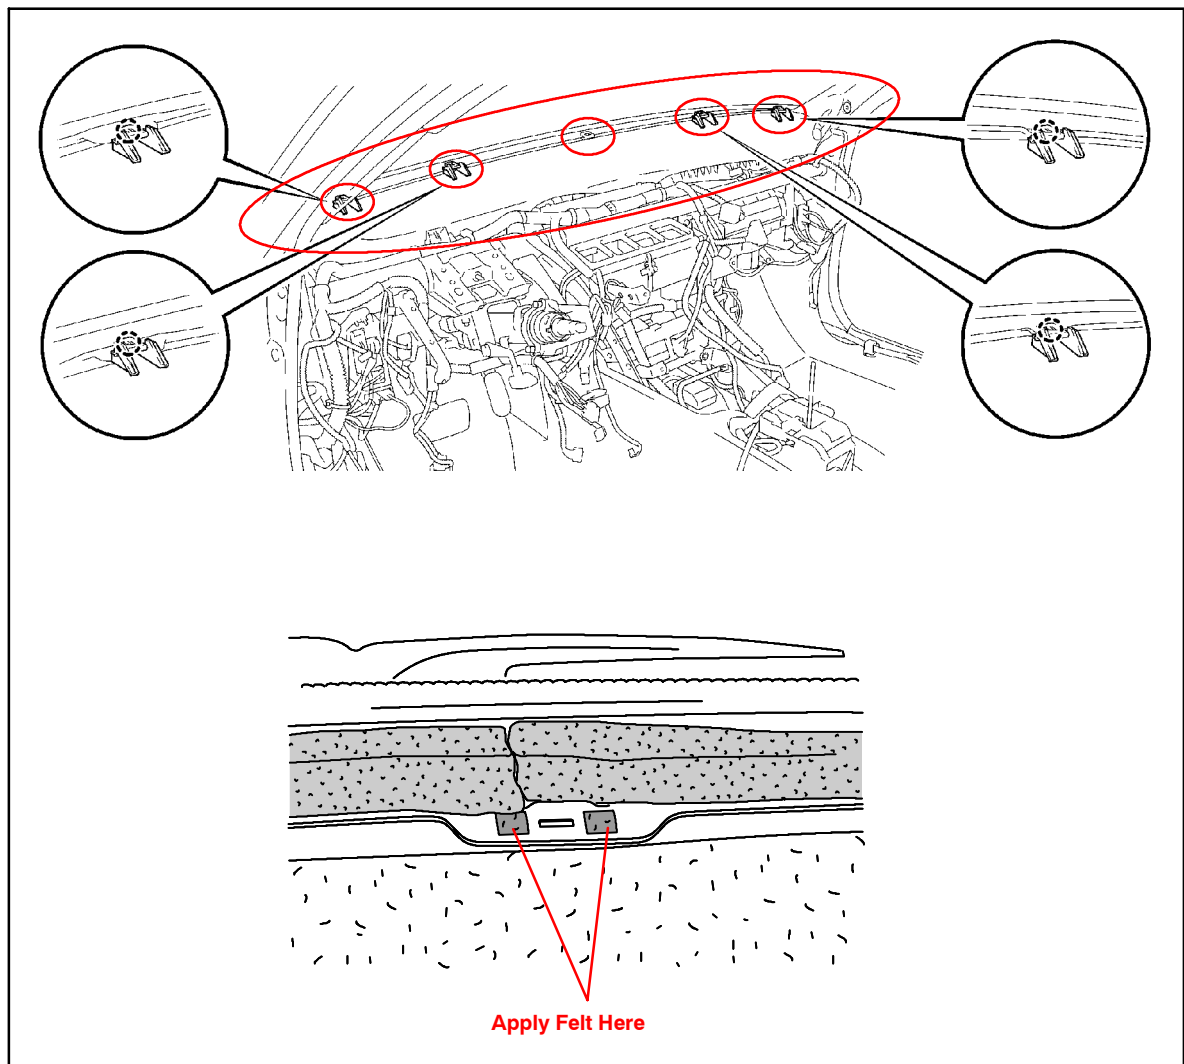
Introduction Some customers may complain of rattle noises coming from the front of the instrument panel at the base of the windshield. The following procedure has been developed to improve this condition.

1. Remove the instrument panel sub-assembly.
Refer to the Technical Information System (TIS), 2006 model year IS 250 or IS 350 Repair Manual: *Instrument Panel: Instrument Panel Safety Pad: Removal, Disassembly.*
2. Remove the instrument panel sub-assembly to expose the instrument panel attachment clips.
3. Remove the instrument panel attachment clips and apply two (2) felt squares to each of the five (5) cowl side attachment points as shown in the following illustration.

Felt Size:**Length: 10 mm (0.39 in.)****Width: 10 mm (0.39 in.)****Thickness: 0.5 mm (0.02 in.)**

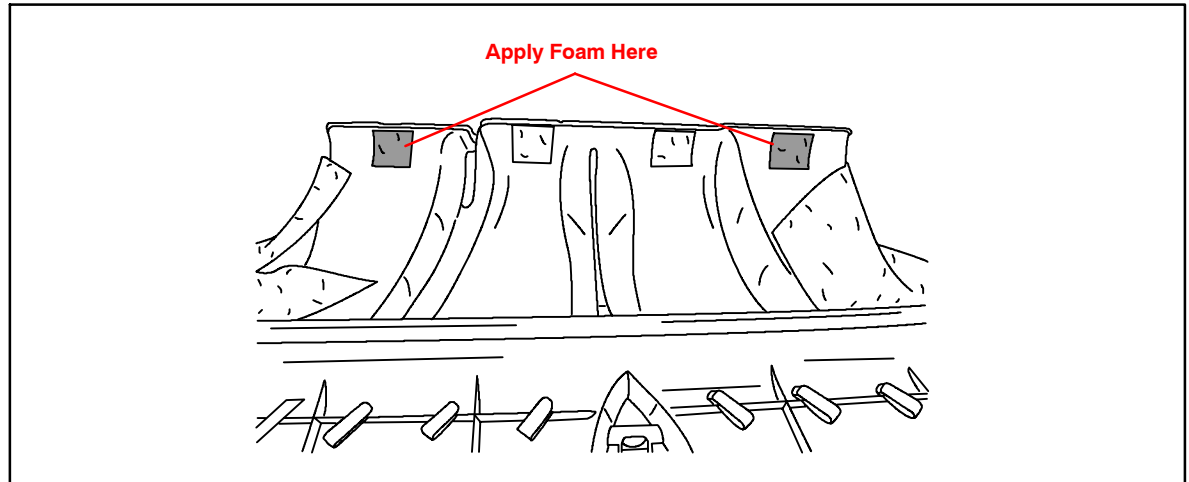
Instrument panel pad is shown upside down.

5. Apply foam to the instrument pad HVAC duct as shown in the following illustration.

Foam Size:

- Length: 30 mm (1.18 in.)**
- Width: 30 mm (1.18 in.)**
- Thickness: 5 mm (0.20 in.)**
