Service Category	Vehicle Interior		Lexus Supports	
Section	Heating/Air Conditioning	Market	USA	Lexus Supports ASE Certification

TSIB SUPERSESSION NOTICE

Introduction

Some GS and IS vehicles may exhibit a condition of water present on the front or rear carpets of the vehicle due to the HVAC evaporator drain becoming blocked by debris. Use the following repair procedure to correct this condition.

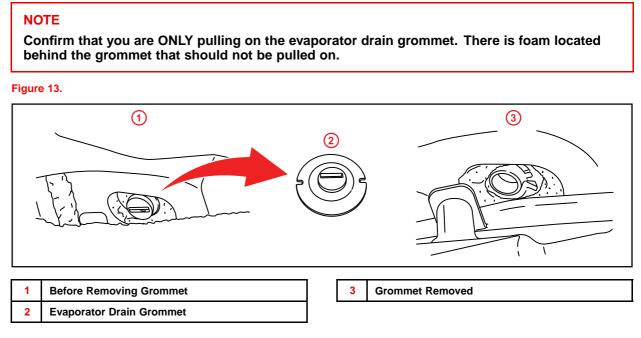
11. Take a long pair of needle nose pliers and gently pull out the evaporator drain grommet (see Figure 13). Confirm that there is NO foam blocking the evaporator drain port. If foam is blocking the drain port, trim only the foam that is blocking the port.

- Install the shift linkage bolt.
 Torque: 16 N*m (163 kgf*cm, 12 ft*lbf)
- 13. Raise the transmission back to its original position and install the 4 bolts to the cross member. Torque: 26 N*m (265 kgf*cm, 19 ft*lbf)
