L-TCI-5015 Rev. 1 Sept

8AR Rocking (Forward and Back) Sensation on Acceleration

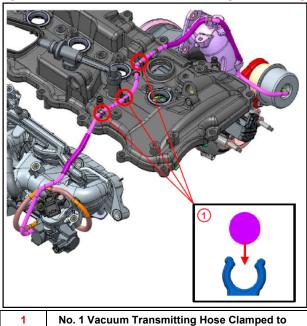
Figure 1. Previous No. 1 Vacuum Transmitting Hose Routing

Figure 1 shows the routing of the previous No. 1 vacuum transmitting hose.

Cylinder Head Cover at Three Portions

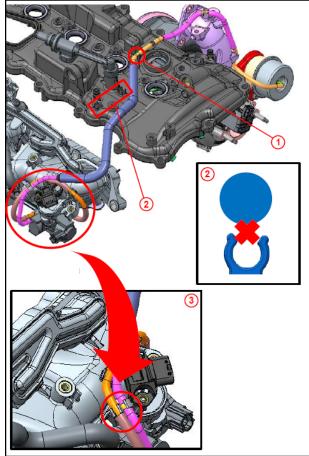
Figure 2. New No. 1 Vacuum Transmitting Hose Routing

1	No. 1 Vacuum Transmitting Hose Clamped to Cylinder Head Cover at One Portion
2	Cylinder Head Covers Incompatible With New No. 1 Vacuum Transmitting Hose
3	Additional Clamp Point (No. 1 Vacuum Transmitting Hose is Clamped to Other Hose by Using Hose Clamp)

3. Replace the No. 1 vacuum transmitting hose with the NEW No. 1 vacuum transmitting hose. Follow the routing as shown in Figure 2.
