Wind Noise from Front Side Glass

Service Category Vehicle Exterior

Section Window/Glass

YEAR(S)	MODEL(S)	ADDITIONAL INFORMATION
2010	RX350

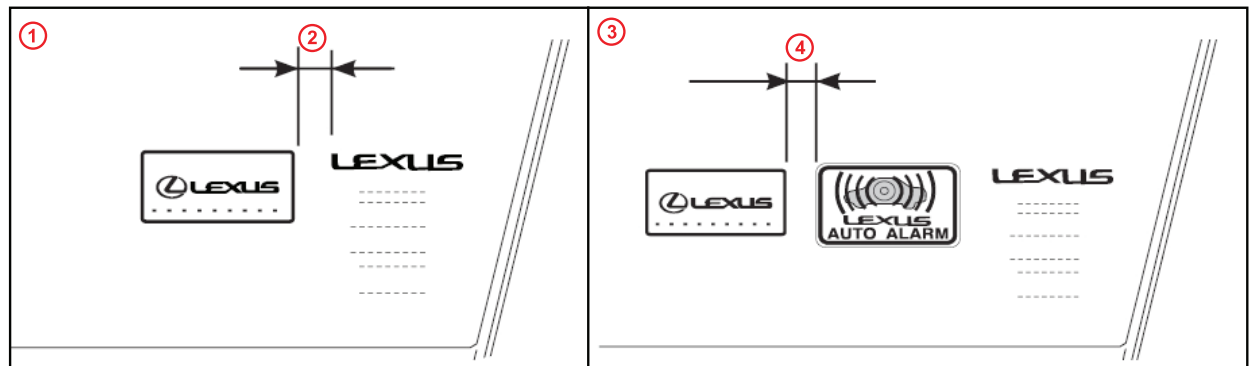
1	How to Align to the Etching
2	10 mm

3	How to Align to Other Labels
4	1–5 mm

4. Install window labels in correct position.
 - A. Use household glass cleaner to clean the inside of the front door windows.
 - B. Use a piece of clear tape to lift the label from the protective backing.
 - C. Attach the label as shown in Figure 1.
 - D. Repeat steps A–C with the other window

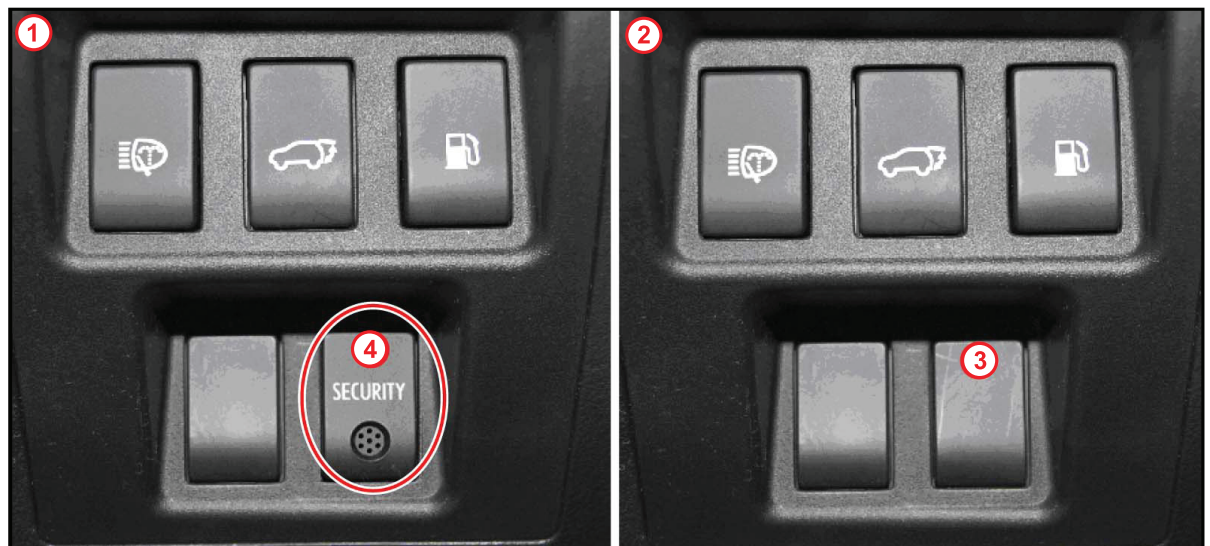
Figure 2.

1	Factory Installed
2	PPO / DIO Installed

3	No "Security" Tab
4	Security Tab

5. Glass Breakage Sensor Calibration, if applicable.
 - A. For vehicles equipped with a Glass Breakage Sensor, the sensor position and/or system sensitivity will need to be calibrated for the new glass.
 - B. Determine if the Glass Breakage Sensor was installed at the Factory or as a Post Production Option (PPO)/ Dealer Installed Option (DIO).

- C. If Factory Installed, follow the PPO/DIO Glass Breakage Sensor Accessory Installation Procedure in TIS to adjust GBS system sensitivity for acoustic glass.

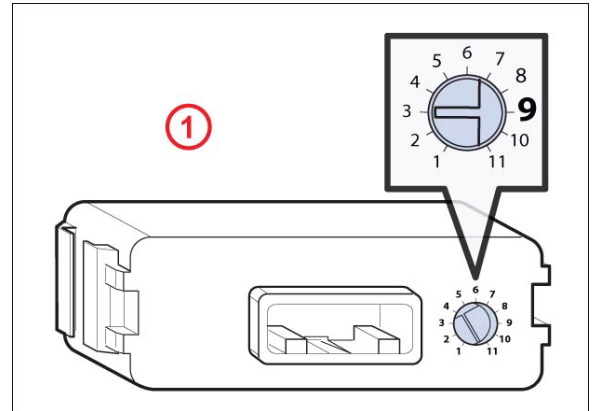
Figure 3.

1 Vehicles with Acoustic Windows Only

- D. If PPO/DIO, follow the PPO/DIO Glass Breakage Sensor Accessory Installation Procedure in TIS to adjust GBS system sensitivity and relocate the GBS microphone for acoustic glass.

System Sensitivity should be set to 9.
