Hesitation on Acceleration

Service Category Engine/Hybrid System

Section Engine Control

YEAR(S)	MODEL(S)	ADDITIONAL INFORMATION
2007 – 2008	LS460

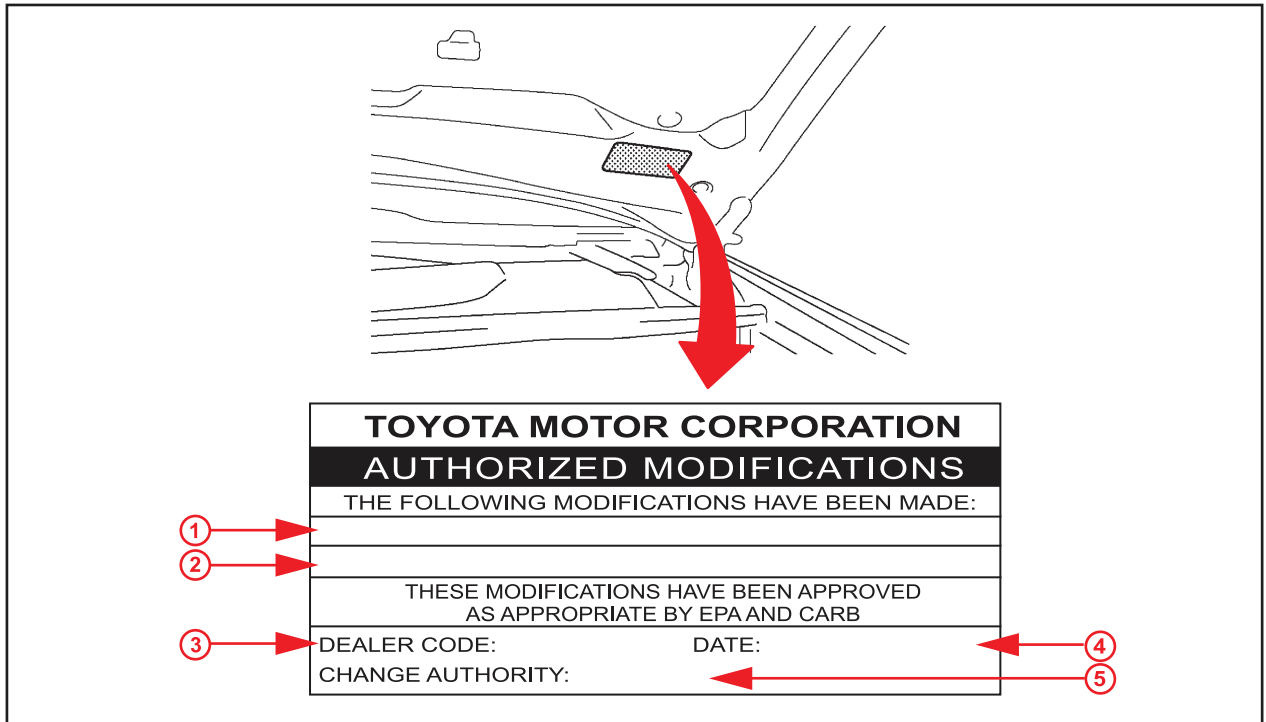
Figure 1. Location of Authorized Modifications Label on 2007 LS 460

1. Check for the Authorized Modifications Label affixed to the vehicle in the location shown in Figure 1. Confirm if the ECM (PCM) calibration has been updated. If the calibration ID listed is NOT the latest ECM (PCM) calibration — go to step 2.

3. Install the Authorized Modifications Label.
 - A. Using a permanent marker, enter the following information on the label:
 - ECM part number [Refer to the **Parts Information** section for the **CURRENT PART NUMBER**]
 - Calibration ID(s) [Refer to the **Calibration Identification Chart** for the **NEW CALIBRATION ID**]
 - Dealer Code
 - Repair Date
 - Change Authority [**This TSIB** number]
 - B. Affix the Authorized Modifications Label to the vehicle at the location shown in Figure 1. The Authorized Modifications Label is available through the MDC, P/N 00451-00001-LBL.
4. Start the engine and warm it up to normal operating temperature before test driving.
5. Test drive the vehicle to confirm that the hesitation is NO longer present.
