Vehicle Pulling to One Side

Service Category Suspension

Section Alignment/Handling Diagnoses

YEAR(S)	MODEL(S)	ADDITIONAL INFORMATION
2007 – 2008	LS460	VDS(s): BL46F, GL46F
2008	LS600H	VDS(s): DU46F

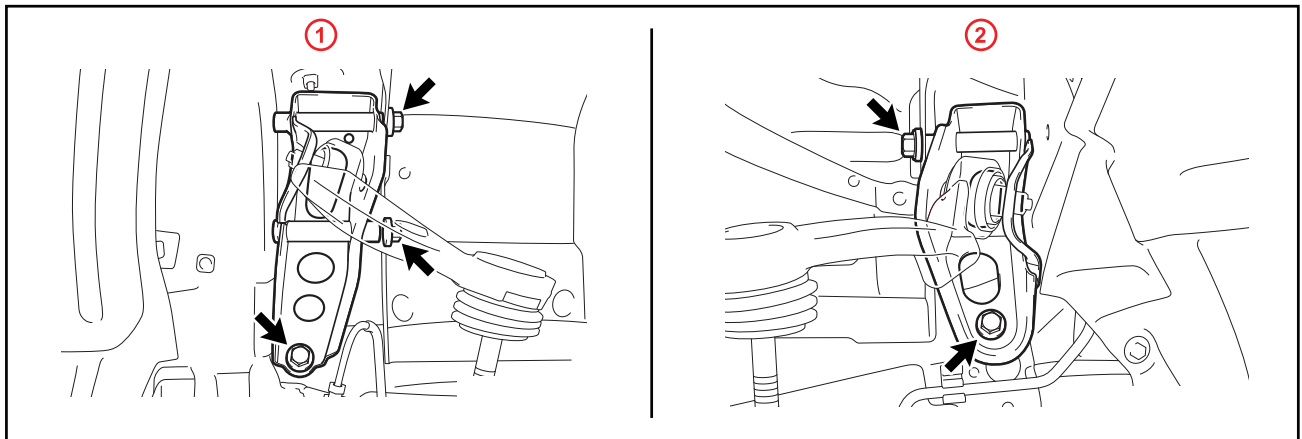
Figure 1.

1 No. 1 Arm Attachment Plate Inner (LH Shown)

2 No. 2 Arm Attachment Plate Inner (LH Shown)

- No. 1 arm has 3 attachment bolts and is the upper control arm towards the FRONT of the vehicle.
- No. 2 arm has 2 attachment bolts and is the upper control arm towards the REAR of the vehicle.
