Hesitation on Acceleration

Service Category Engine/Hybrid System

Section Engine Control

YEAR(S)	MODEL(S)	ADDITIONAL INFORMATION
2007 – 2008	LS460

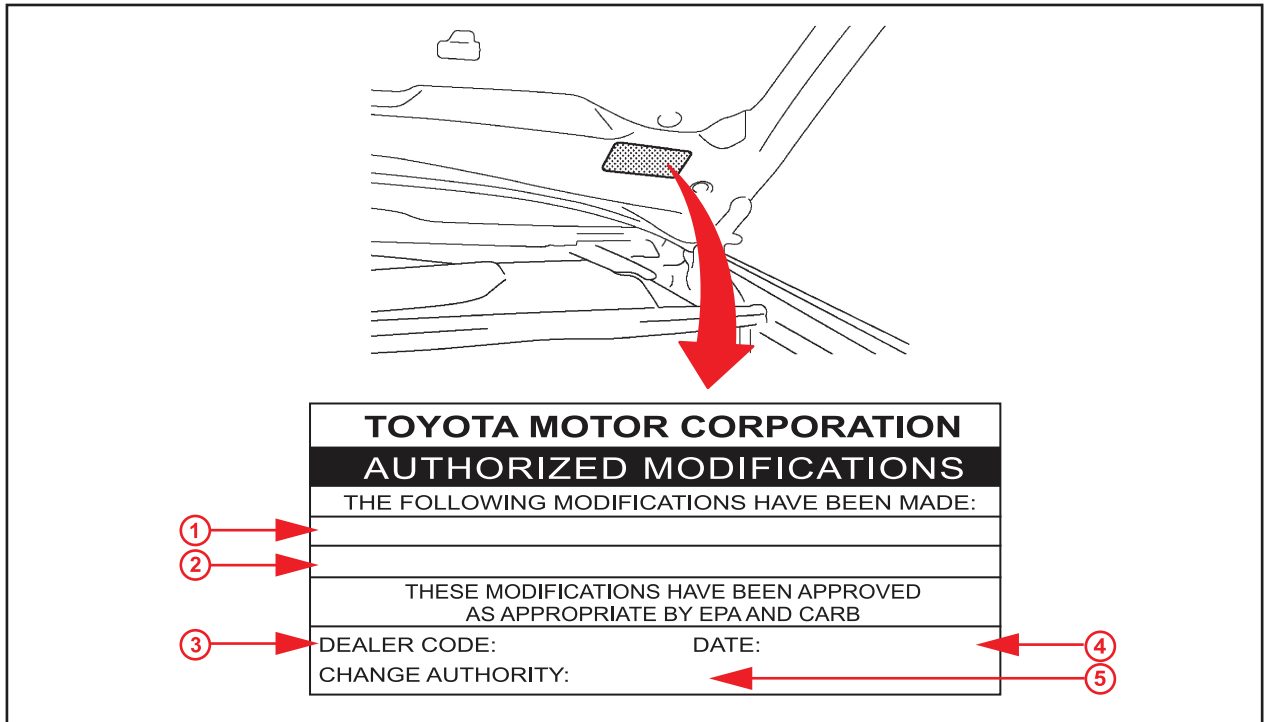
Figure 1. Location of Authorized Modifications Label on 2007 LS 460

1. Check for the Authorized Modifications Label affixed to the vehicle in the location shown in Figure 1. Confirm if the ECM (PCM) calibration has been updated. If the calibration ID listed is NOT the latest ECM (PCM) calibration — go to step 2.

1	Replacement ECM (PCM) Part Number (i.e., 89661-50C02)
2	New Calibration ID(s) (i.e., 35055200)
3	Dealer Code

4	Date Completed
5	This TSIB Number
