Vehicle Pulling to One Side

Service Category Suspension

Section Alignment/Handling Diagnoses

YEAR(S)	MODEL(S)	ADDITIONAL INFORMATION
2007 – 2010	LS460	
2008 – 2010	LS600H

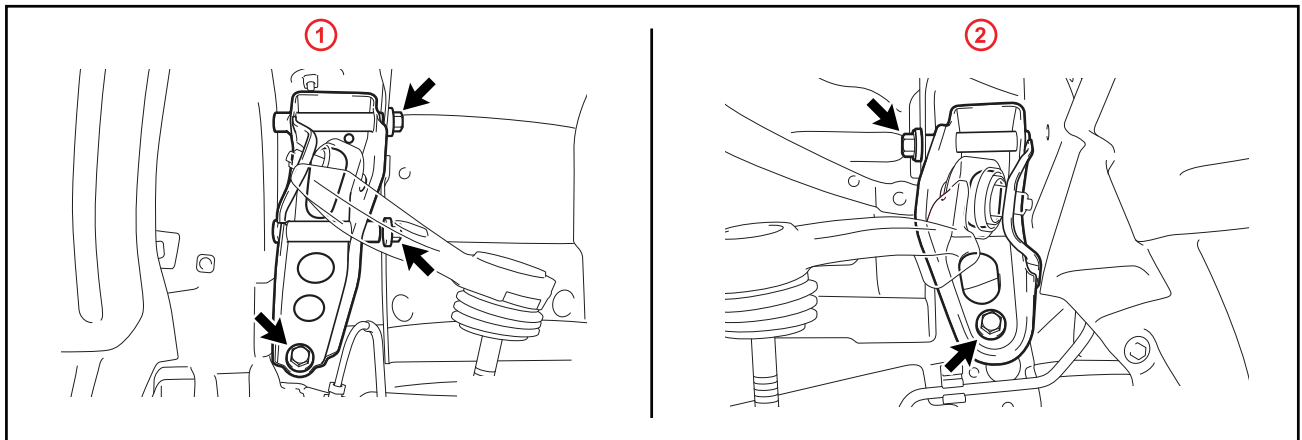
Figure 1.

1 No. 1 Arm Attachment Plate Inner (LH Shown)

2 No. 2 Arm Attachment Plate Inner (LH Shown)

- No. 1 arm has 3 attachment bolts and is the upper control arm towards the FRONT of the vehicle.
- No. 2 arm has 2 attachment bolts and is the upper control arm towards the REAR of the vehicle.

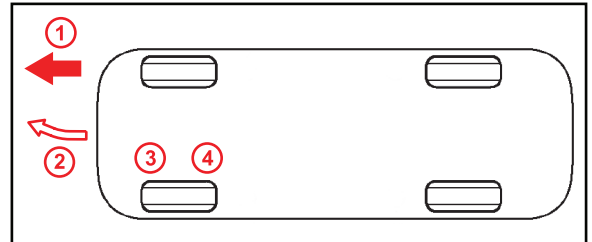
Figure 4.

1	Front of Vehicle
2	Pulls Right
3	No. 1 Arm Attachment Inner Plate
4	No. 2 Arm Attachment Inner Plate

- If the vehicle is still pulling to the **RIGHT**, replace the No. 1 and No. 2 arm attachment inner plates on the **LEFT** side. This adjusts camber.

Complete the alignment by adjusting front and rear toe to Repair Manual specifications. Test drive the vehicle to ensure the pull condition no longer exists.

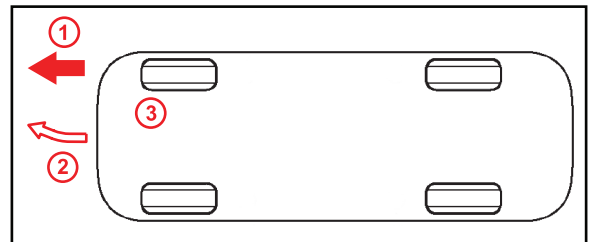
Figure 5.

1	Front of Vehicle
2	Pulls Right
3	No. 1 Arm Attachment Inner Plate

- If the vehicle is still pulling to the **RIGHT**, replace the No. 1 arm attachment inner plate on the **RIGHT** side. This adjusts caster.

Complete the alignment by adjusting front and rear toe to Repair Manual specifications. Test drive the vehicle to ensure the pull condition no longer exists.

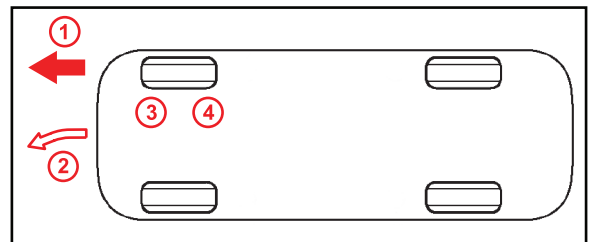
Figure 6.

1	Front of Vehicle
2	Pulls Left
3	No. 1 Arm Attachment Inner Plate
4	No. 2 Arm Attachment Inner Plate

- If the vehicle is still pulling to the **LEFT**, replace the No. 1 and No. 2 arm attachment inner plates on the **RIGHT** side. This adjusts camber.

Complete the alignment by adjusting front and rear toe to Repair Manual specifications. Test drive the vehicle to ensure the pull condition no longer exists.

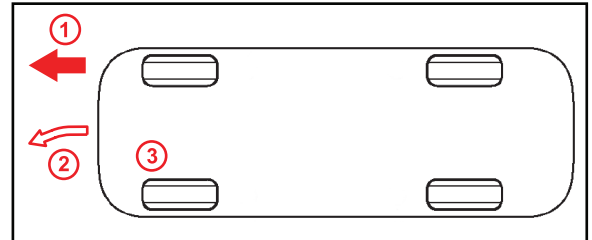
Figure 7.

1	Front of Vehicle
2	Pulls Left
3	No. 1 Arm Attachment Inner Plate

8. If the vehicle is still pulling to the LEFT, replace the No. 1 arm attachment inner plate on the **LEFT** side. This adjusts caster.

Complete the alignment by adjusting front and rear toe to Repair Manual specifications. Test drive the vehicle to ensure the pull condition no longer exists.
