Center Console Wood Grain Panel Cracked

Service Category Vehicle Interior

Section Interior Panels/Trim

Some 2007-2011 model year LS 460/460L/600hL vehicles may exhibit a “crack” in the clear coat of wood trimmed center console components. Updated center console components are now available for Medium Brown Walnut and Matte Dark Brown Ash Burl colored panels.

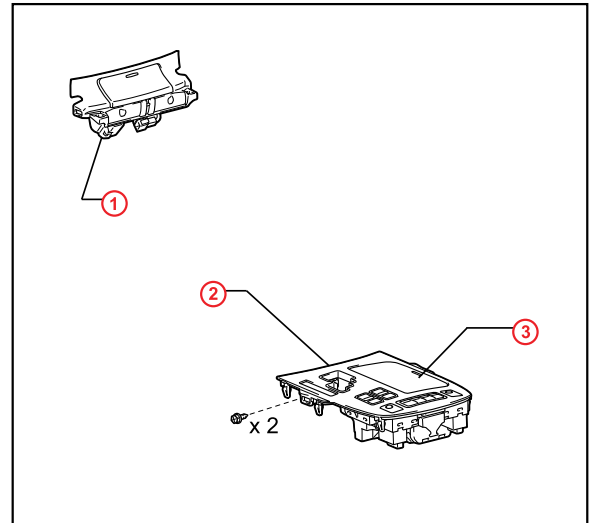
Figure 1.

1. Inspect the upper console panel sub-assembly, upper rear console panel sub-assembly, and instrument panel cup holder sub-assembly wood grain panels for cracks in the clear coat.

1	Upper console panel sub-assembly
2	Upper rear console panel sub-assembly
3	Instrument panel cup holder sub-assembly

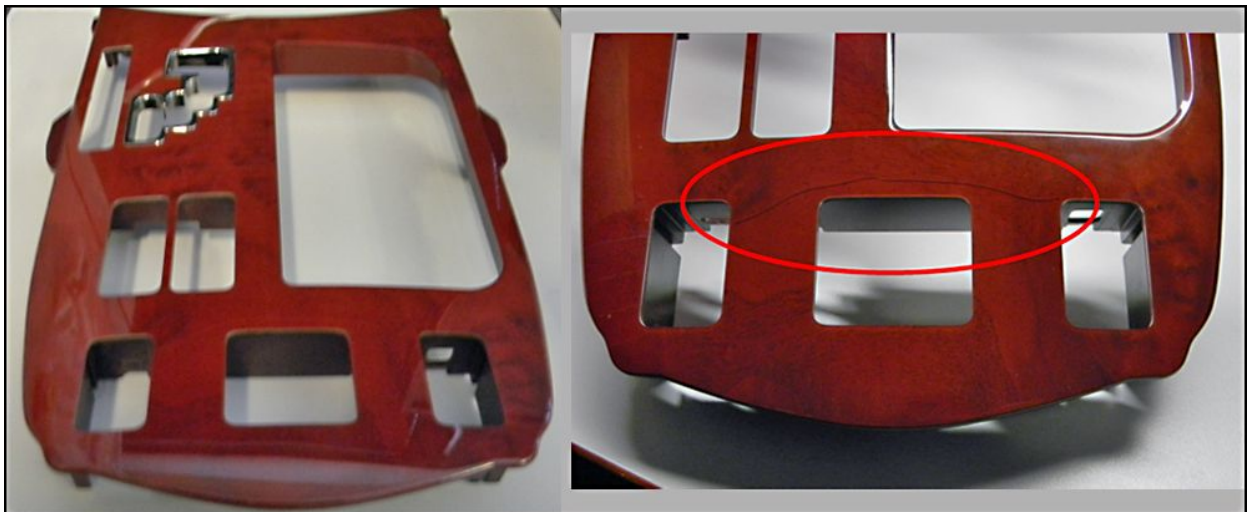
2. If a crack is found in the clear coat of one or more of the upper console panels, proceed to step 2, otherwise, this TSIB does not apply.

Figure 2. Example of condition

3. Remove the affected front center console components. Refer to the Technical Information System (TIS), applicable model and model year Repair Manual.

- 5. Install the NEW front center console component(s) and reassemble the front console box. Refer to TIS, applicable model and model year Repair Manual.

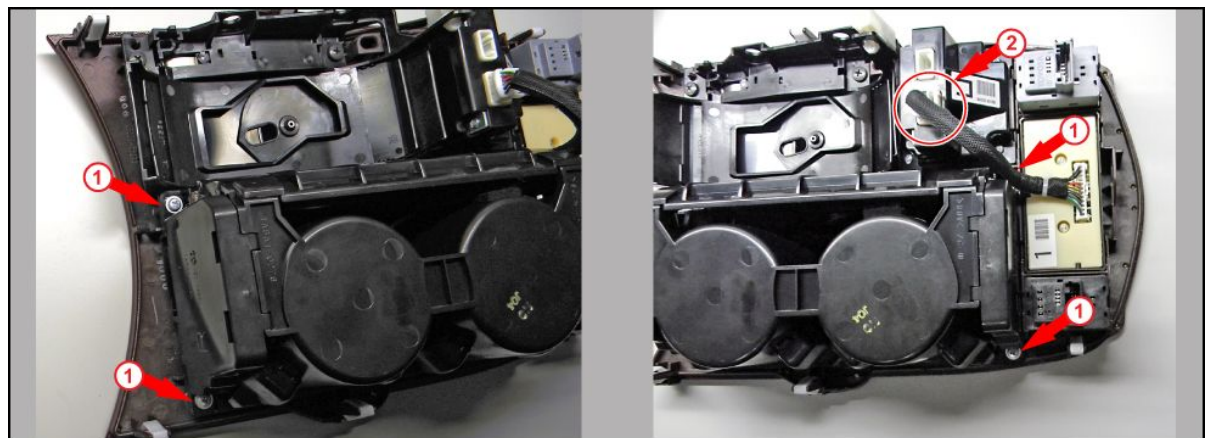
Figure 3.

1	Screw
----------	--------------

2	Jumper harness
----------	-----------------------

4. If necessary, separate the Instrument Panel Cup Holder from the Upper Rear Console Panel Sub Assembly.
 - A. Flip the Upper Rear console Panel Sub-Assembly over and disconnect the jumper harness to the combination switch assembly.

- B. Remove the 4 Instrument Panel Cup Holder retention screws.
 - C. Flip the Upper Rear Console Panel Sub-Assembly over and apply masking tape to the Instrument Panel Cup Holder Cover to avoid damaging the finish.

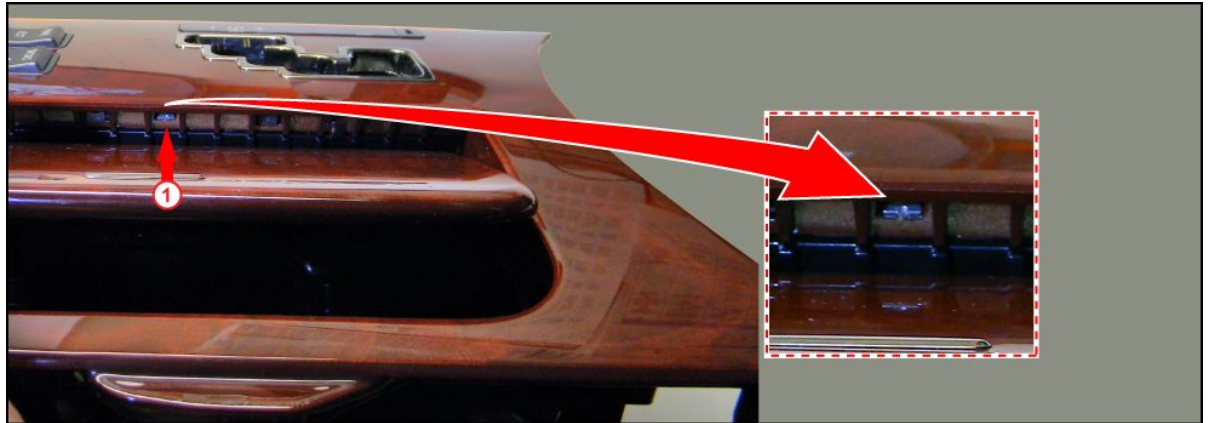
Figure 4.

1	Plastic retention claw
---	------------------------

- D. Open the Instrument Panel Cup Holder Cover half-way to expose the plastic retention claw and using a small flathead screwdriver or similar tool, disengage the claw.
