Hesitation on Acceleration and/or P2119

Category Engine/Hybrid System

YEAR(S)	MODEL(S)	ADDITIONAL INFORMATION
2007 - 2012	LS460, LS600H

2 L-SB-0122-17 May 3, 2017 Page 2 of 11

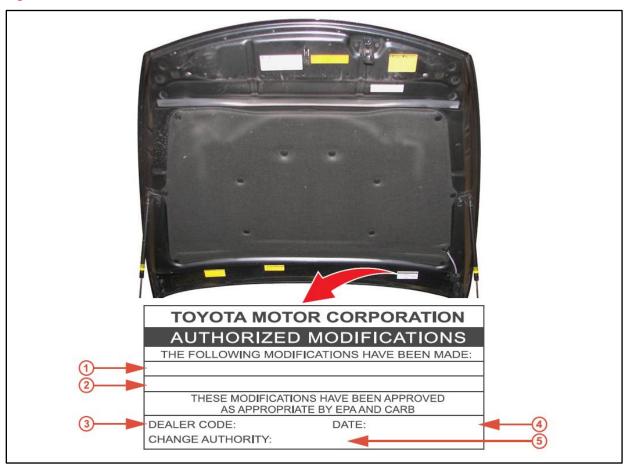
Figure 1. Location of Authorized Modifications Label on 2007 - 2012 LS 460

1. Check for the Authorized Modifications Label affixed to the vehicle in the location shown. Confirm if the ECM (PCM) calibration has been updated.

- B. Install the Authorized Modifications Label to the vehicle at the location shown in Figure 1. The Authorized Modifications Label is available through the MDC, P/N 00451-00001-LBL.
