TSIB

Title: **EVAP SYSTEM DIAGNOSIS: P0441 / P0446**
 Models: **ES 300, SC 400, LS 400, LX 450**

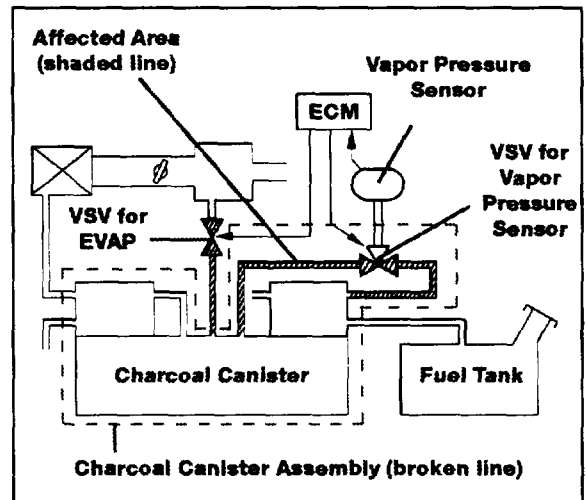
NOTE:
 When performing diagnostics for an occurrence of a MIL "ON" condition, the Diagnostic Trouble Code (DTC) P0441 may be the result of debris in the Evaporative Emission Control System. This may cause blockage of a vapor line, or a stuck VSV, as described in the troubleshooting area of the Repair Manual.

- A. Diagnostics for P0441:**
1. Remove Vacuum Hoses between EVAP VSV and Charcoal Canister and discard.
 2. If there is a metal vapor pipe between EVAP VSV and Charcoal Canister, clean inside of vapor pipe.
 3. Replace EVAP VSV and Charcoal Canister assembly with new parts.
 4. Install new vacuum hoses between EVAP VSV and Charcoal Canister.
- B. Diagnostics for P0446:**
1. Inspect vacuum hoses and pipes between EVAP (Purge) VSV and Charcoal Canister for leaks.
 2. Replace Vapor Pressure VSV and Canister.
