**Technical Service
Information Bulletin**

TONNEAU COVER LATCH RATTLE

'04 – '06 RX 330, '06 – '07 RX 400h, &
'07 RX 350

NVH
NV001-07

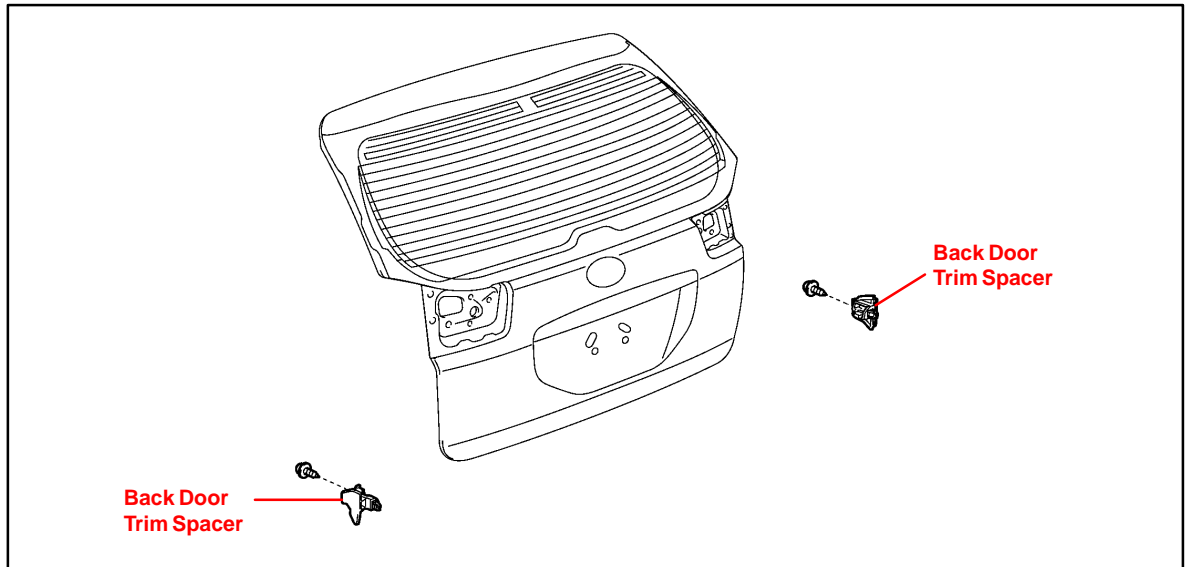
Introduction Some customers may experience a rattle noise from the rear of the vehicle when going over bumps. This problem is due to lack of insulation and excessive clearance between the tonneau cover locks and the back door trim spacers. Perform the following procedure to correct this condition.

3. Remove the screw and then remove the back door trim spacer RH and LH.
