# Water Leak At Back Door Hatch

YEAR(S)	MODEL(S)	ADDITIONAL INFORMATION
2004 – 2009	RX330, RX350, RX400H

## Introduction

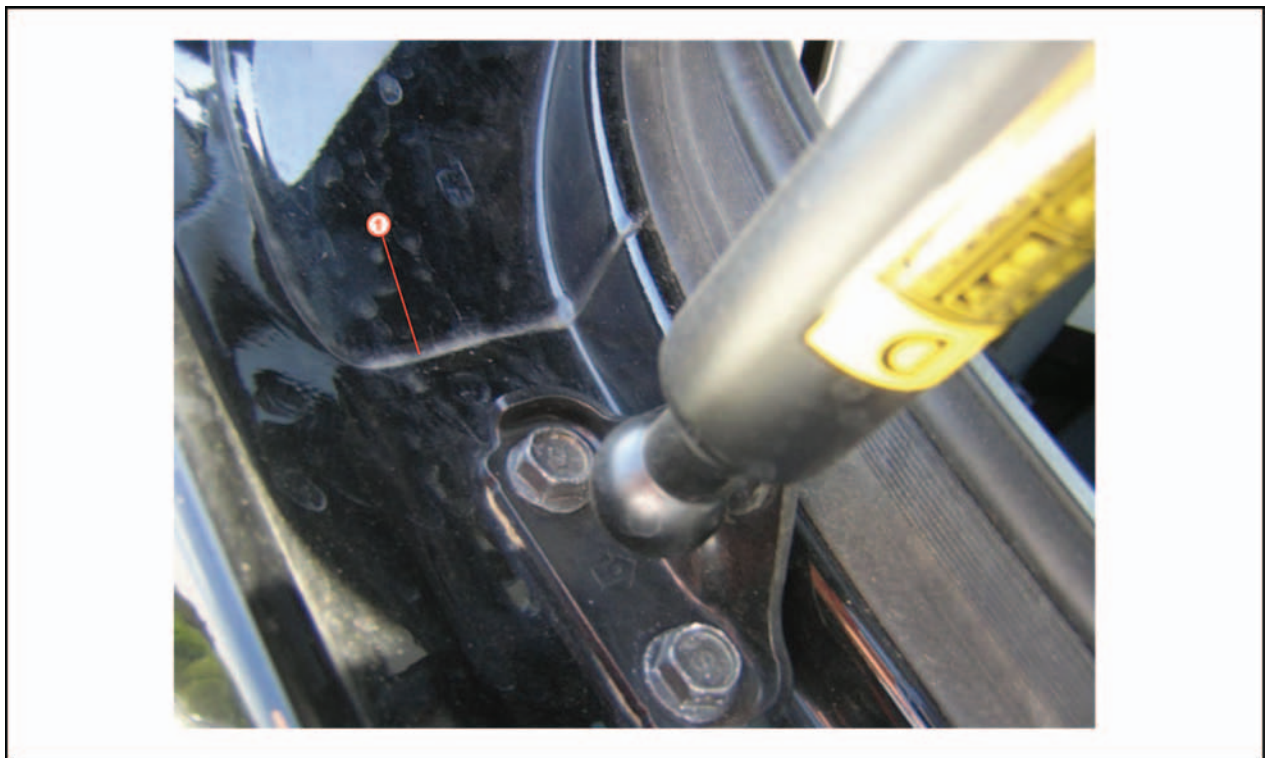
Figure 1.

Some RX models may exhibit water intrusion into the rear of the vehicle due to cracked body seam sealer just above the back door strut mounting area. The following repair information has been provided to correct this condition.

1. Visually inspect both sides for cracks at the seam above the upper back door strut mounting bracket.

<b>1</b>	<b>Inspection Area</b>
----------	------------------------

- A. If water is present, proceed to step 2 of the repair procedure.
  - B. If No water is present, STOP. The source of water is coming from a different location. This TSIB does NOT apply.
2. Send the vehicle to the body shop.

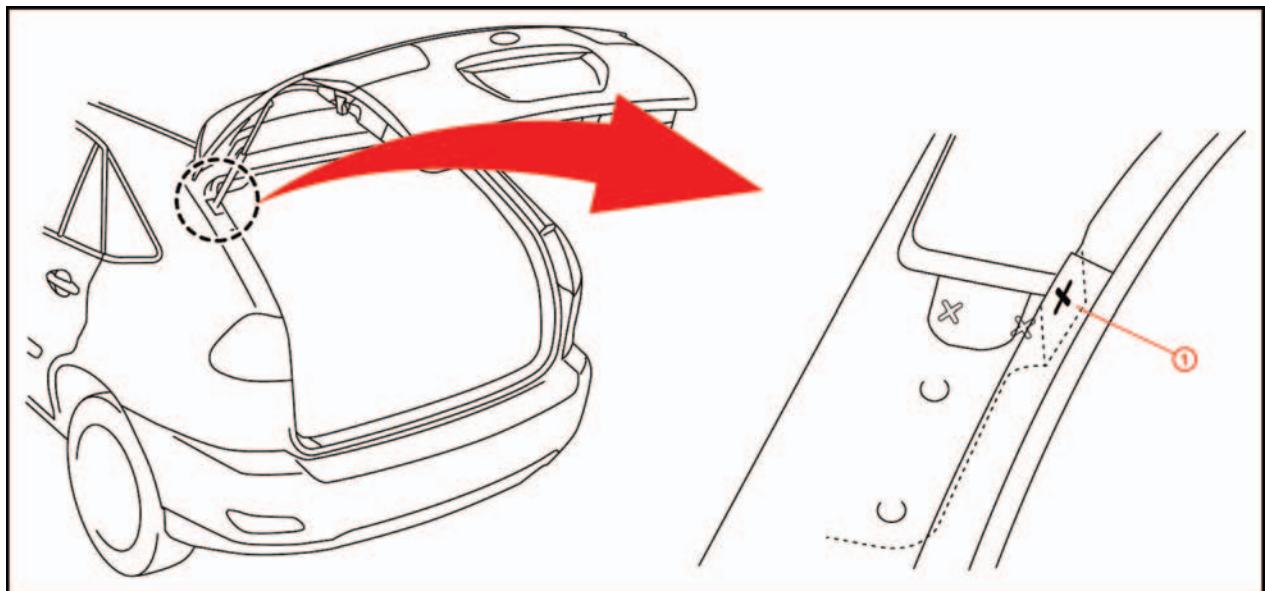
Figure 2.

1	Spot weld location
---	--------------------

- A. Record radio presets.
- B. Add a spot weld to the location as illustrated below to left and right strut area (Left side shown for reference).

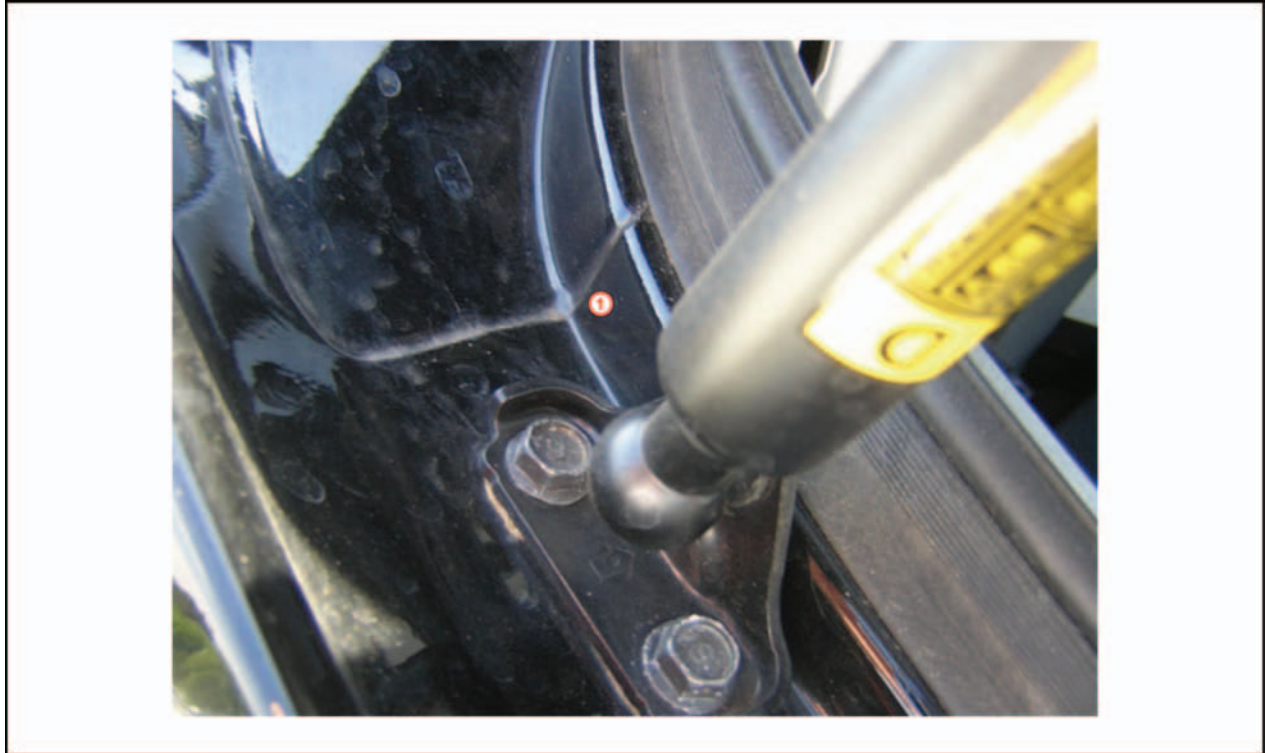
Figure 3. Left side shown for reference

1	Spot Weld Location
---	--------------------

5. Apply seam sealer to the weld location and repaint the rear hatch area according to the paint manufacturer's recommendations.
6. Confirm leak is eliminated by water testing.
7. Connect battery and reinitialize the moon roof and reset radio as necessary. Refer to TSIB [L-SB-0003-08](#): "Initialization of Power Back Door During PDS".
