# Water Leak At Back Door Hatch

YEAR(S)	MODEL(S)	ADDITIONAL INFORMATION
2004 – 2009	RX330, RX350, RX400H

March 10, 2009 Rev1:

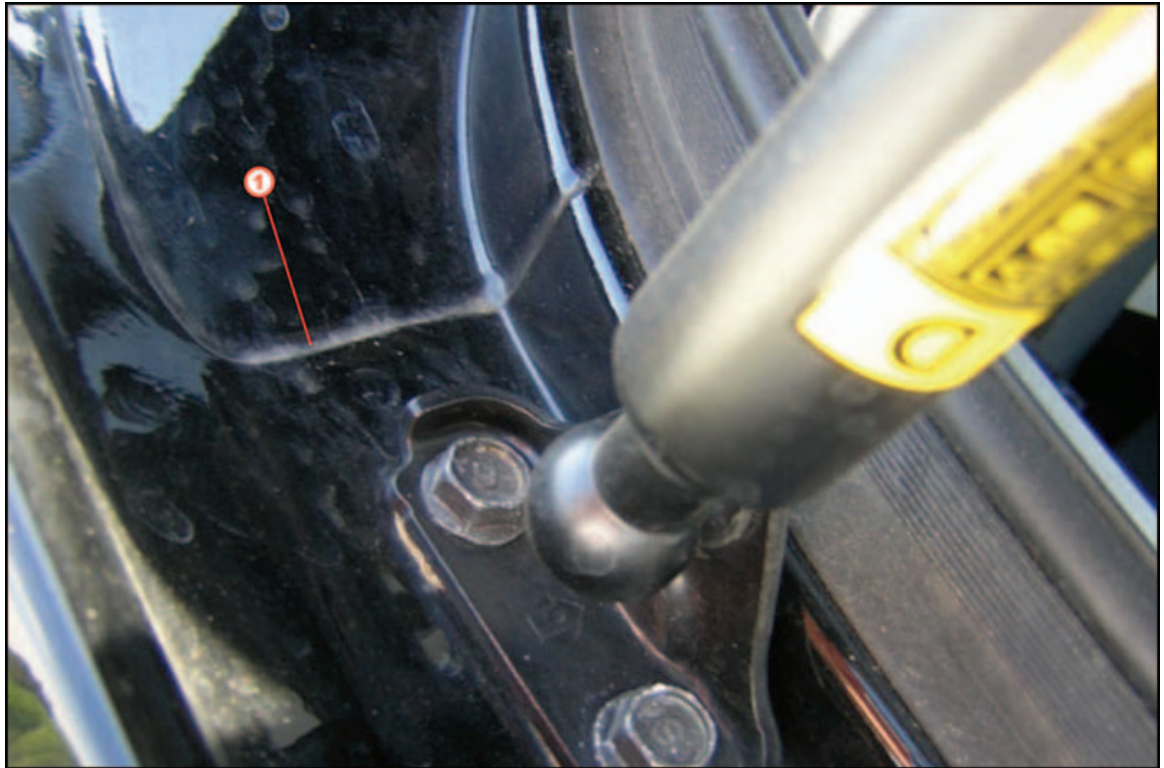
Figure 1.

Some RX models may exhibit water intrusion into the rear of the vehicle due to cracked body seam sealer just above the back door strut mounting area. The following repair information has been provided to correct this condition.

1. Visually inspect both sides for cracks at the seam above the upper back door strut mounting bracket.

1	Inspection Area
---	-----------------

- A. If water is present, proceed to step 2 of the repair procedure.

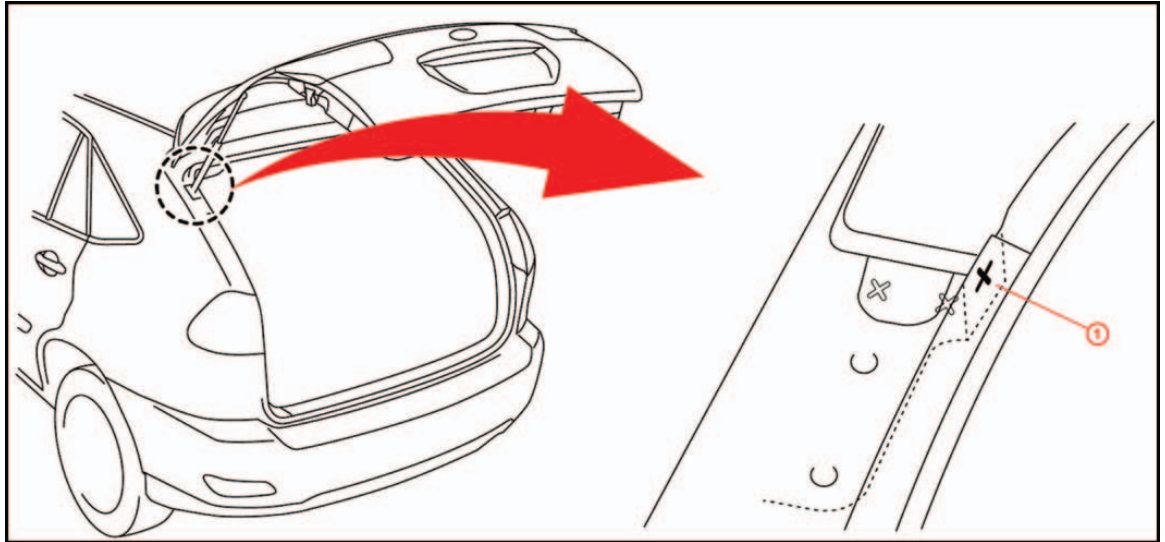
Figure 2.

1 Spot weld location

- A. Record radio presets.
- B. Add a spot weld to the location as illustrated below to left and right strut area (Left side shown for reference).

5. Apply seam sealer to the weld location and repaint the rear hatch area according to the paint manufacturer's recommendations.
6. Confirm leak is eliminated by water testing.
7. Connect battery and reinitialize the moon roof and reset radio as necessary. Refer to TSIB [L-SB-0003-08](#): "Initialization of Power Back Door During PDS".

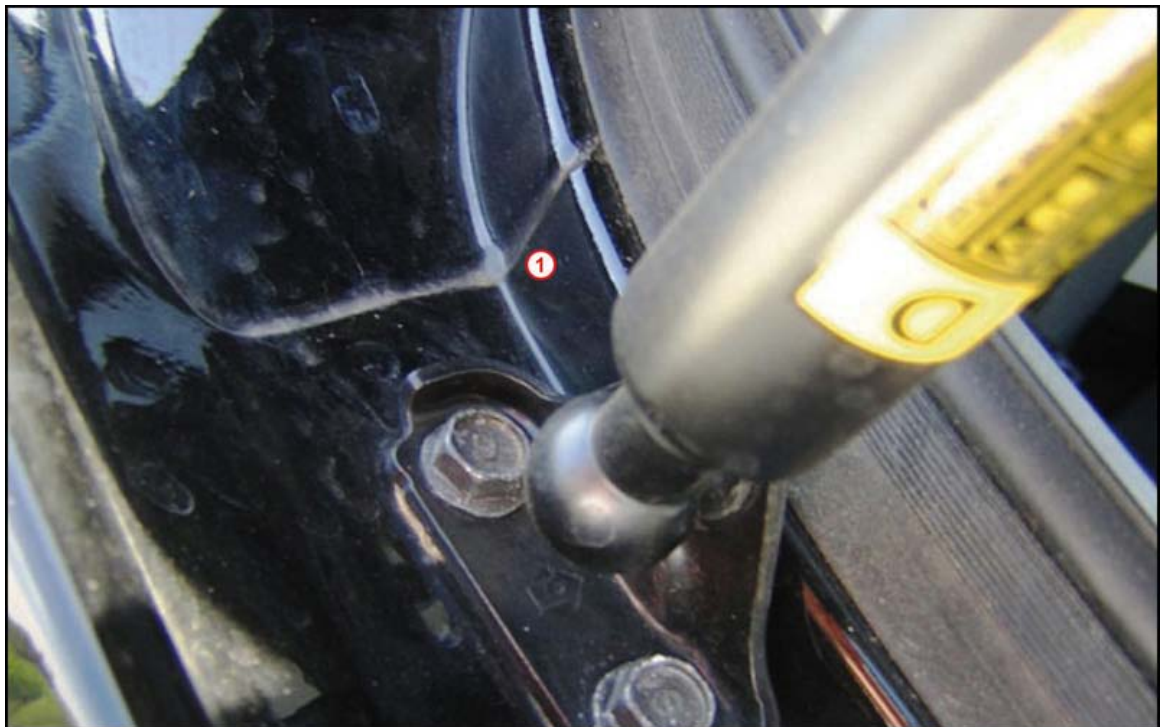
Figure 3. Left side shown for reference

1 Spot Weld Location
