**Technical Service  
Information Bulletin**

**REPAIR MANUAL SUPPLEMENT:  
VEHICLE PULLING TO ONE SIDE**

**All '02 - '06 Model**

REVISSED  
ST004-01  
STEERING

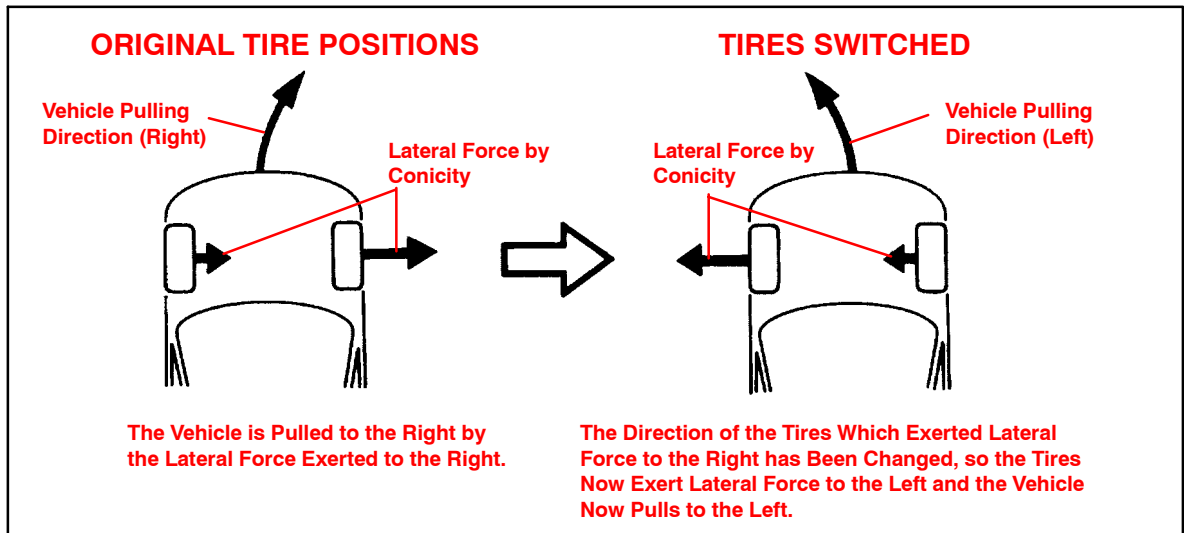
- The direction of lateral force from tire conicity becomes reversed when the left and right tires are switched. Therefore, if the pulling direction changes when the tires are switched, it can be concluded that vehicle pulling is caused by tire conicity.

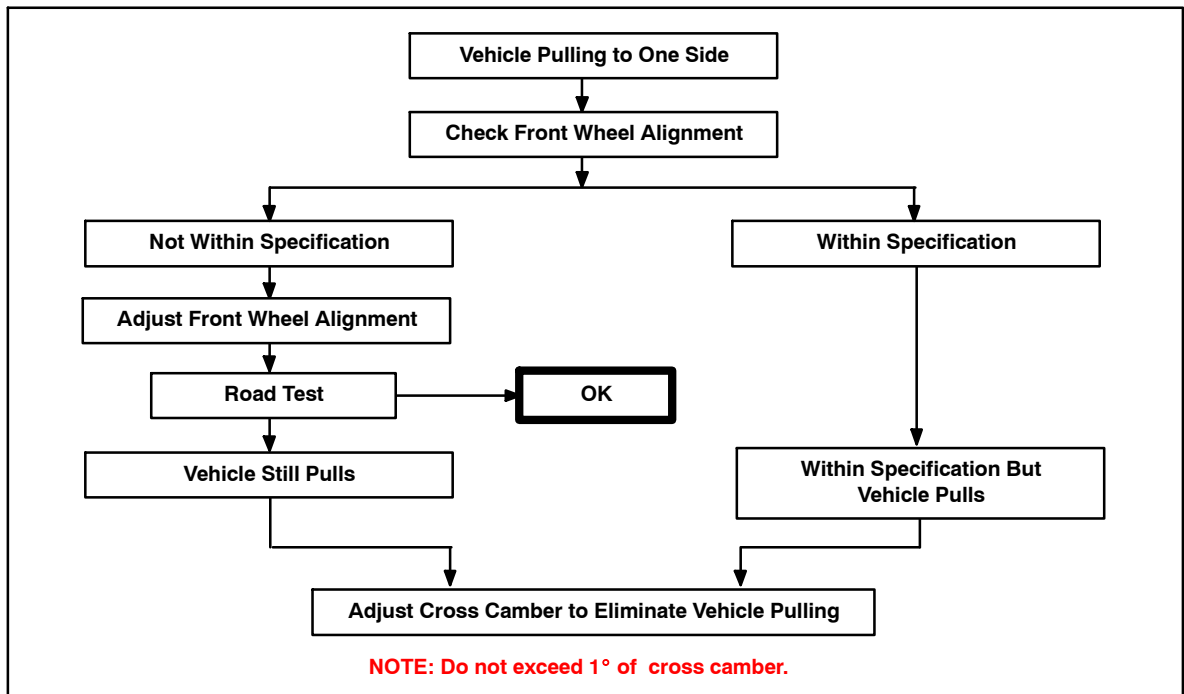
When it is determined by troubleshooting that the vehicle pulling to one side is caused by wheel alignment, perform repairs according to the following procedure.

WHEN VEHICLE PULLS TO LEFT	WHEN VEHICLE PULLS TO RIGHT
Increase right front camber and decrease left front camber until vehicle pulling is eliminated	Increase left front camber and decrease right front camber until vehicle pulling is eliminated

- Keep the cross camber within 1° or less.
- Keep the camber of each wheel within specifications (+/-45' of center value).
- If adjustment exceeds the specifications, uneven tire wear will result.

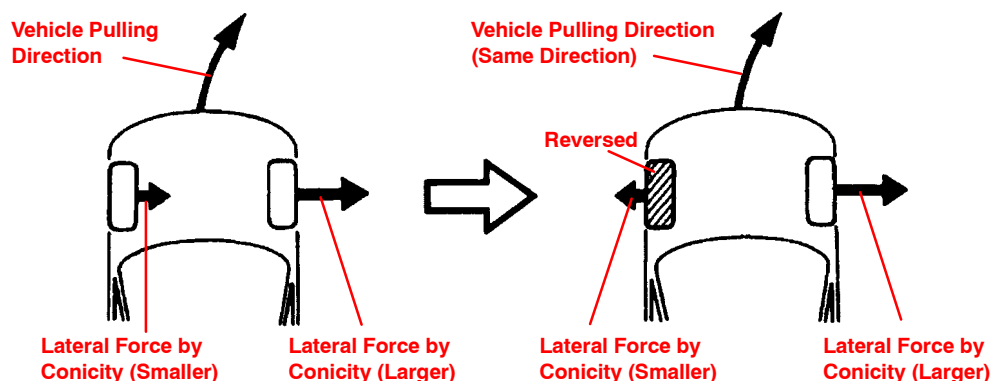
**If Vehicle Pulls in the Same Direction: Go to STEP 2.**

The lateral force generated by the right front tire is greater than the left tire, so the vehicle is pulling due to the lateral force of the right tire.

Remove the front left tire from the wheel and reverse the tire. Then perform a road test and check for change in the pulling direction.

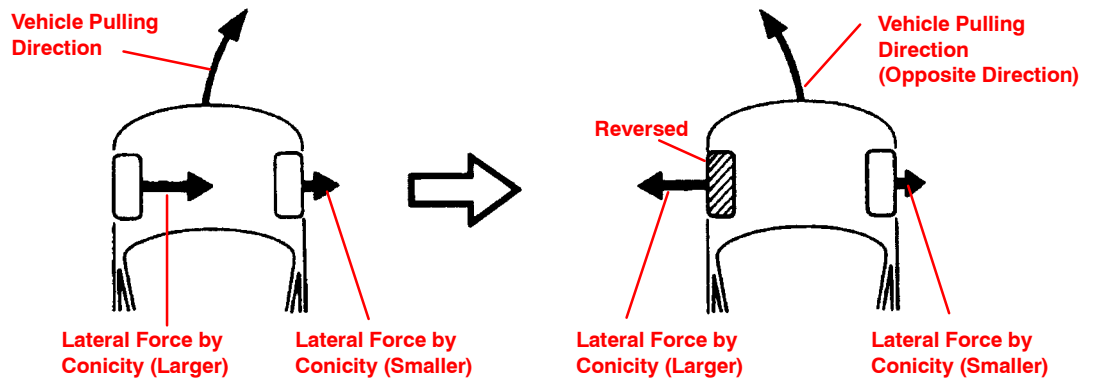
**If Vehicle Pulls in the Opposite Direction: Go to STEP 2.**

The lateral force generated by the left front tire is greater than the right tire, so the vehicle is pulling due to the lateral force of the left tire.
