Technical Service Information Bulletin

AUDIO DOOR OPENING/CLOSING EFFORT IMPROVEMENTS

'02 – '05 SC 430

BODY
B0001-05

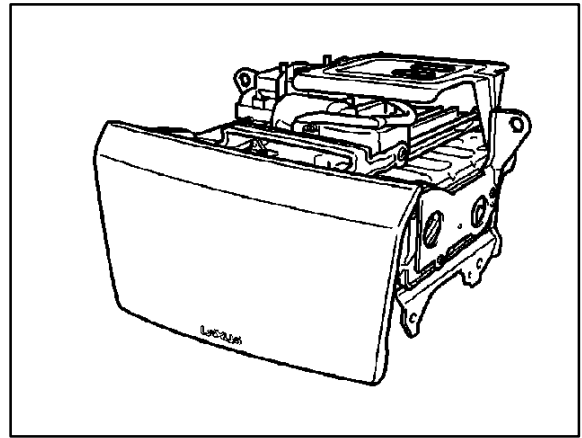
Introduction To improve the opening and closing effort of the audio door, the following repair procedures have been developed.

1. Replace Instrument Cluster Finish Panel Sub-assembly LWR CTR.

- A. Remove the 2 clips shown in the illustration.

It is OK to cut the clips as new ones are provided in the service parts kit.
