**Technical Service  
Information Bulletin**

# PRECAUTION FOR CONSOLE PANEL UPPER INSTALLATION

'02 SC 430

**BODY**  
**BO012-01**

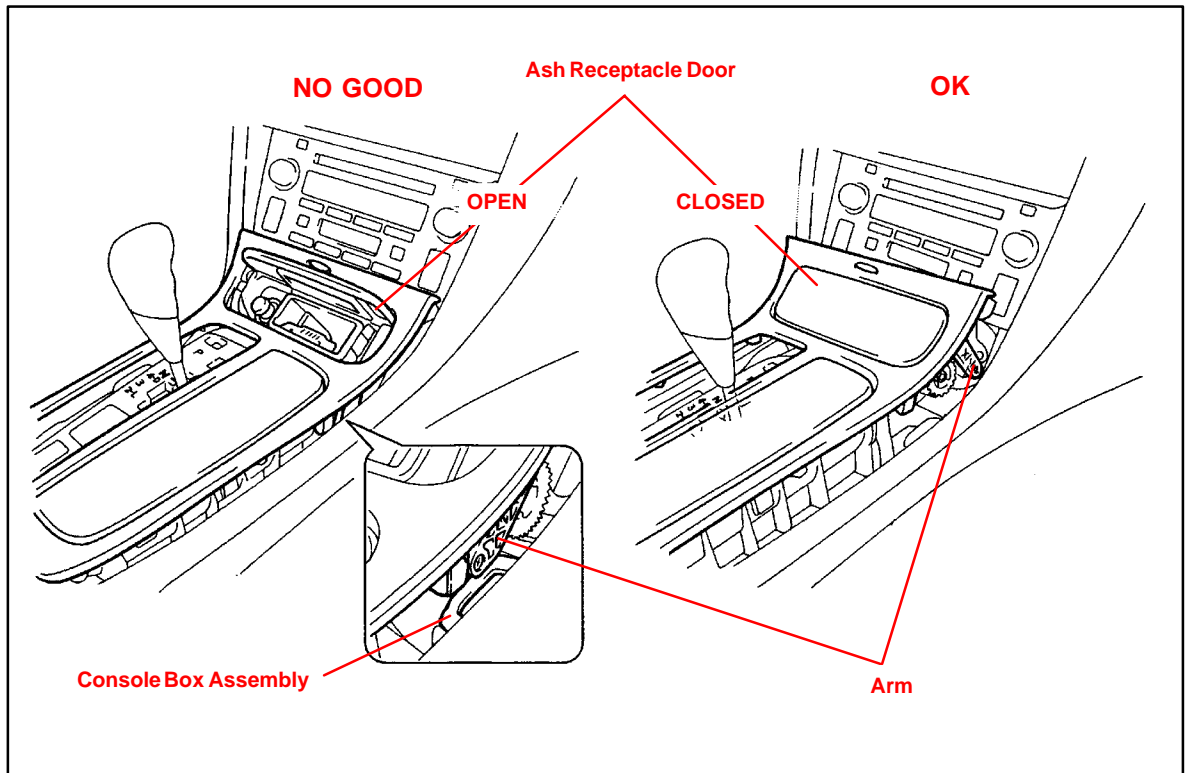
**Introduction** When installing the console panel sub-assembly upper, be sure to close the ash receptacle door because the arm may interfere with the console box assembly and damage it if the ash receptacle door is open.
