# Paint Stains Under Rapgard

**Section** Paint/Coatings

The information contained in this bulletin supersedes Service Bulletin No. L-SB-0014-08.

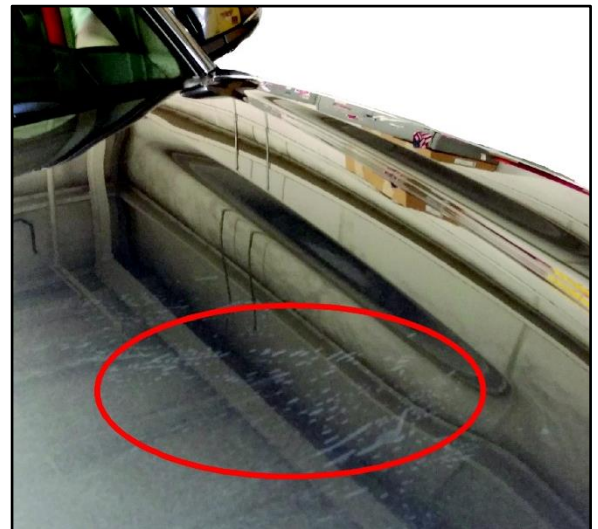
Figure 1.

Some 2010 – 2019 model year Lexus vehicles may exhibit paint stains after the removal of Rapgard™. The paint stains may appear to be under the clear coat but are usually under wrinkles in the Rapgard™. The wrinkles may trap water and cause the paint to stain from the trapped moisture, especially on horizontal surfaces such as the hood, roof, and trunk. Follow the Repair Procedure in this bulletin to address this condition.

AFTER Rappgard™ removal, does the vehicle exhibit paint stains as shown?

2. Using aluminum foil or a damp cloth, cover ANY plastic and/or rubber parts located near the stain.
3. With an infrared lamp or heat gun, apply heat to the stain for 5 – 10 minutes at 158°F – 176°F (70°C – 80°C).

Do NOT allow the surface temperature to become higher than 176°F (80°C). Measure the temperature with a thermometer.

4. Wait AT LEAST 5 minutes AFTER heat application, then examine the area and determine if the stain has been removed.
