Technical Service Information Bulletin

January 31, 2003

'02 - '06 All Models

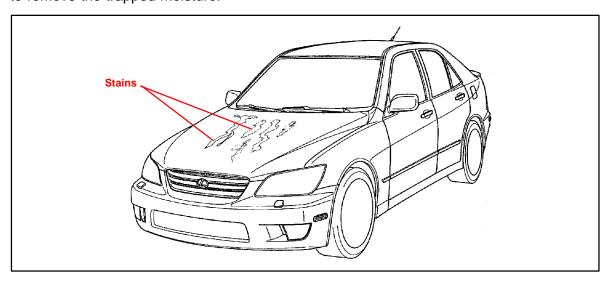
Introduction On some vehicles, when Rapgard[™] is removed, the paint may have a stained appearance under the clear coat. These stains should not be considered a defect in the paint (clear coat or color coat). Wrinkles in the Rapgard[™] sometimes trap water and cause the paint to stain from the trapped moisture, especially on horizontal surfaces, such as the hood, roof, and trunk. Stains can be removed by heating the stained surface to remove the trapped moisture.

- Repair1.Use the aluminum foil or damp cloth to cover plastic/rubber parts that are nearProcedurethe stain.
 - 2. Apply heat to the stain using an infrared lamp or heat gun.

Apply heat for 5 – 10 minutes at $158^{\circ}F - 176^{\circ}F$ ($70^{\circ}C - 80^{\circ}C$). Do NOT allow the surface to become hotter than $176^{\circ}F$ ($80^{\circ}C$). Measure the temperature with a thermometer.

3. After applying heat for 5 minutes, examine the area to determine if the stain has been removed. If the stain still exists, continue to apply heat and re-examine the stain 5 minutes later.
