**Technical Service
Information Bulletin**

Title:
DOOR WOOD TRIM PANEL VIBRATION

Models:
'02 – '04 SC 430

NVH
NV002-04

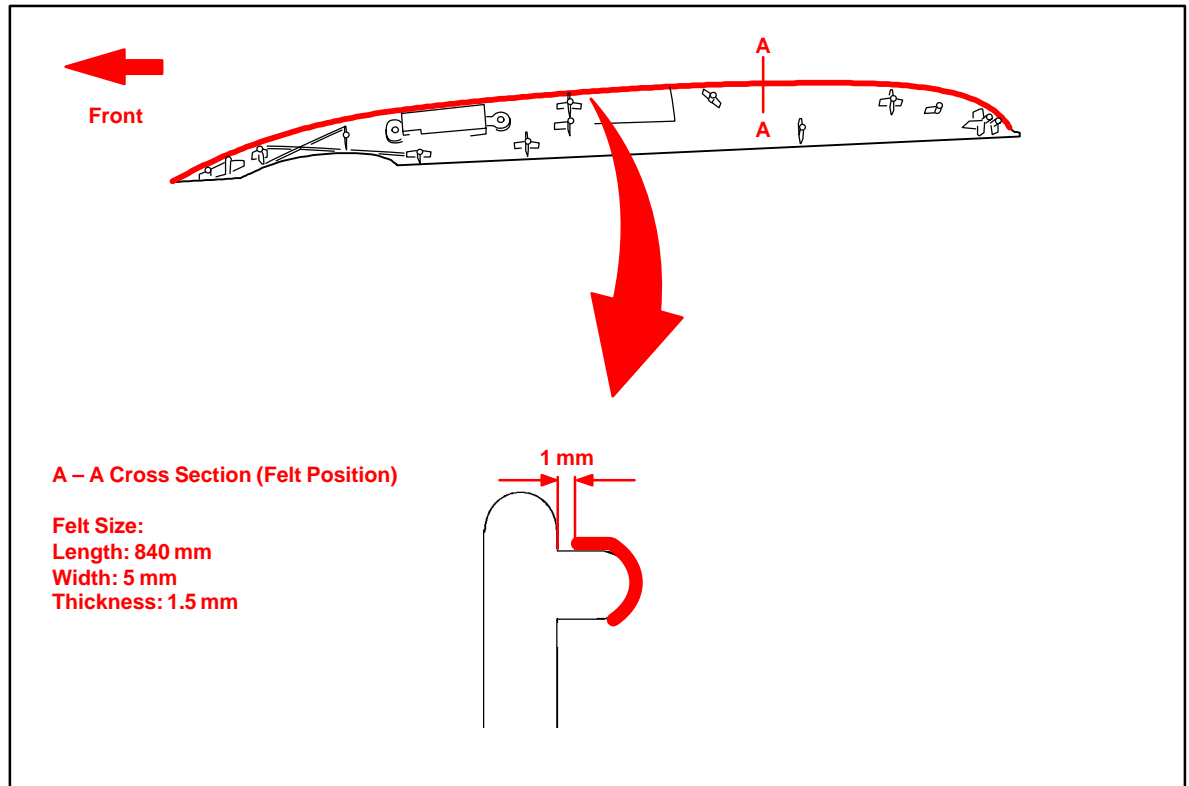
Introduction Some 2002 – 2004 model year SC 430 vehicles may exhibit a vibration/buzzing noise from the wood portion of the inner door trim panel while playing heavy bass from the speakers. The procedures below have been developed to correct this condition.

6. Fit a felt piece to the ornament as shown in the illustration (red portion).

Felt Size:
Length: 840 mm
Width: 5 mm
Thickness: 1.5 mm

- If 1.5 mm thick felt material is not available, layer multiple pieces to obtain the correct thickness.
- If felt material is shorter or longer than the following ornament length, patch multiple pieces together or cut the felt.
