Applies To: **2006–08 Civic** – ALL except GX, Hybrid, and Si**December 24, 2008****Engine Overheats or Leaks Coolant****(Supersedes 08-044, dated July 25, 2008, to update the information marked by the black bars)****SYMPTOM**

The engine is leaking coolant and may be overheating.

The engine block is cracking at the coolant passages.

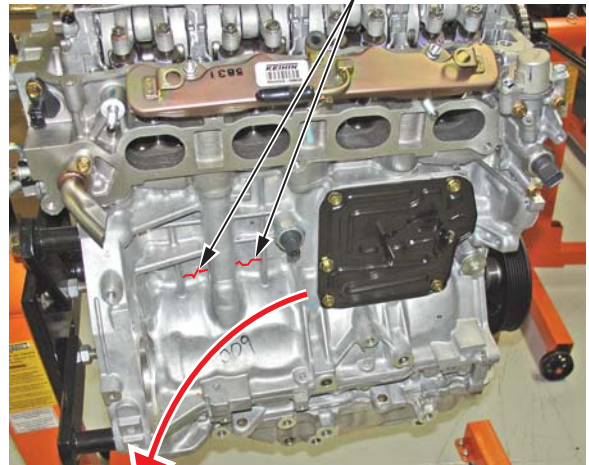
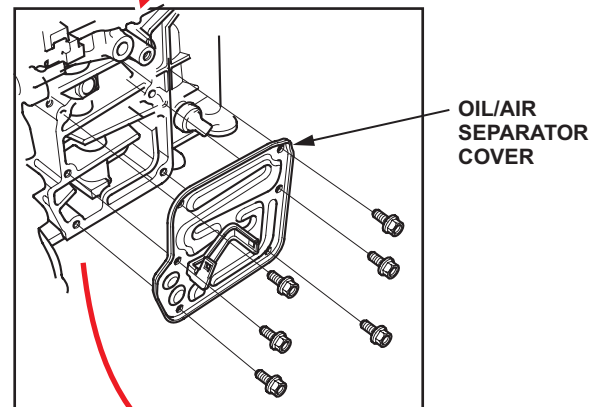
**BACK
OF THE ENGINE**

Look for coolant leaking from cracks in the block at the points shown below. On the back side of the engine, remove the oil/air separator cover so you can check beneath it. Pressure-test the cooling system if needed.

CRACK LOCATIONS

Install a new engine block assembly.
