Last Modified: 7-13-2007		1.7 G
Service Category: Vehicle Interior	Section: Supplemental Restraint Systems	
Model Year: 2008	Model: ES350	Doc ID: RM000000V2X00FX
Title: SUPPLEMENTAL RESTRAINT SYSTEM: FRONT PASSENGER SIDE KNEE AIRBAG ASSEMBLY: ON-VEHICLE INSPECTION (2008 ES350)

ON-VEHICLE INSPECTION

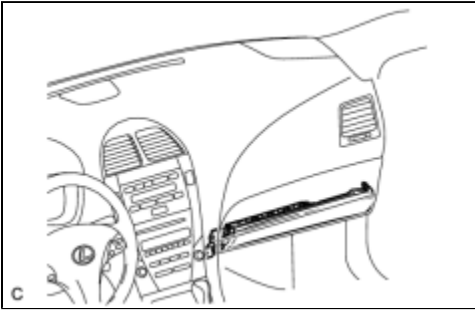
(b) With the front passenger side knee airbag assembly installed on the vehicle, perform a visual check. If there are any defects as mentioned below, replace the front passenger side knee airbag assembly with a new one:

Cuts, minute cracks or marked discoloration on the front passenger side knee airbag assembly.

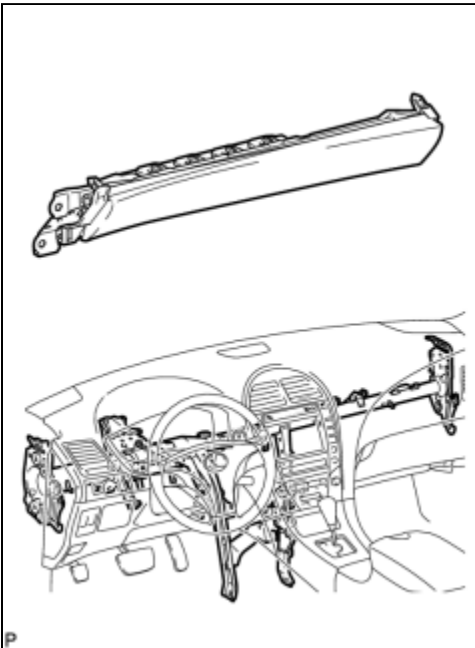
(b) With the front passenger side knee airbag assembly removed from the vehicle, perform a visual check. If there are any defects as mentioned below, replace the front passenger side knee airbag assembly with a new one:

- Cuts, minute cracks or marked discoloration on the front passenger side knee airbag assembly.
- Cracks or other damage to the connector.
- Deformation or cracks on the instrument panel reinforcement.
