Last Modified: 7-13-2007		1.7 A
Service Category: Vehicle Interior	Section: Supplemental Restraint Systems	
Model Year: 2008	Model: ES350	Doc ID: RM000000V2W00FX
Title: SUPPLEMENTAL RESTRAINT SYSTEM: FRONT PASSENGER SIDE KNEE AIRBAG ASSEMBLY: REMOVAL (2008 ES350)

REMOVAL

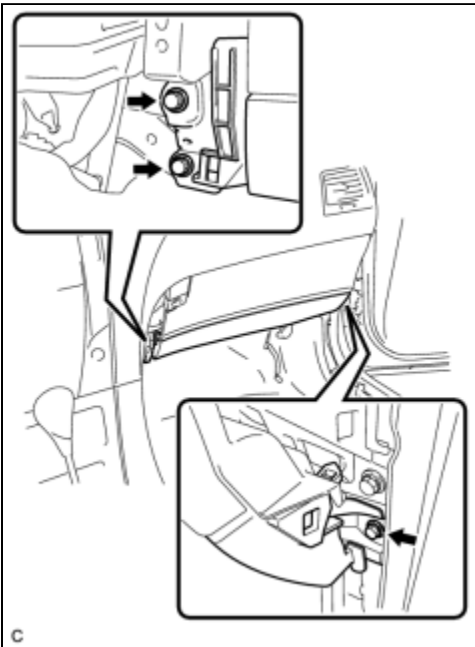
(a) Remove the 3 bolts.

(b) Disconnect the front passenger side knee airbag connector.

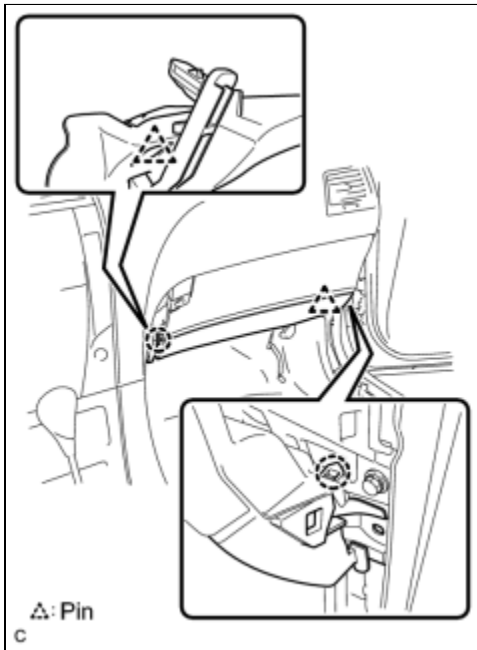
(c) Disengage the 2 claws and 2 pins, and remove the front passenger side knee airbag assembly.

When handling the airbag connector, take care not to damage the airbag wire harness.
