# B-Pillar Lower Garnish Damaged

Some 2006-2008 model year GS vehicles may exhibit gouging and scratching on the lower center “B” pillar garnish moldings. A countermeasured garnish molding has been developed to remedy this condition. This bulletin provides updated parts information and recommended repair procedures for replacement of both the RH and LH lower “B” pillar garnish moldings.

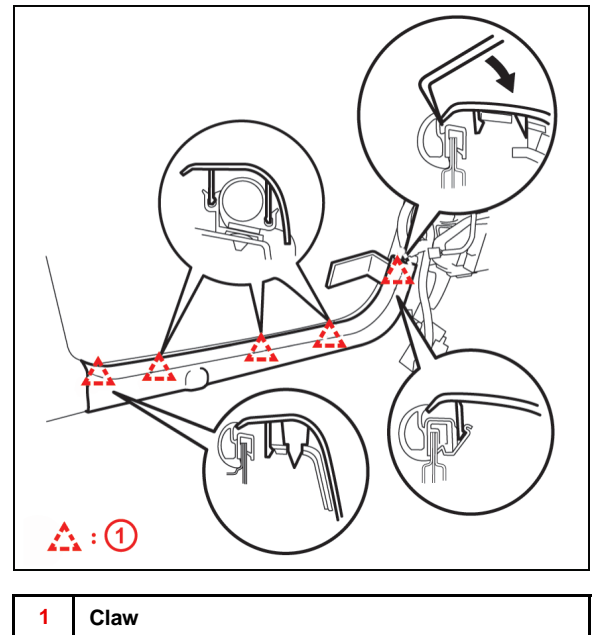
Figure 1.

1. Remove the front door scuff plate LH.

Using a molding remover, detach the 5 claws and remove the scuff plate.

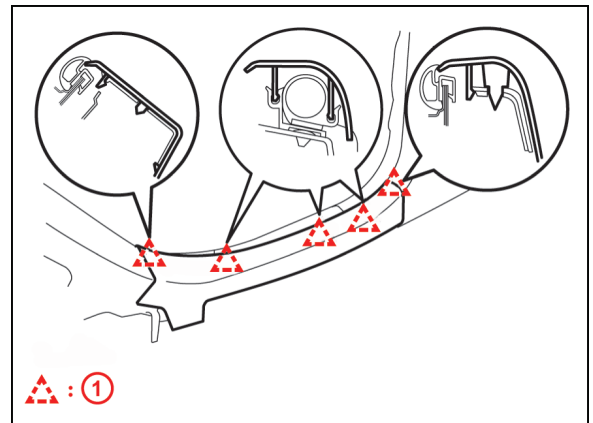
Figure 2.

5. Remove the rear door scuff plate LH

Detach the 5 claws and remove the scuff plate.

1	Claw
---	------

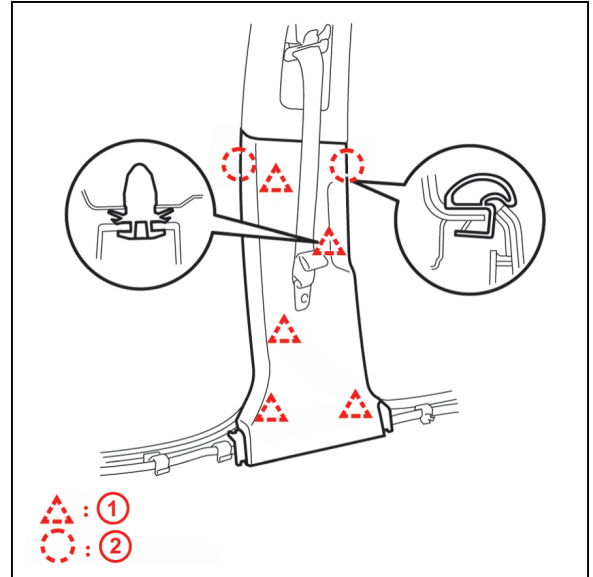
Figure 3.

- Remove the center pillar garnish Lower LH

Detach the 2 claws and 5 clips, and remove the garnish.

1	Clip
2	Claw

- Reinstall in reverse order.
