B-Pillar Lower Garnish Damaged

Service Category Vehicle Interior

Section Interior Panels/Trim

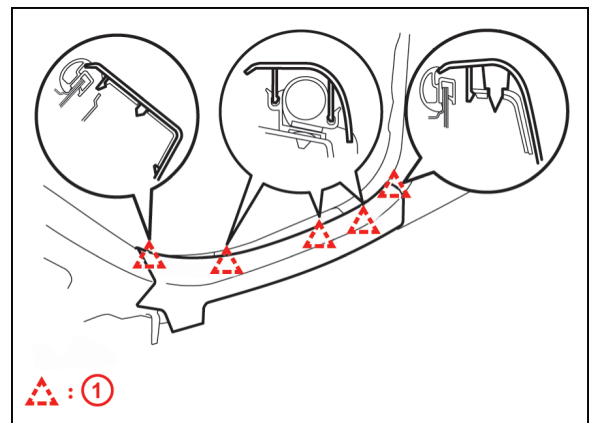
Figure 2.

5. Remove the rear door scuff plate LH

Detach the 5 claws and remove the scuff plate.

| 1 | Claw |

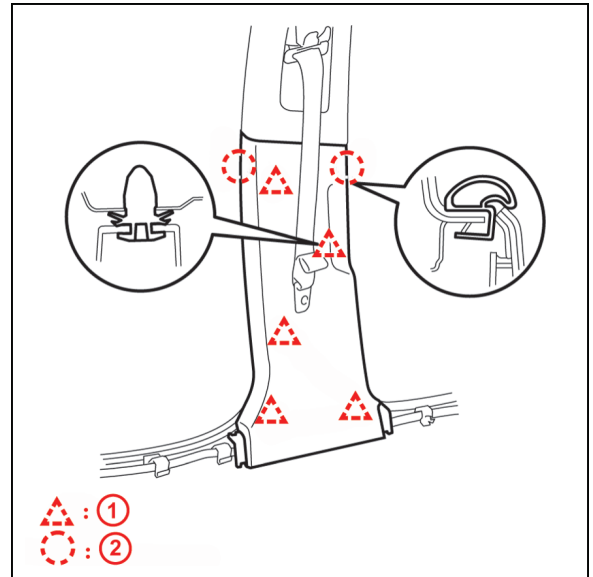
Figure 3.

7. Remove the center pillar garnish Lower LH

Detach the 2 claws and 5 clips, and remove the garnish.

| 1 | Clip |
| 2 | Claw |
