B-Pillar Lower Garnish Damaged

Service Category Vehicle Interior

Section Interior Panels/Trim

Some 2006-2008 model year GS vehicles may exhibit gouging and scratching on the lower center “B” pillar garnish moldings. A countermeasured garnish molding has been developed to remedy this condition. This bulletin provides updated parts information and recommended repair procedures for replacement of both the RH and LH lower “B” pillar garnish moldings.

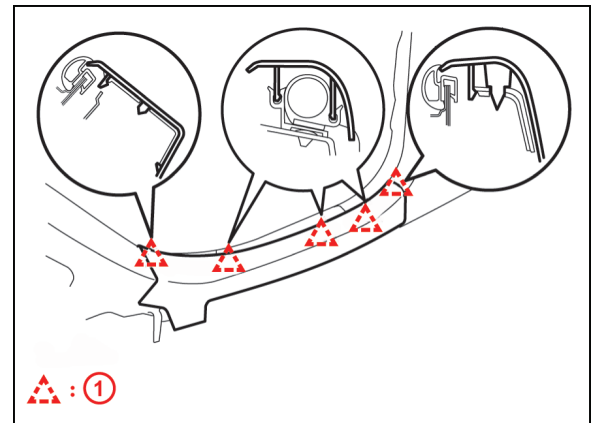
Figure 2.

5. Remove the rear door scuff plate LH
Detach the 5 claws and remove the scuff plate.

1	Claw
---	------
