**Technical Service  
Information Bulletin**

Title: **AUDIO QUICK REFERENCE GUIDE**

Models: **'01 - '07 All Lexus**

**AUDIO**  
**AU001-06**

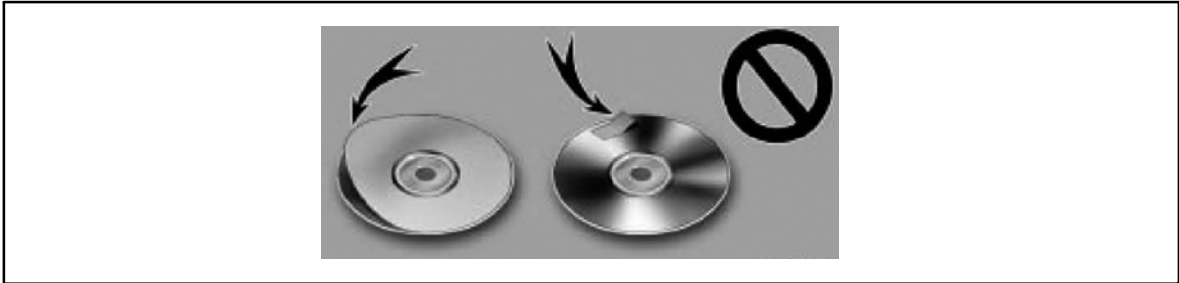
2. Inspect customer’s CDs. Common problem areas are:

- CDR (with label)

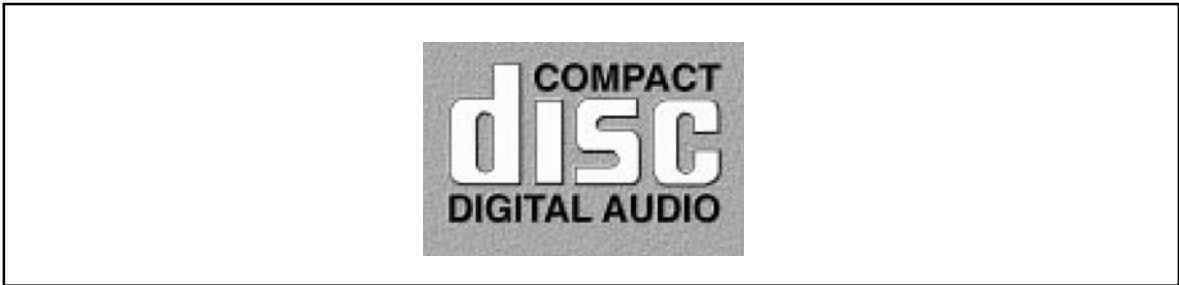
- Scratches/cracks
- Fingerprints
- Dust and/or dirt
- 8 cm diameter CDs
- CD Digital Audio logo (Confirm the CD has this logo. Lexus CD player may NOT be able to play CDs that do NOT have this logo.)

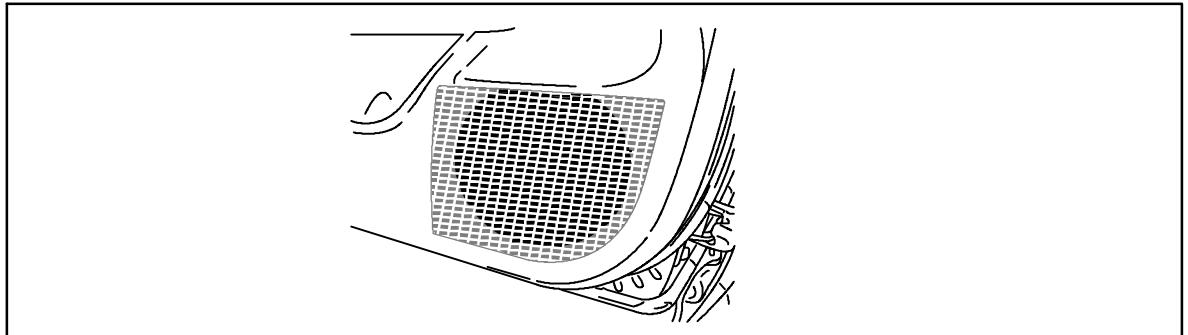
1. Gather detailed information.  
Ask the customer when the problem occurs (for example: rough roads, bumps, or volume level maximum/minimum).
2. Confirm the condition.
  - A. Remove the door trim panel, if necessary.
  - B. Confirm if noise occurs in AM/FM mode or CD mode.
3. Repair the door trim panel as needed.

- A. Confirm rattle noise is gone in the area where the vibration is occurring.
  - B. Reinstall the door trim and confirm the area where the vibration is occurring. Use the NVH kit (P/N 08231-00810) on the trim panel area that is vibrating.
4. Repair loose parts.  
Check the wiring harness, water shield, clips, and/or other parts that are vibrating. Use the NVH kit (P/N 08231-00810) on parts that are vibrating.
5. Replace the speaker.
  - A. Unbolt the speaker and remove from the door/body panel.
  - B. If the noise is still coming from the speaker, replace the speaker.

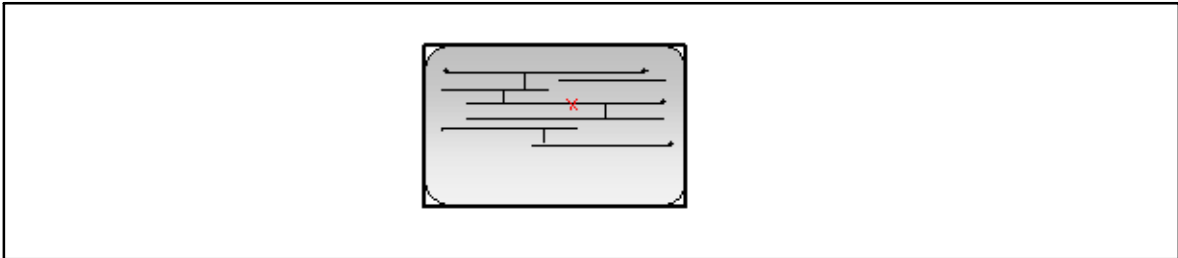
5. Inspect the glass antenna for open/cut patterns.

**If NO OPEN pattern is found or reception is still poor after glass antenna repair, go to step 7 for antenna amplifier systems.**

**If an OPEN pattern is found, repair as needed and recheck reception quality.**
