# Interior Panels Sticky/Poor Appearance

YEAR(S)	MODEL(S)	ADDITIONAL INFORMATION
2006 – 2008	IS250, IS350

Some 2006 – 2008 model year IS 250/350 vehicles may exhibit sticky interior panels that have a shiny/degraded appearance. This condition may be present on the Instrument Panel Pad and/or the Door Panel Trim. Revised interior panels have been developed to address this condition.

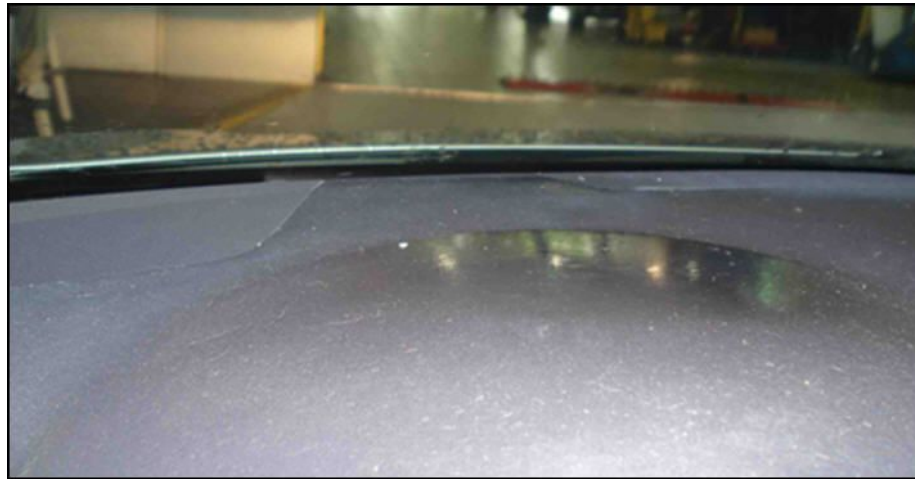
Figure 1.

1. Confirm the customer specified interior components for sticky feel/poor appearance (see Figure 1).
  - If sticky components are identified, continue to step 2.
  - If not, this TSIB does NOT apply.

2. Remove the affected interior panel.

3. Install the NEW interior components.
