# Water Pump Inspection and Diagnosis Tips

**Service Category** Engine/Hybrid System

**Section** Cooling

This service bulletin contains water pump leak inspection and diagnostic tips.

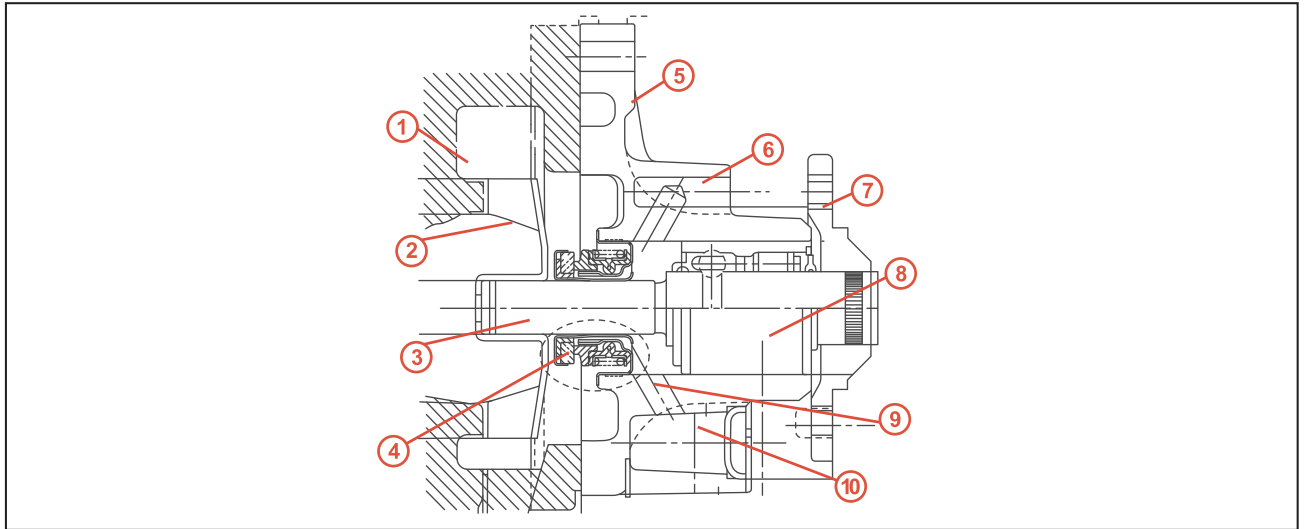
Figure 1. Water Pump Construction

1	Engine Block
2	Impeller
3	Shaft
4	Mechanical Seal
5	Pump Body

6	Breather Hole
7	Pulley Seat
8	Bearing
9	Weep Hole
10	Fluid Catch Pocket

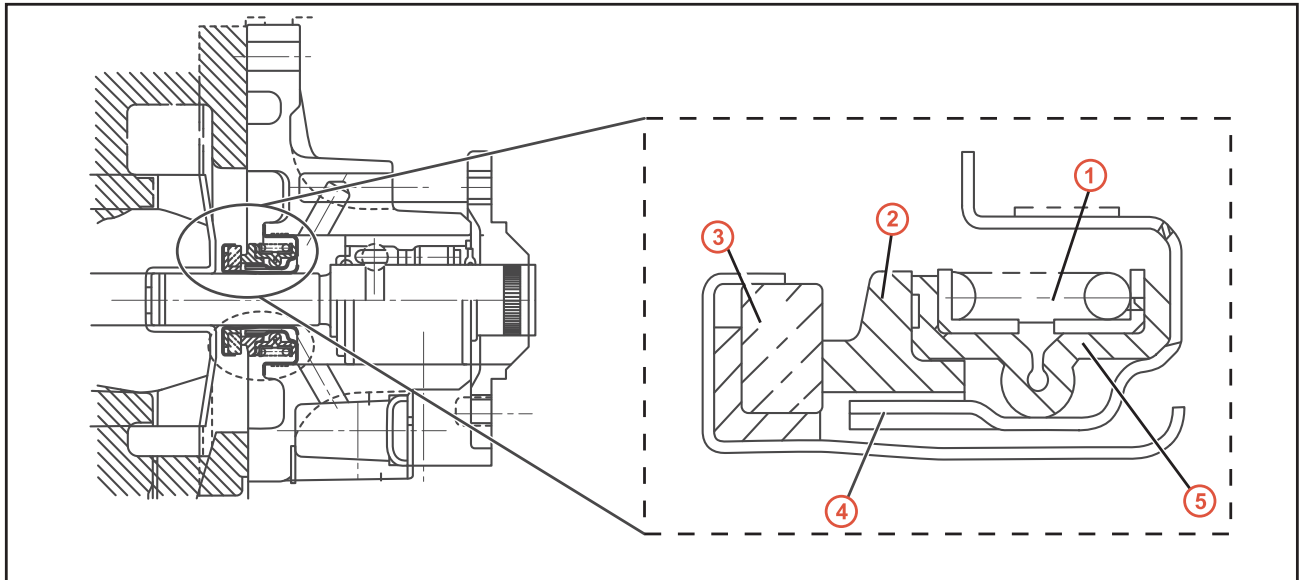
**Figure 2. Mechanical Seal Components**

The water pump shaft is sealed by a mechanical type seal.

<b>1</b>	<b>Spring</b> – Applies pressure to the seal ring to ensure the seal ring and mating ring are in constant contact.
<b>2</b>	<b>Seal Ring</b> – Stationary sealing member in the water pump housing, held in place by the cartridge.
<b>3</b>	<b>Mating Ring</b> – Rotates with the water pump shaft and provides sealing surface for the seal ring.

<b>4</b>	<b>Cartridge</b> – Locates the seal ring and bellows in the water pump housing.
<b>5</b>	<b>Bellows</b> – Seals the cartridge and the seal ring.

The seal and mating rings are lubricated by the surrounding coolant; a small amount of coolant leakage is normal.

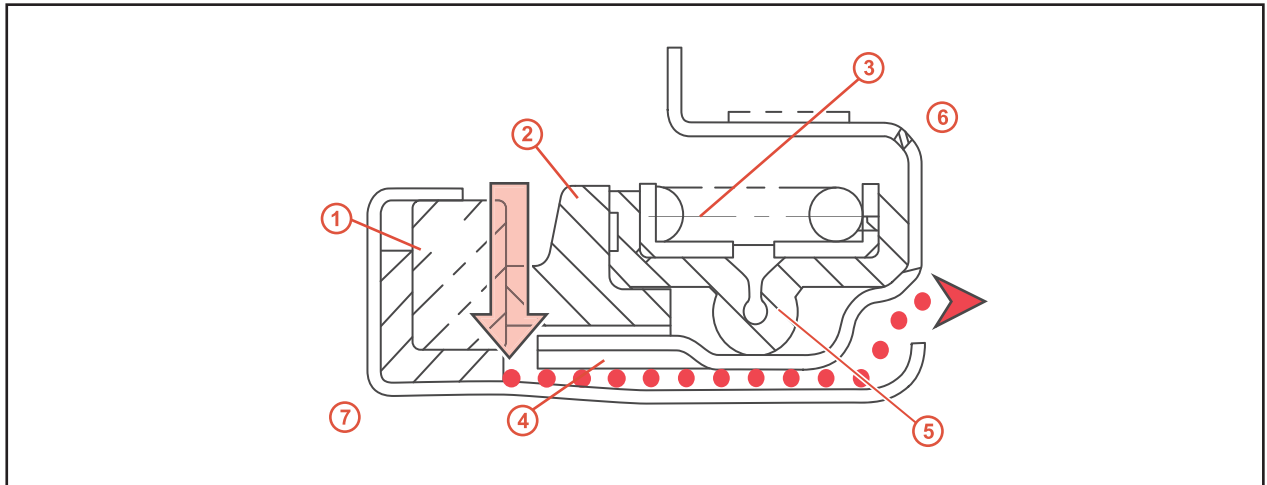
Figure 3. Debris in Mechanical Seal

If debris becomes trapped between the mating ring and seal ring a small gap is formed. This allows coolant to bypass the mechanical seal, flow into the fluid catch pocket, and drain out of the weep hole. This condition is temporary and will no longer be present once the debris is crushed or works its way out of the seal. **Water pump replacement is not necessary.**

1	Mating Ring
2	Seal Ring: gap formed by debris
3	Spring
4	Cartridge

5	Bellows
6	Housing Side
7	Impeller Side

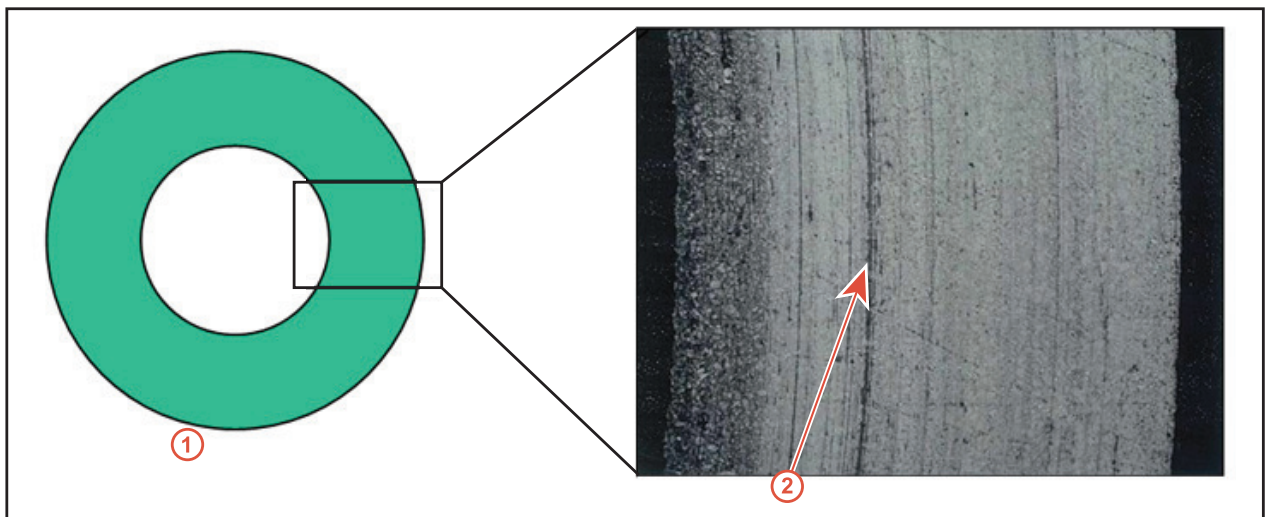
Figure 4. Mechanical Seal Mating Ring Sealing Surface

If debris was trapped between the seal ring and mating ring an abrasion mark may have been left on the mating ring surface. This abrasion mark does not affect sealing performance due to the large sealing surface of the mating ring. Once the debris is no longer present the mechanical seal performance will return to normal operation. **Water pump replacement is not necessary.**

1	Mating Ring
---	-------------

2	Debris Abrasion Mark
---	----------------------

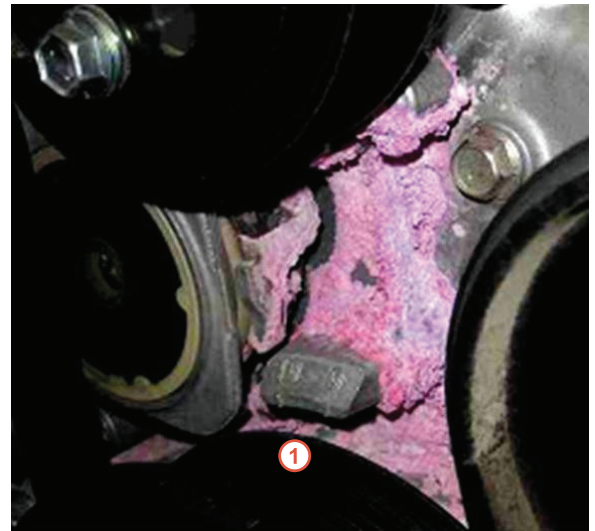
**Figure 5. Current Leak – Replace Water Pump**

1. Visually inspect the water pump and coolant level in the coolant reservoir. Replace the water pump if any of the following conditions exist:
  - A. The coolant level is below the “low” level and the water pump appears to be leaking.
  - B. Water pump pulley/bearing has excessive free play or does not turn smoothly.
  - C. Heavy coolant deposits are present on both the water pump and surrounding components (i.e. pulleys, engine block, timing cover, under hood).

<b>1</b>	Heavy coolant deposits present on water pump and all surrounding components
----------	---

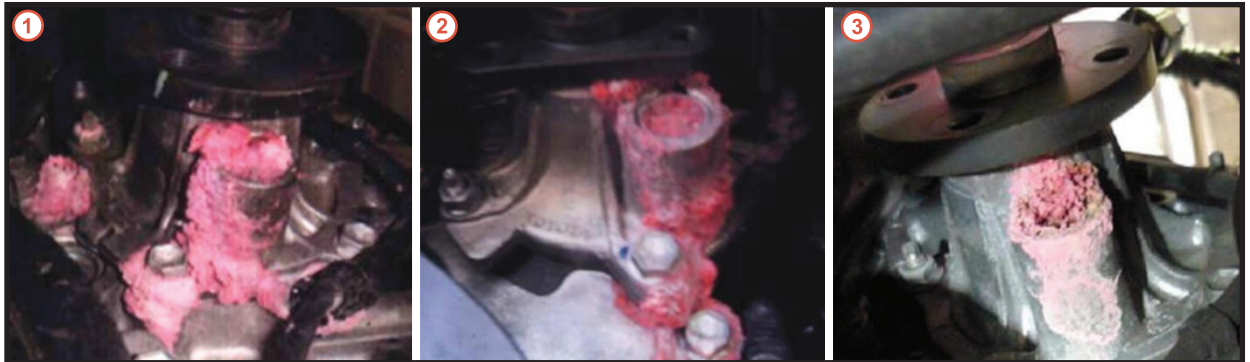
**Figure 6. Possible Temporary Leaks – Inspect Water Pump**

If the above conditions do not apply or amount of deposits are in question, the leak may have been temporary and additional inspection is necessary.

<b>1</b>	Thick coolant deposits present on water pump only
<b>2</b>	Moderate coolant deposits present on water pump only
<b>3</b>	Light coolant deposits present on water pump only

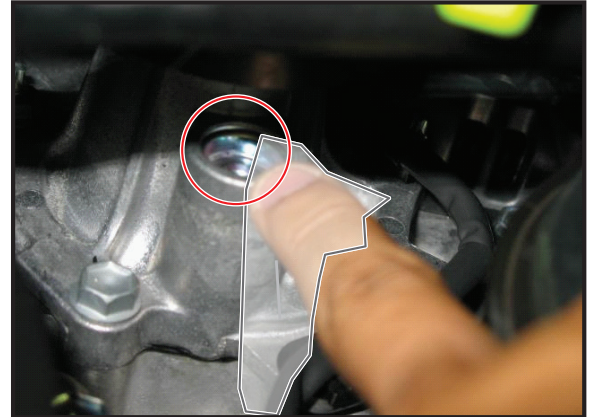
Figure 7.

2. A paper towel should be used to determine if a leak is current, or was temporary due to debris that has now cleared.

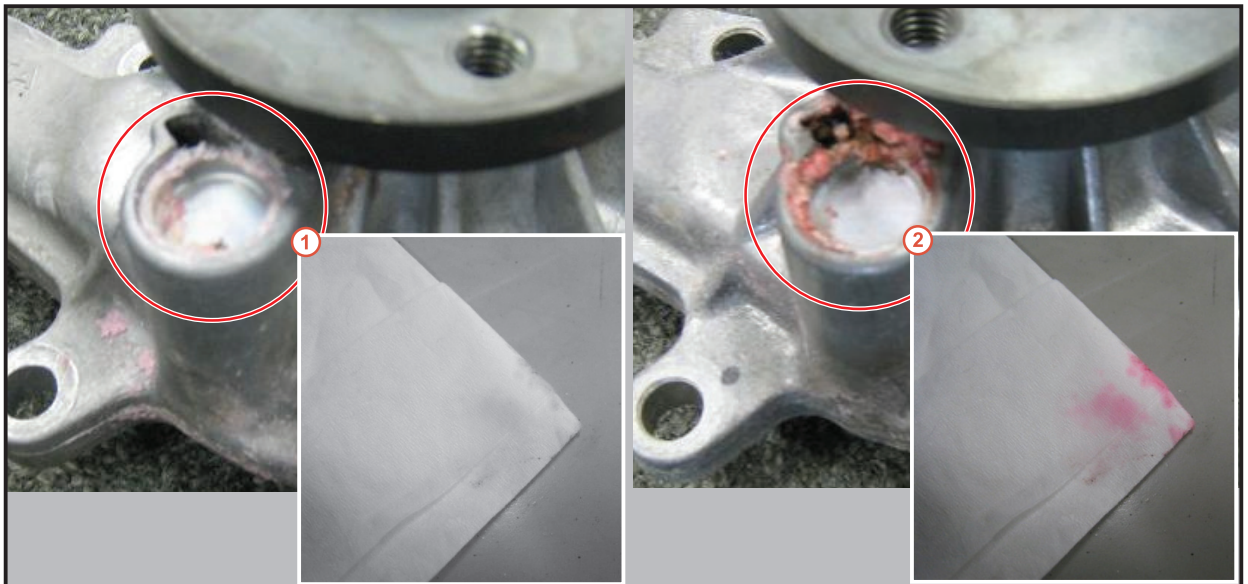
Figure 8.

3. Apply a dry paper towel to the coolant deposits around the weep hole. If the paper towel remains dry the leak was temporary and the water pump does not need to be replaced. If the paper towel becomes wet the leak is current and the water pump should be replaced.

**1** Dry Paper Towel DO NOT Replace Water Pump

**2** Wet Paper Towel Replace Water Pump
