Interior Trim 2015-12

2015 Lexus IS350 F-Sport AWD (with nav.)

Film: 3M 1080 color: Matte red metallic 1080-M203

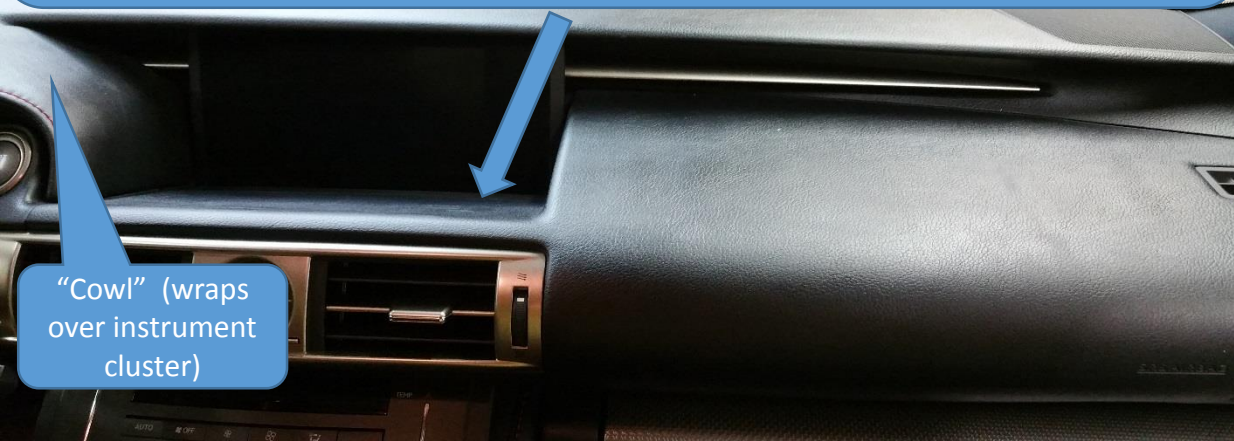
“Cowl” (wraps over instrument cluster)

1) Snap out lower rectangular trim in front of display panel. Lift rear edge with fingernails or plastic tool. Left edge is a bit crammed under cowl, need to wiggle around to get trim piece out.

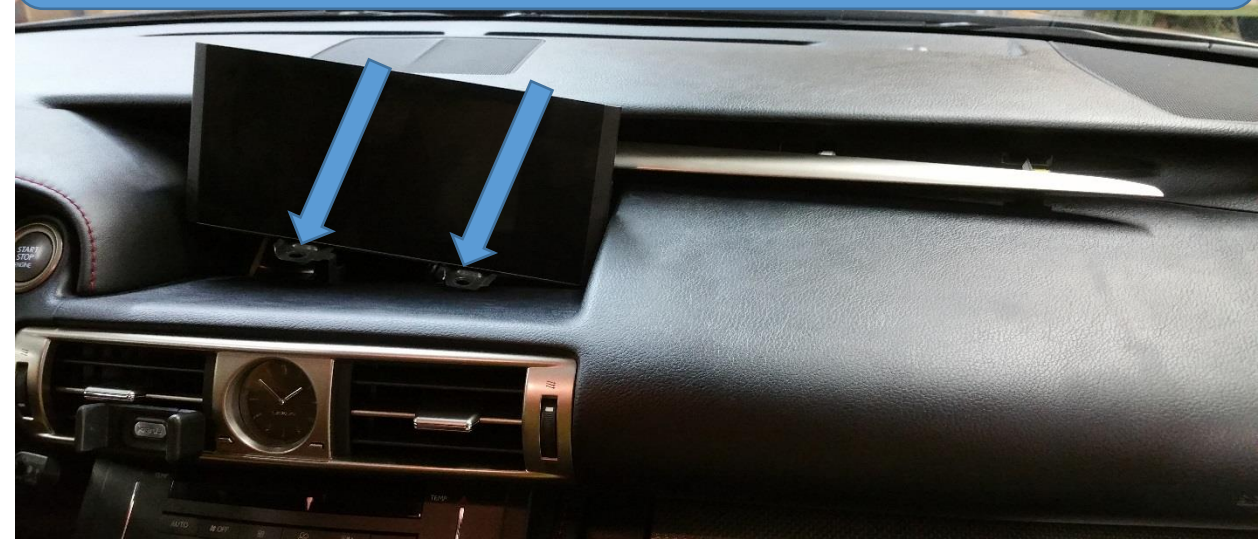
2) Remove (2) screws with M1 socket – careful not to damage screen face. Display panel rotates out – top come rearward first. Then remove (2) wire connectors

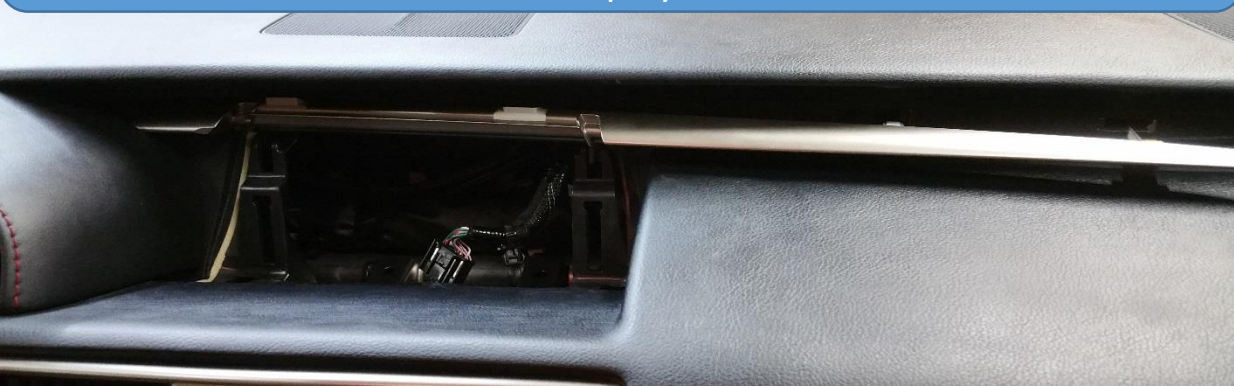
3) This leaves the entire silver trim piece exposed. It snaps out – remove RH end first. Be careful not to break the piece – it’s thin in the center area behind the display. Photo show RH end loose.

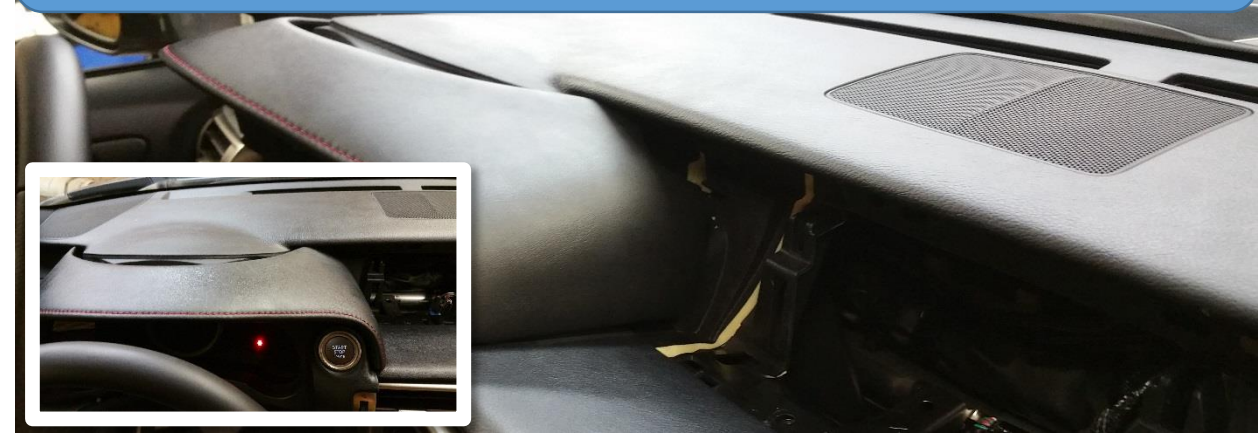
4) Cowl must be loosened to remove LH end of silver trim. Grab ends and the cowl will unsnap rearward. Photos show cowl loosened.

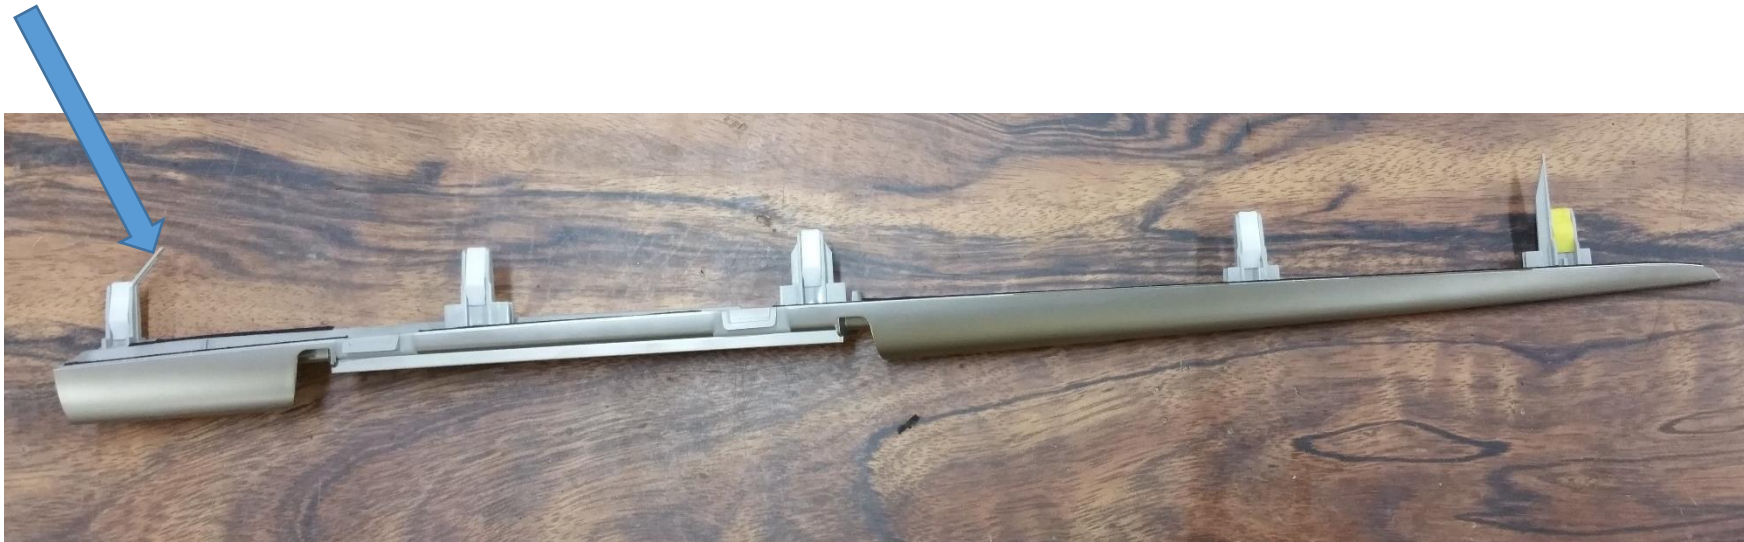
Removing LH end requires twisting piece around a bit, even with cowl loosened. This bent/broke a tiny pre-guide finger on the part, which is inconsequential – presumably it is an assembly aid/locating finger.

It may be possible to remove without breaking the tiny finger with cowl removed further (?)

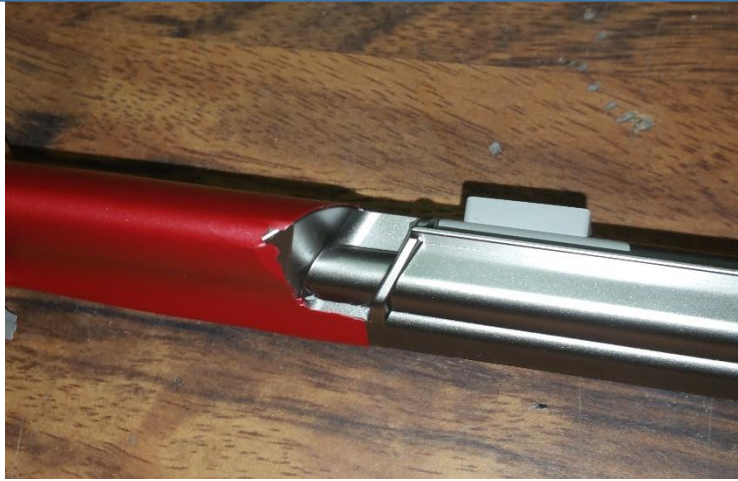
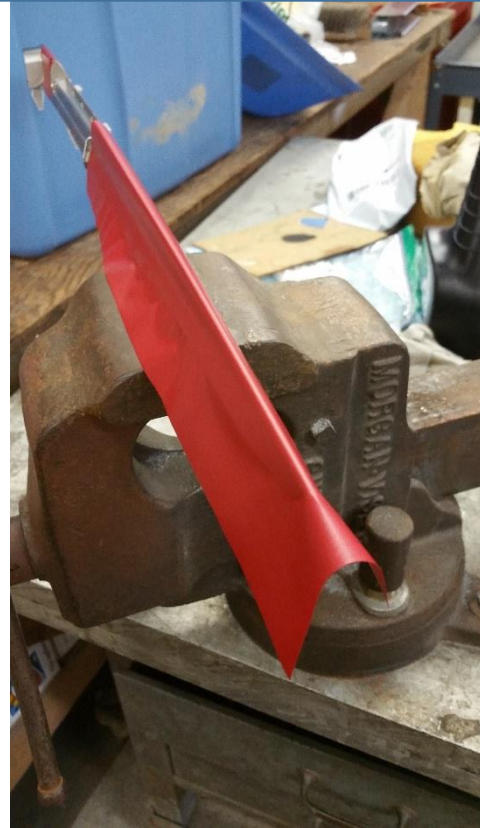
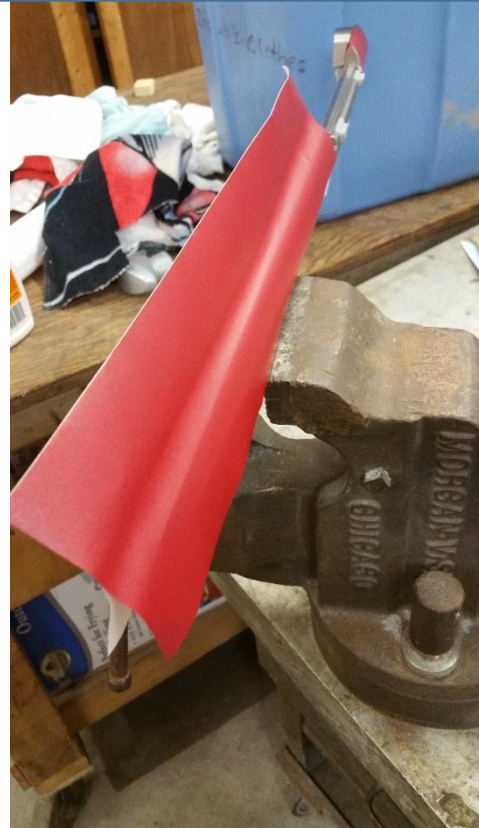
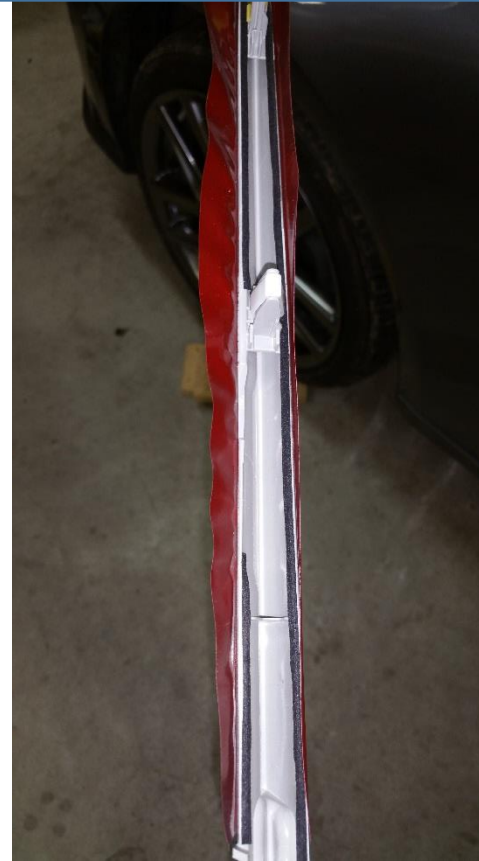
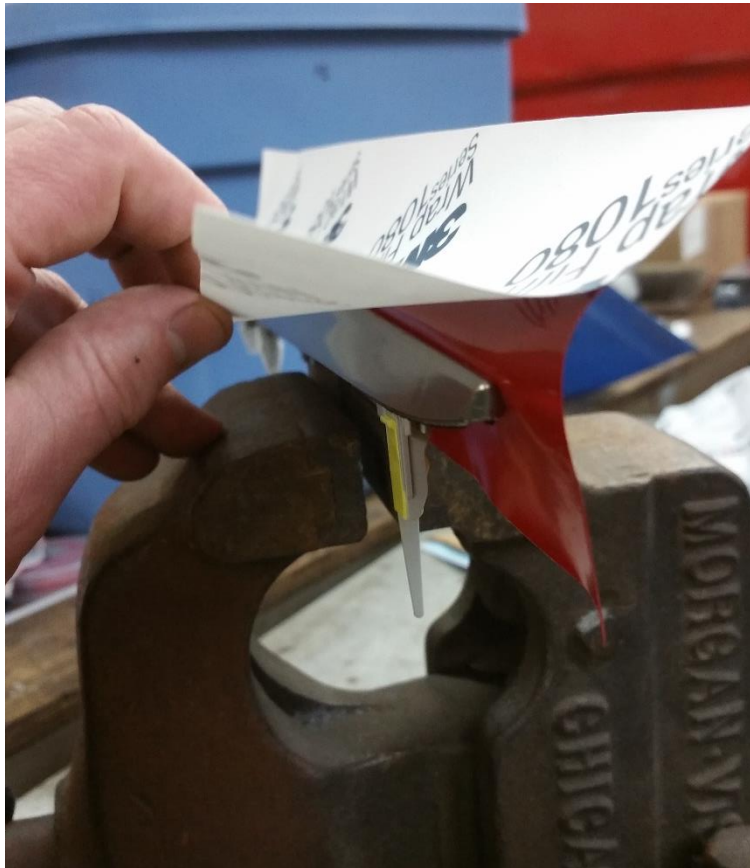
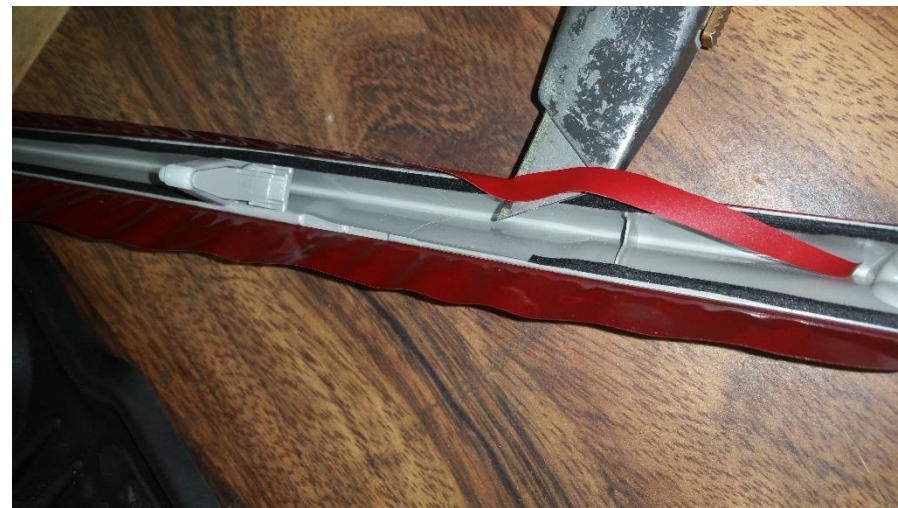
Applying film to dash piece. (YouTube has detailed instructions). For this piece, no heat was needed/used.

Trim edge at end of part is visible – try to wrap as best as possible, and make super-clean trim edge

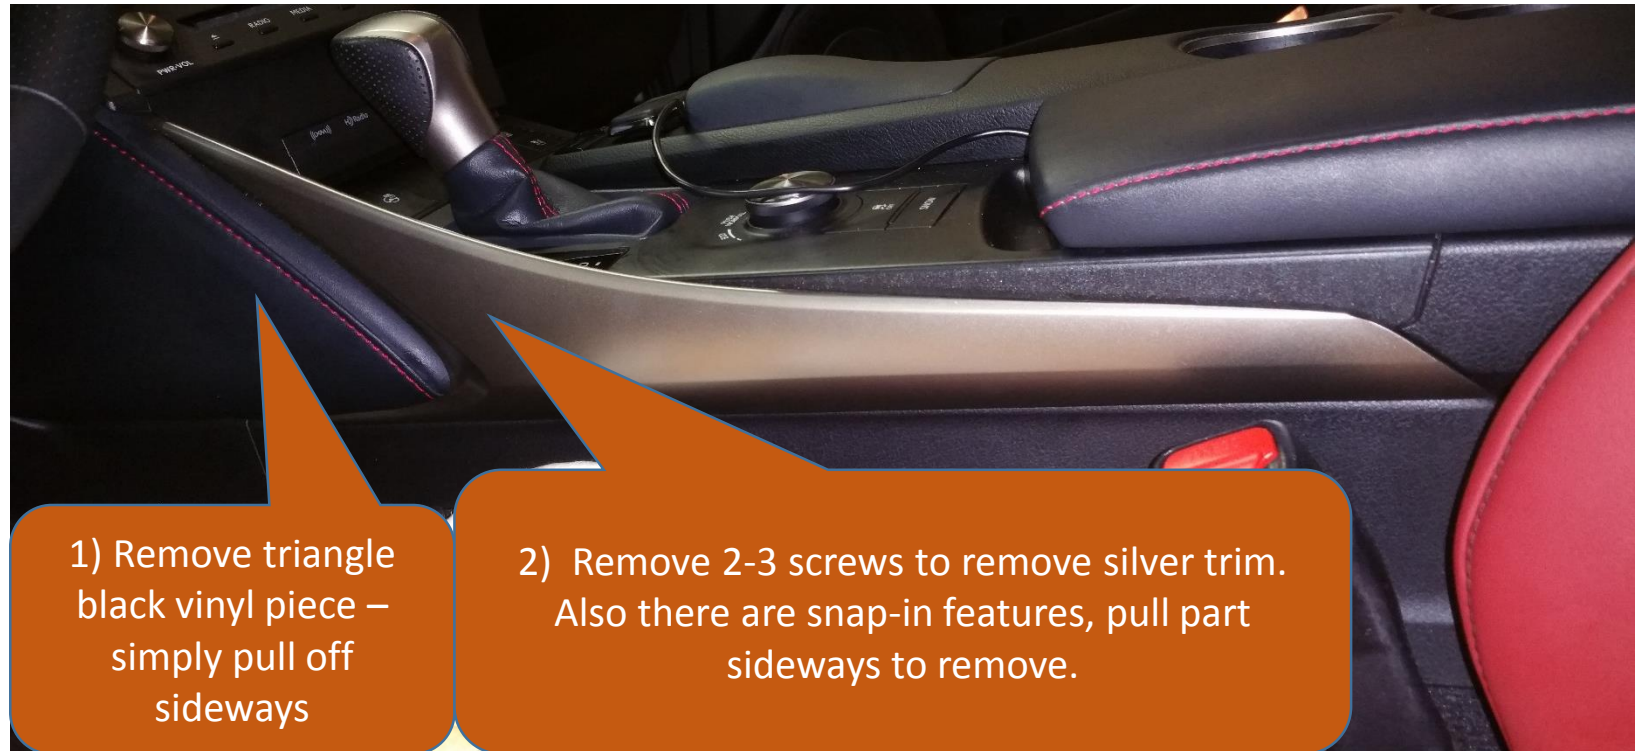
Before removal, note which areas are exposed, and be sure to cover all visible areas completely with wrap.

1) Remove triangle black vinyl piece – simply pull off sideways

2) Remove 2-3 screws to remove silver trim. Also there are snap-in features, pull part sideways to remove.

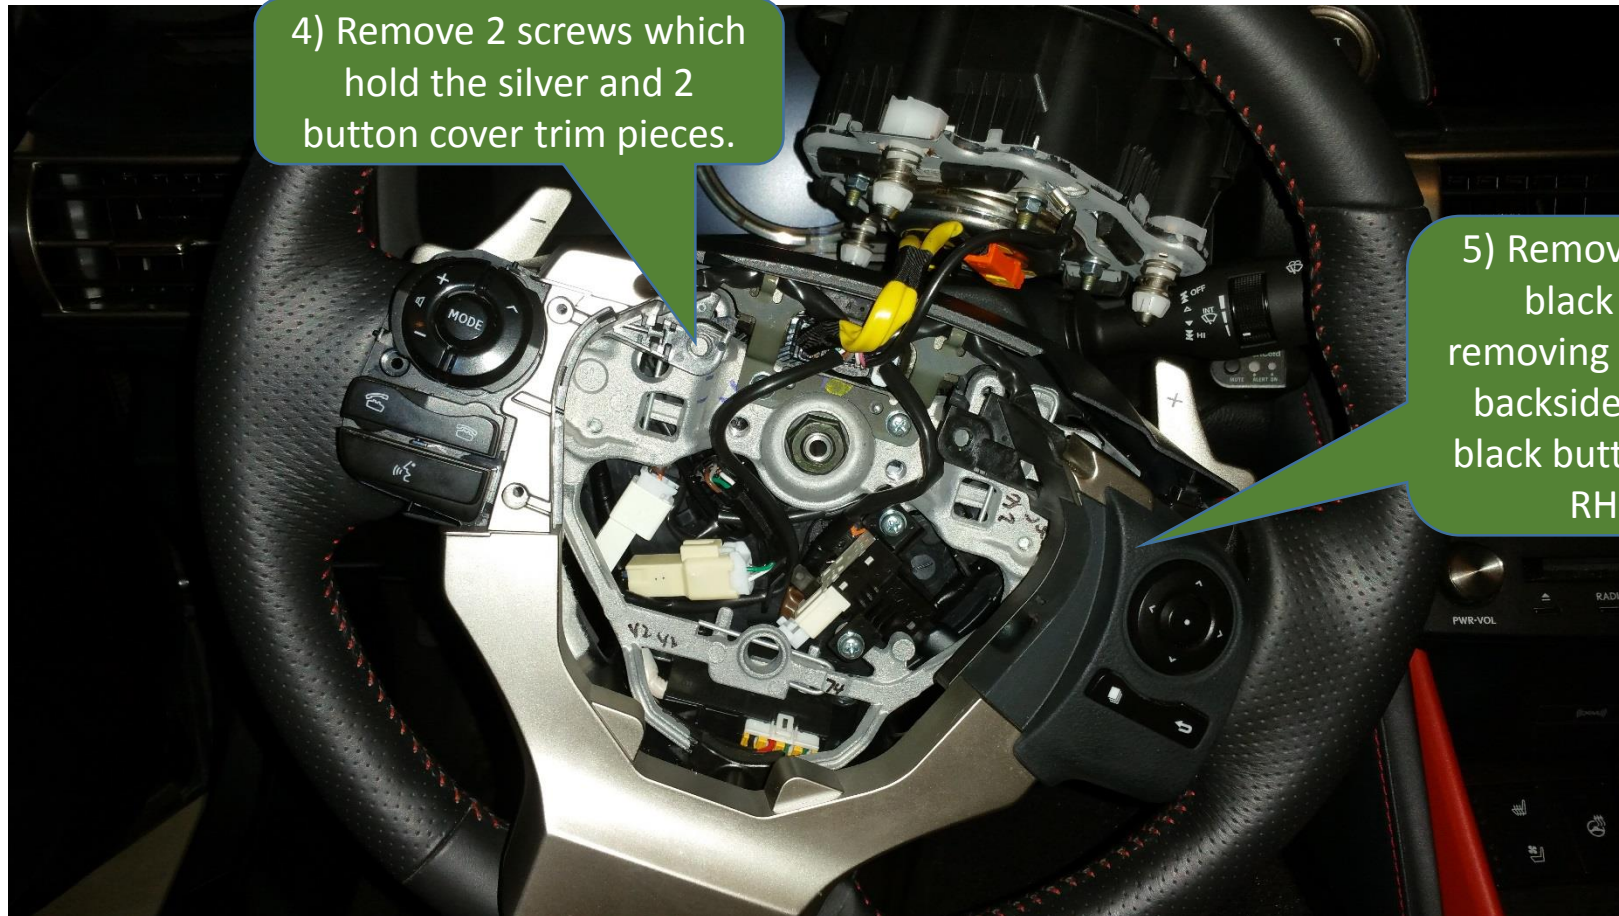
3) Photo below shows airbag removed and set above wheel (no need to unwire airbag)
