Technical Service Bulletin

BE-0090L-0915

Lexus premium navigation - wiping marks on audio navi multidisplay screen after cleaning

IS250; IS300H; RC F; RC350

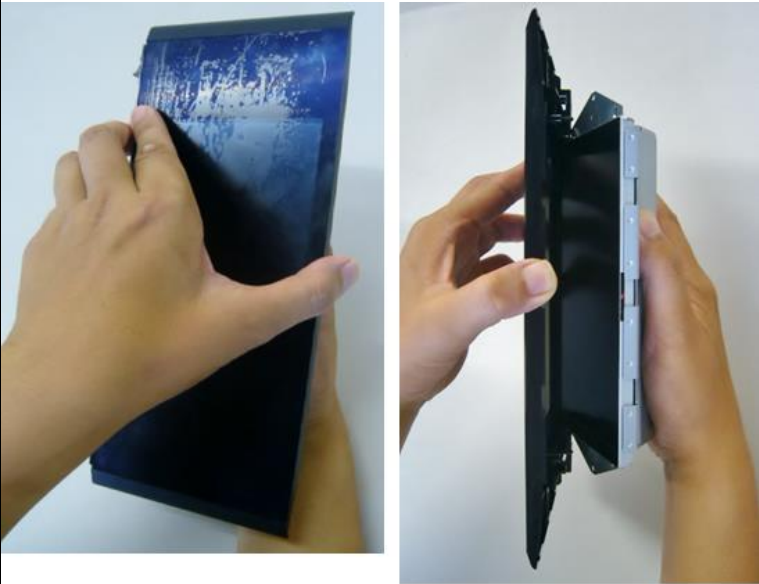
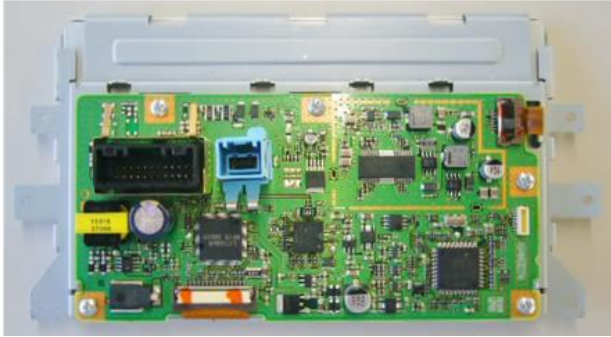
<p>The metal cover protecting the printed circuit board can be easily removed giving access to the printed circuit board. This metal cover should not be removed.</p> <p>1</p> <p>CAUTION</p>

<p>If accidentally removed, observe precautions against electrostatic discharge.</p>

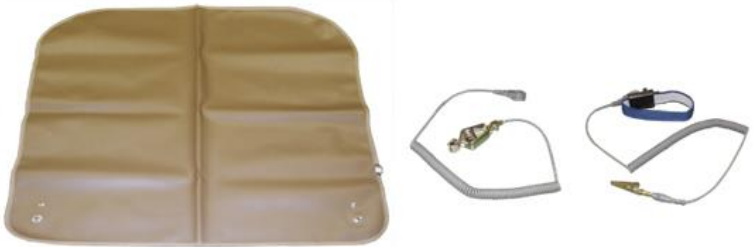
<p>2</p> <p>If available, we advise the rework to be performed on the desktop anti static mat used in the hybrid overhaul (SST: 09890-47010)</p>

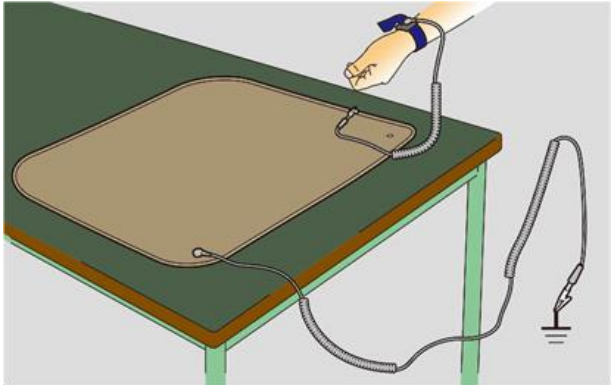
<p>3 Make sure to securely wear an antistatic wrist strap for preventing static electricity.</p> <p>Secure the ground clip of the antistatic mat to the ground point of any structures or work benches.</p>

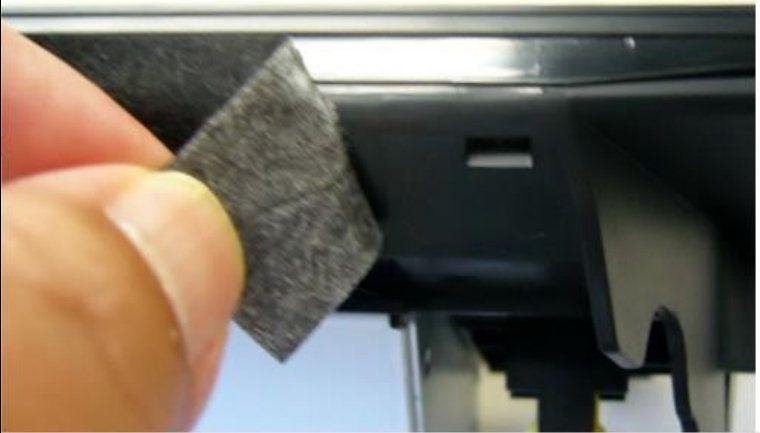
<p>CAUTION</p>	<p>Wash your hands before starting the rework of the multi-display assembly to avoid contamination of the screen and electronic circuit board.</p>	
<p>1 Remove the insulator attached on the top by pulling it slowly from the edge.</p>

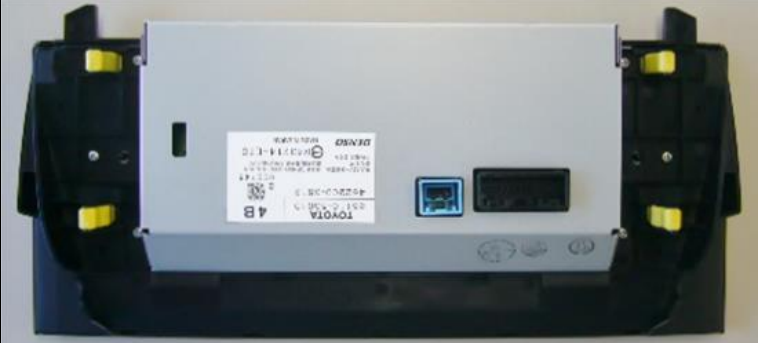
<p>2 Put the multi-display with the front face down on a table.</p>

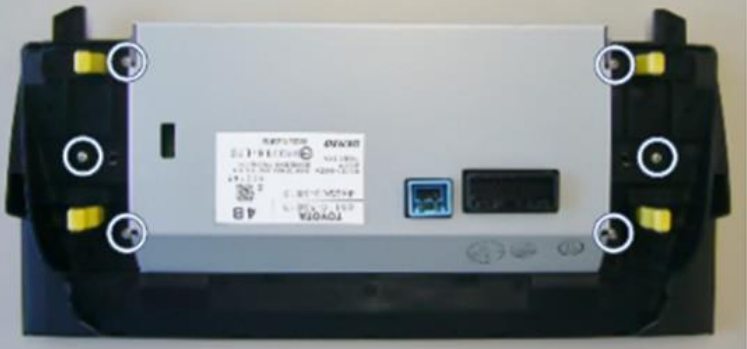
<p>3</p>	<p>Remove the six screws from the rear cover.</p>

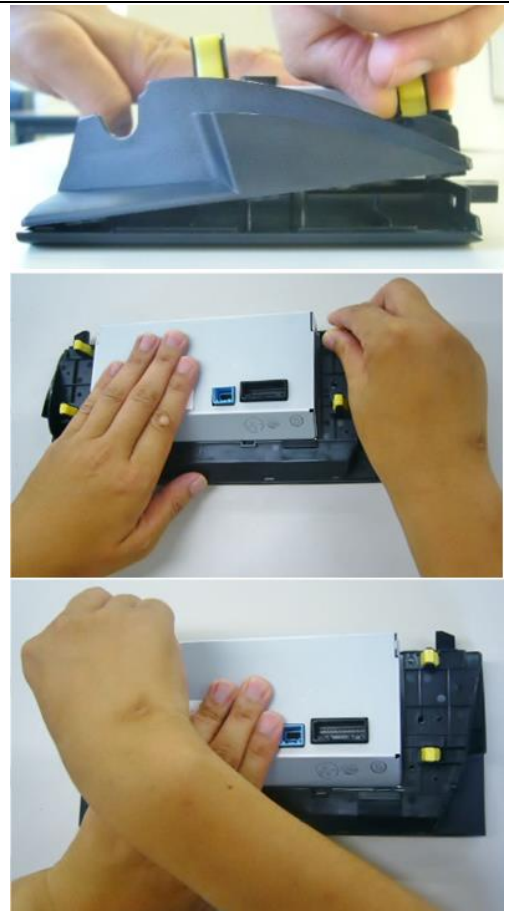
<p>4</p>	<p>Remove the rear cover by pulling slightly upwards at the pins.</p>

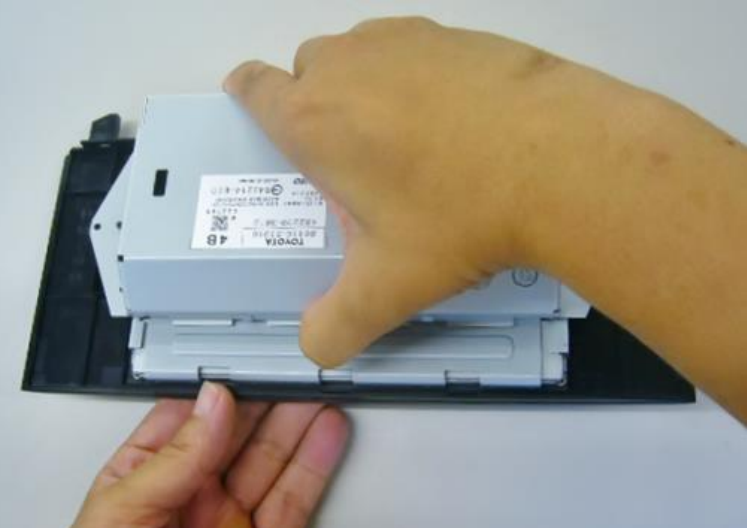
<p>5</p>	<p>Pick up the remaining parts. With the one hand support the metal casing and the multi-display's LCD panel. With the other hand support the plastic front cover. Turn the multi-display over so that it rests in your hand.</p>

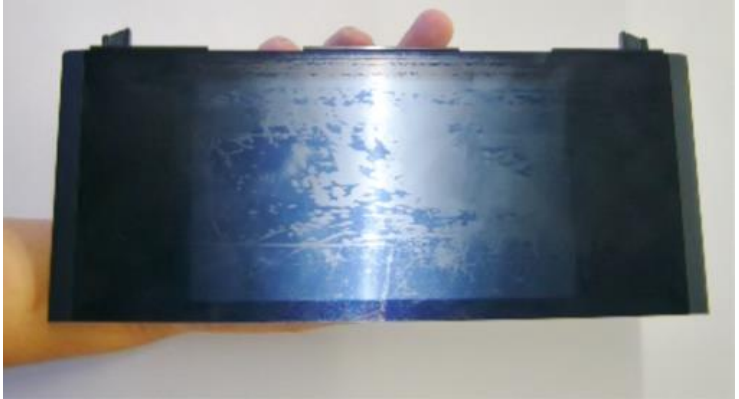
<p>Be careful, the metal casing is not fixed to the LCD panel nor to the plastic front. Observe precautions against electrostatic discharge.</p>

<p>Slightly tilt away the front cover from the multi-display's LCD panel.</p> <p>When the angle between front cover and the LCD panel is approx. 30°, move the front cover slightly back and front to release the pins.</p> <p>6 CAUTION</p>

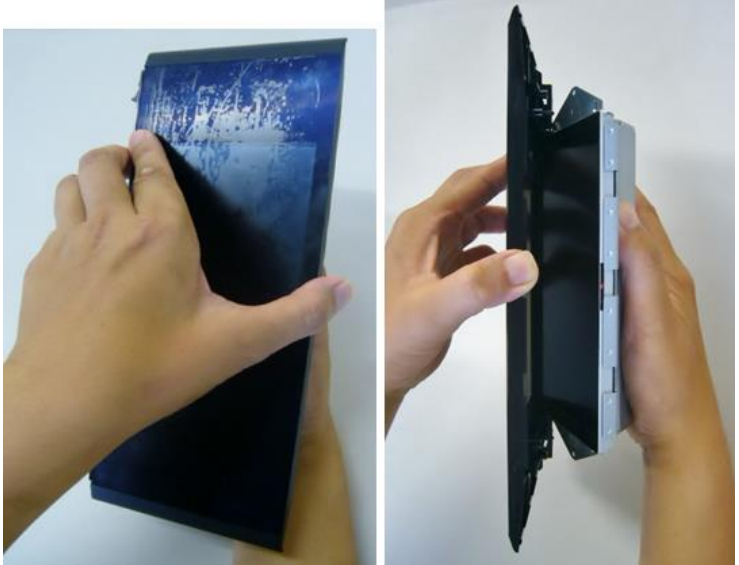
<p>Be careful, the metal casing is not fixed to the LCD panel nor to the plastic front. Observe precautions against electrostatic discharge.</p>

<p>Remove the front cover and hold the LCD panel in your hand.</p> <p>CAUTION</p>

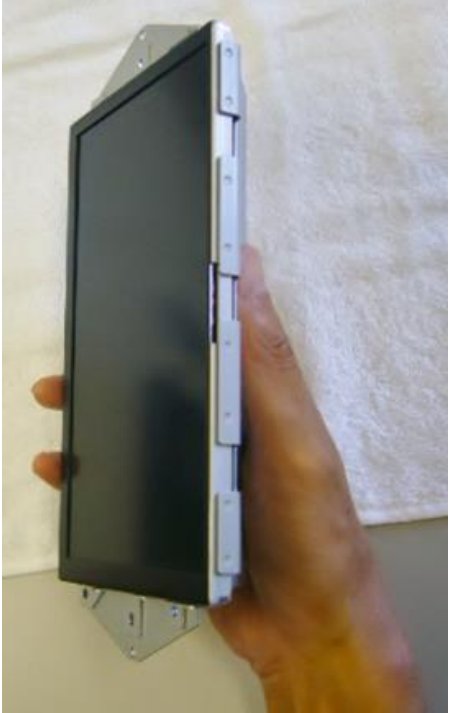
<p>Don't touch the LCD screen with your fingers.</p> <p>7</p>

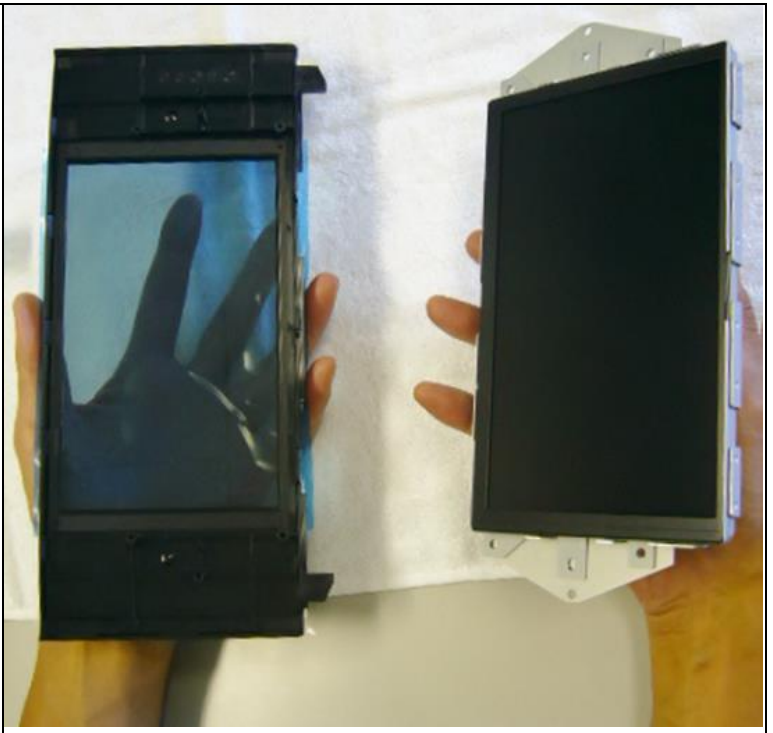
<p>8</p> <p>Take the new front cover from and bring it towards the LCD panel of the multi-display.</p>

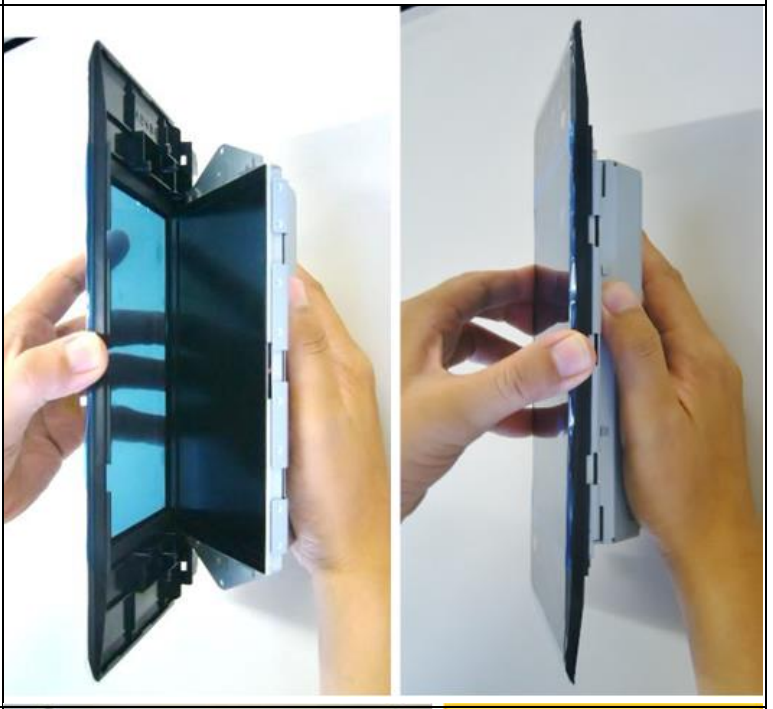
<p>9</p> <p>Assemble the front cover and the multi-display's LCD panel in the reverse order how it was disassembled.</p>

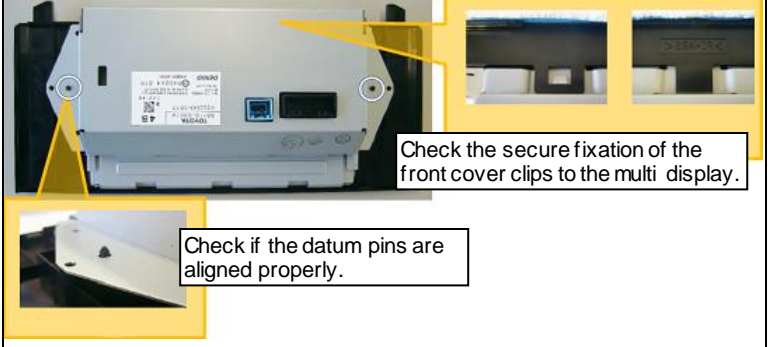
<p>10</p> <p>Check if the multi-display is properly fitted to the front cover.</p> <ul style="list-style-type: none">- Datum pins aligned- All clips are securely fitted

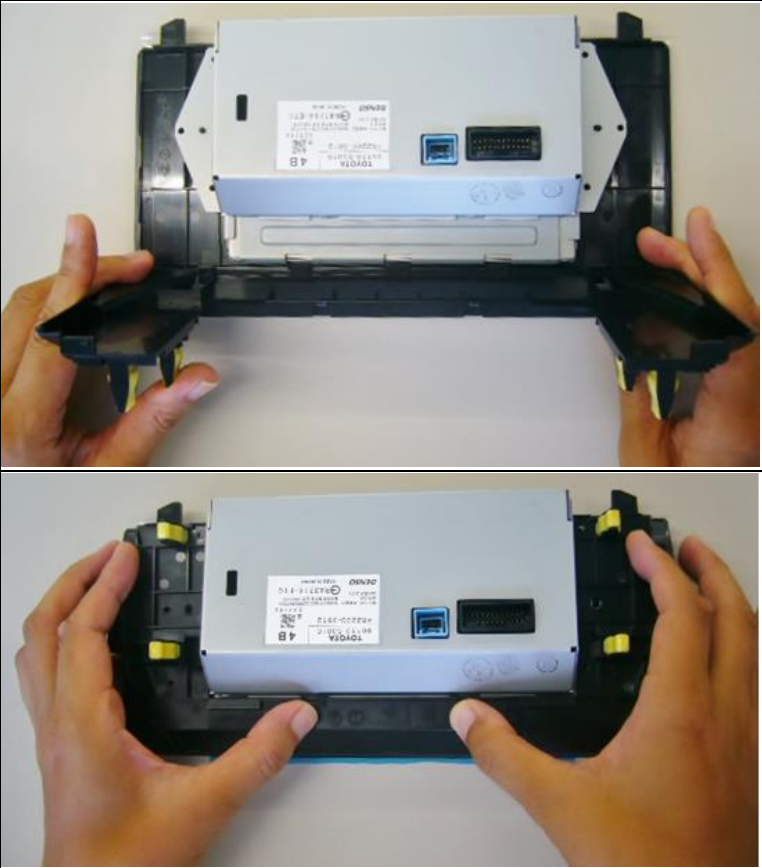
11	Re-assemble the rear cover

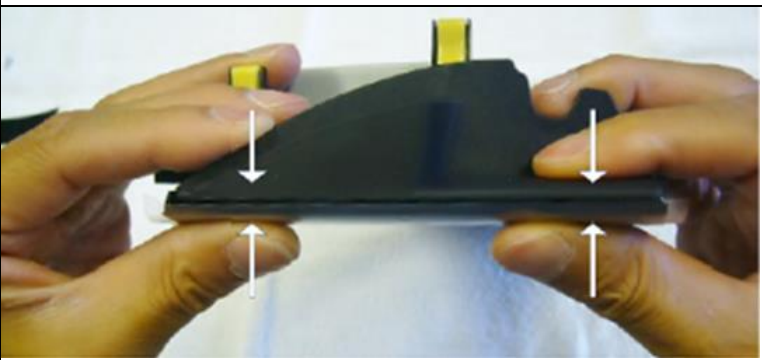
12	Slightly push front and rear cover together to have a tight fit.

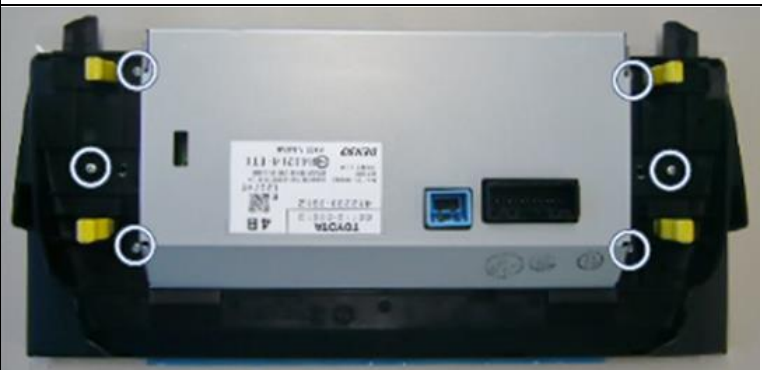
13	Using the 6 screws, secure front and rear cover together.

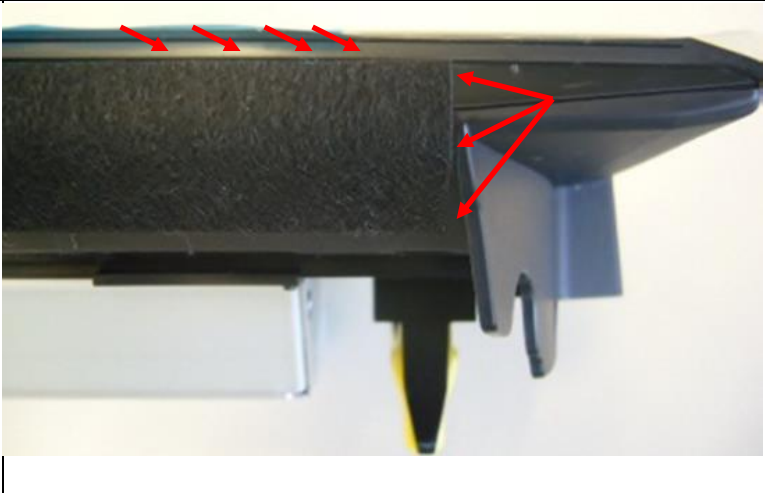
14	Align the insulator tape according the image

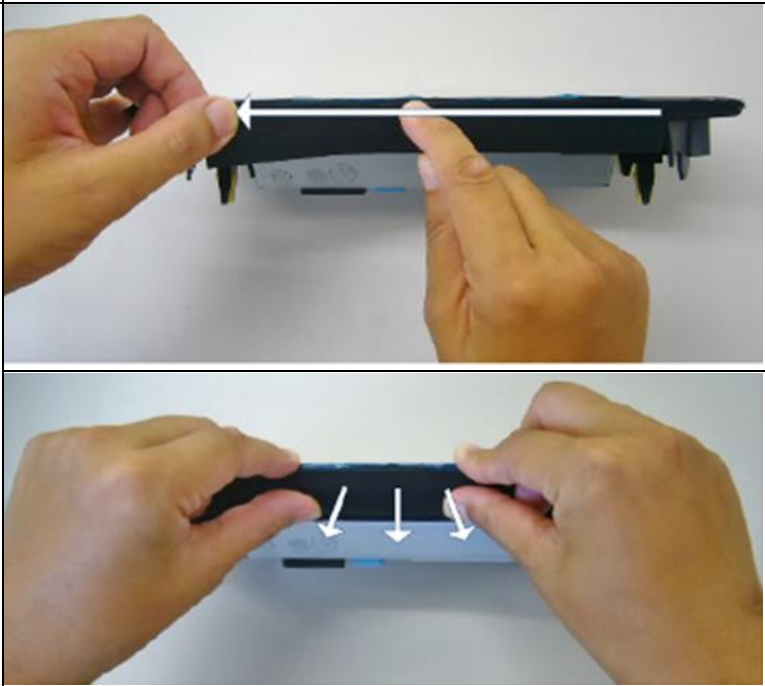
15	Install the insulator tape by applying some slight pressure.
