How to remove the radio head unit in a 2000 Lexus LS400.

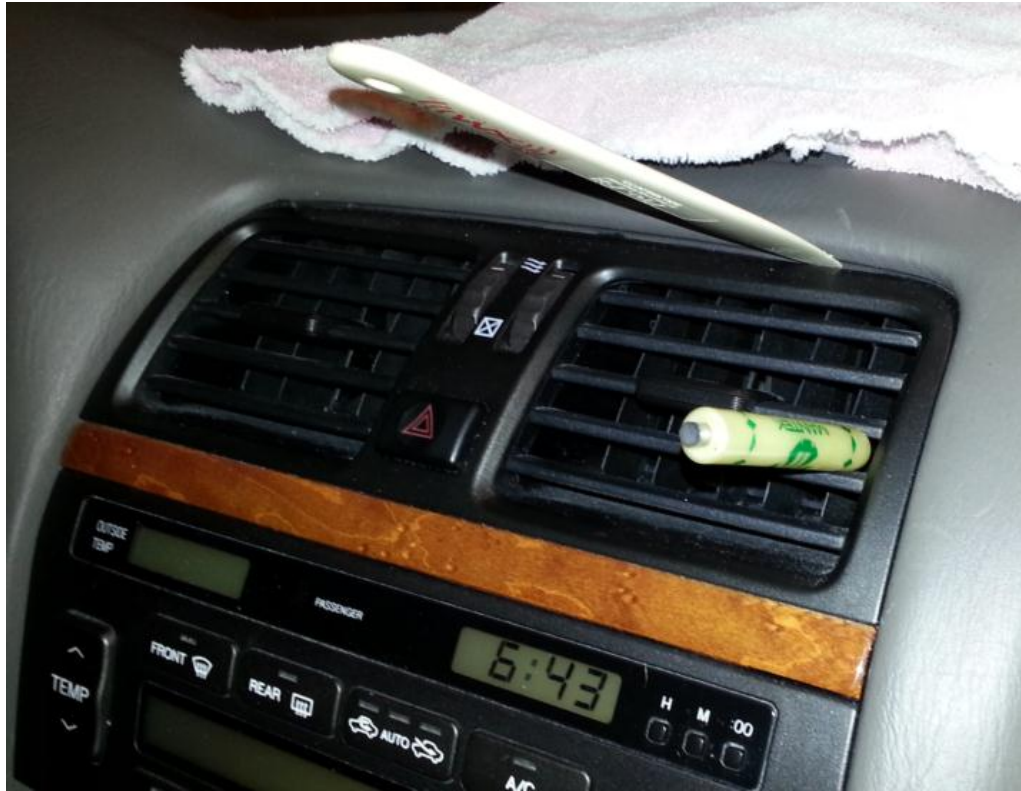
Remove the center vent assembly by pulling the spring loaded retaining clip on each side inward with a small screwdriver while gently prying the assembly out with a non-scarring trim removal tool.

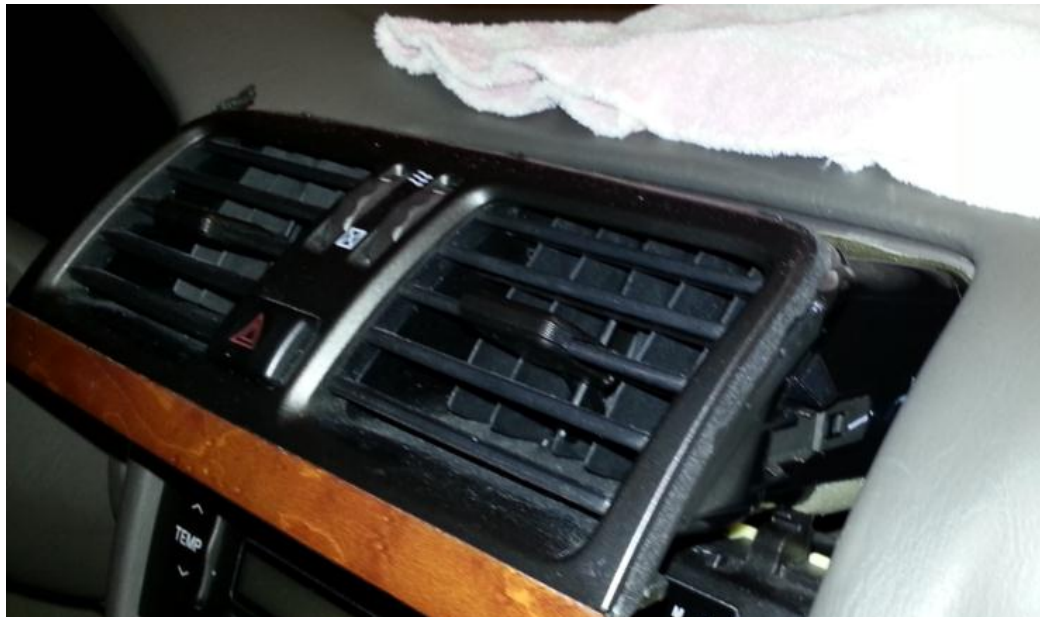
Slide the vent assembly out, move the hazard flasher connector, and set the vent assembly aside.

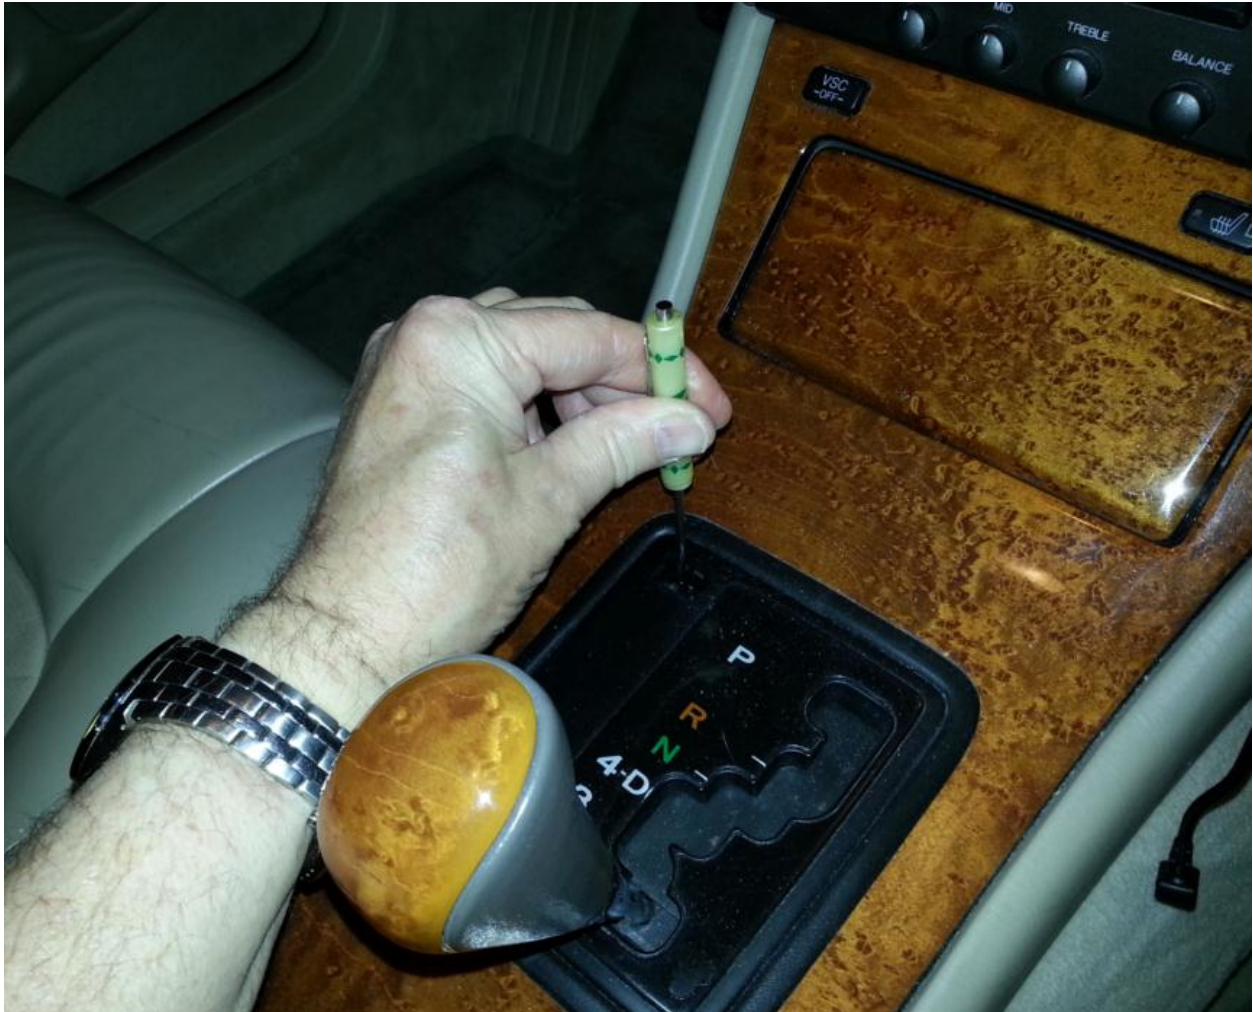
Block the car wheels to prevent the car from rolling when the gear shift is moved from Park. ALSO SET THE PARKING BRAKE. Remove the small cover for the shift interlock switch, press the interlock switch down, and pull the gear shift lever all the way rearward.

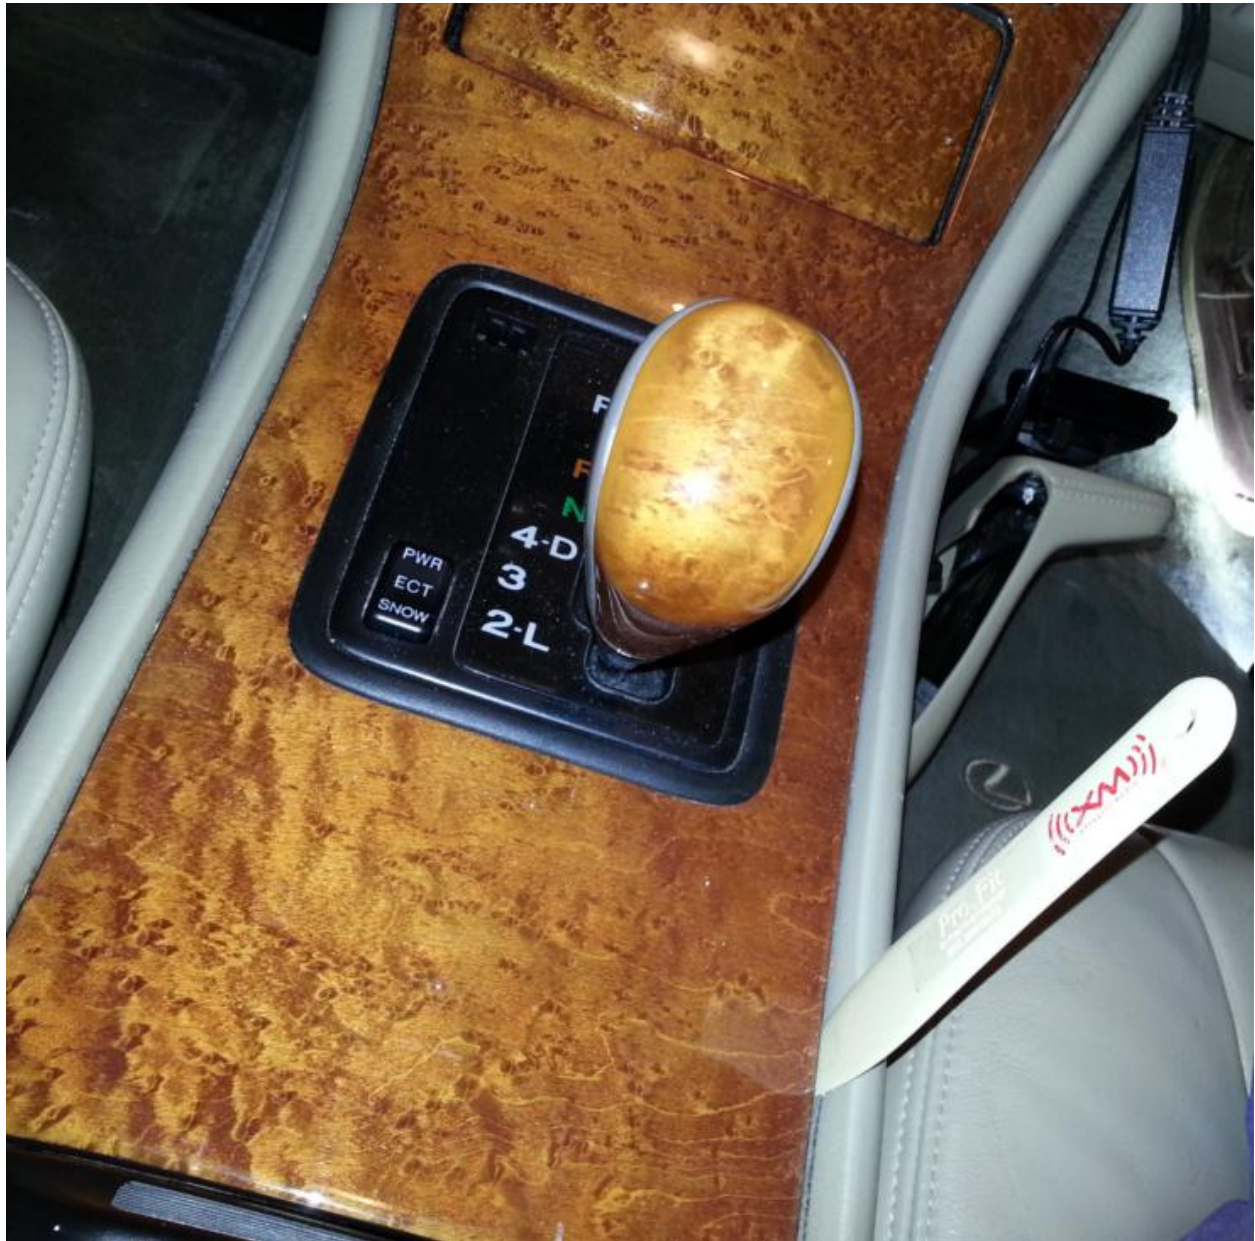
Gently but firmly pry the wood console panel out with a trim removal tool.

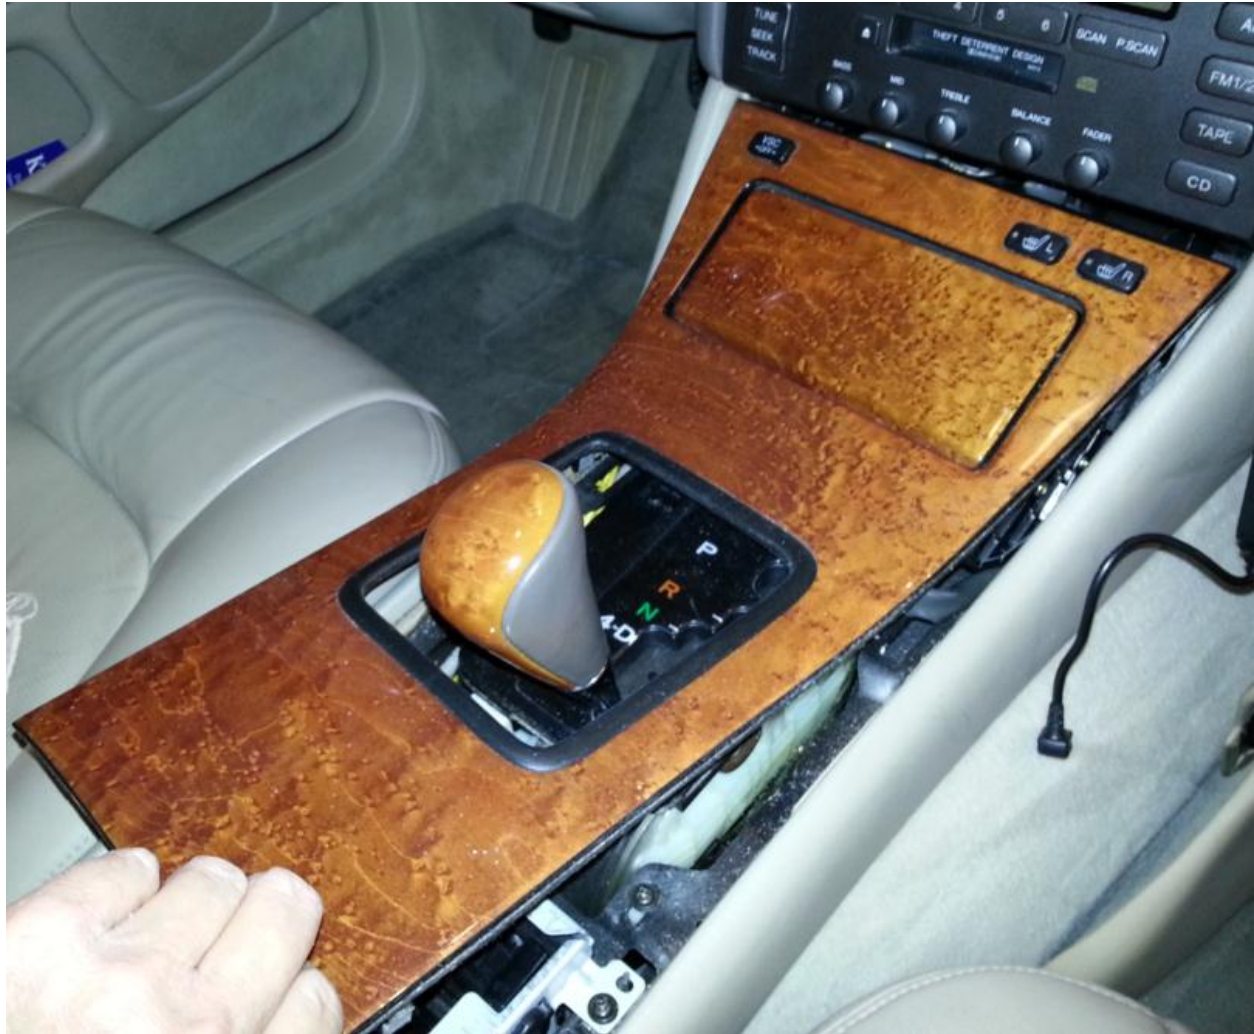
Remove the wood console panel. Disconnect the connectors for the ashtray light, VSC, seat heater switches, etc. Set the wood console panel aside.

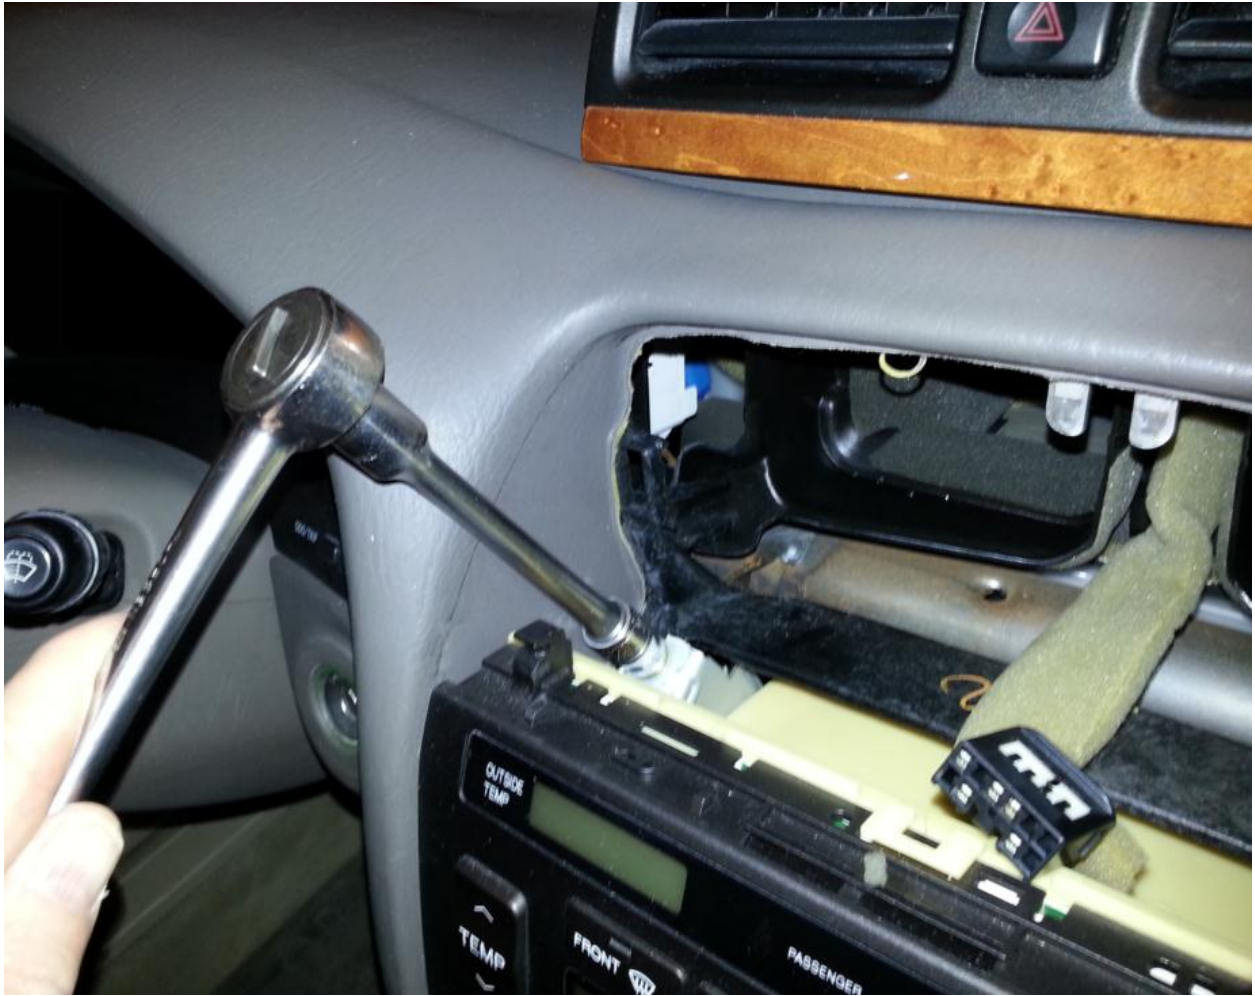
Remove the four 10mm bolts (2 top, 2 bottom) holding the radio/HVAC assembly in place.

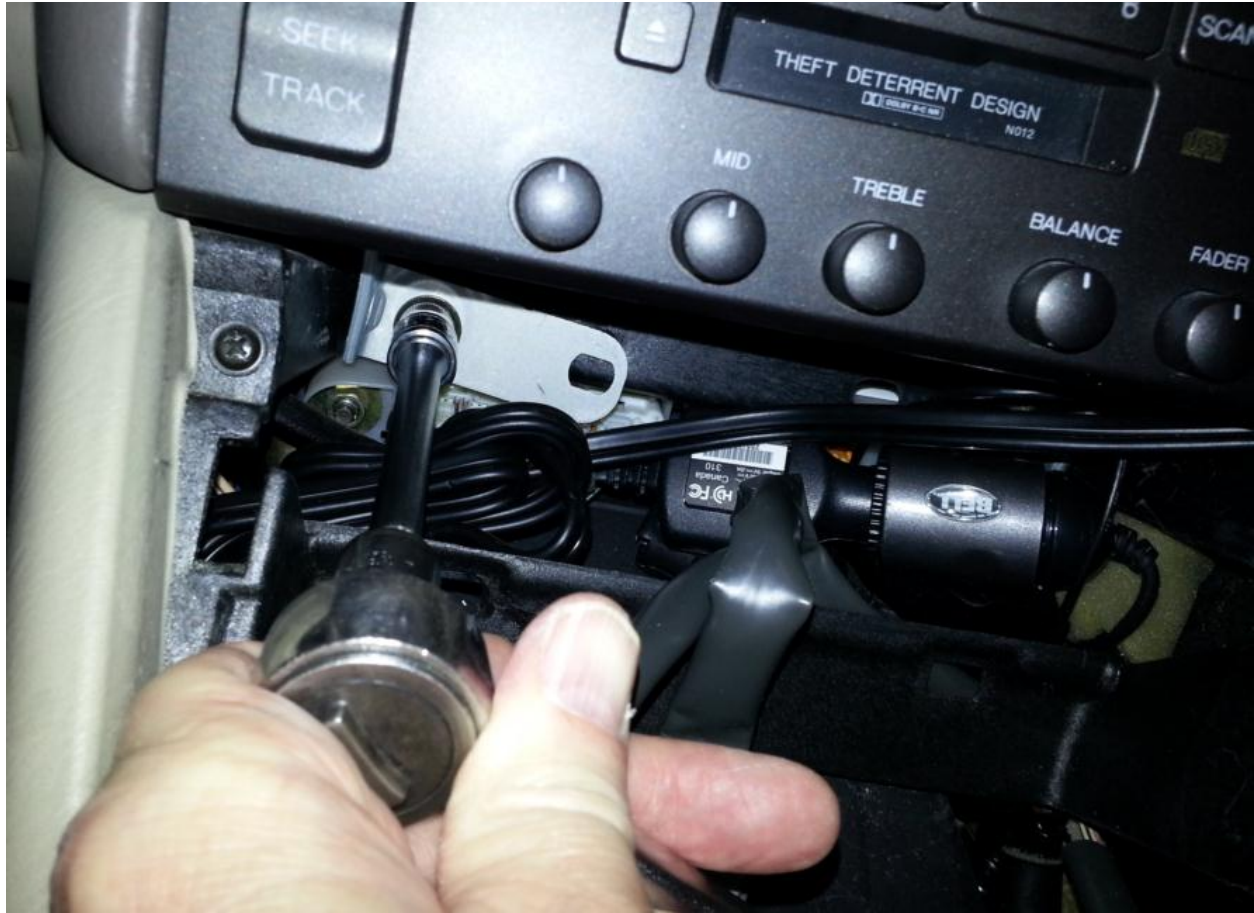
Remove the two bottom 10mm bolts holding the radio/HVAC assembly in place.

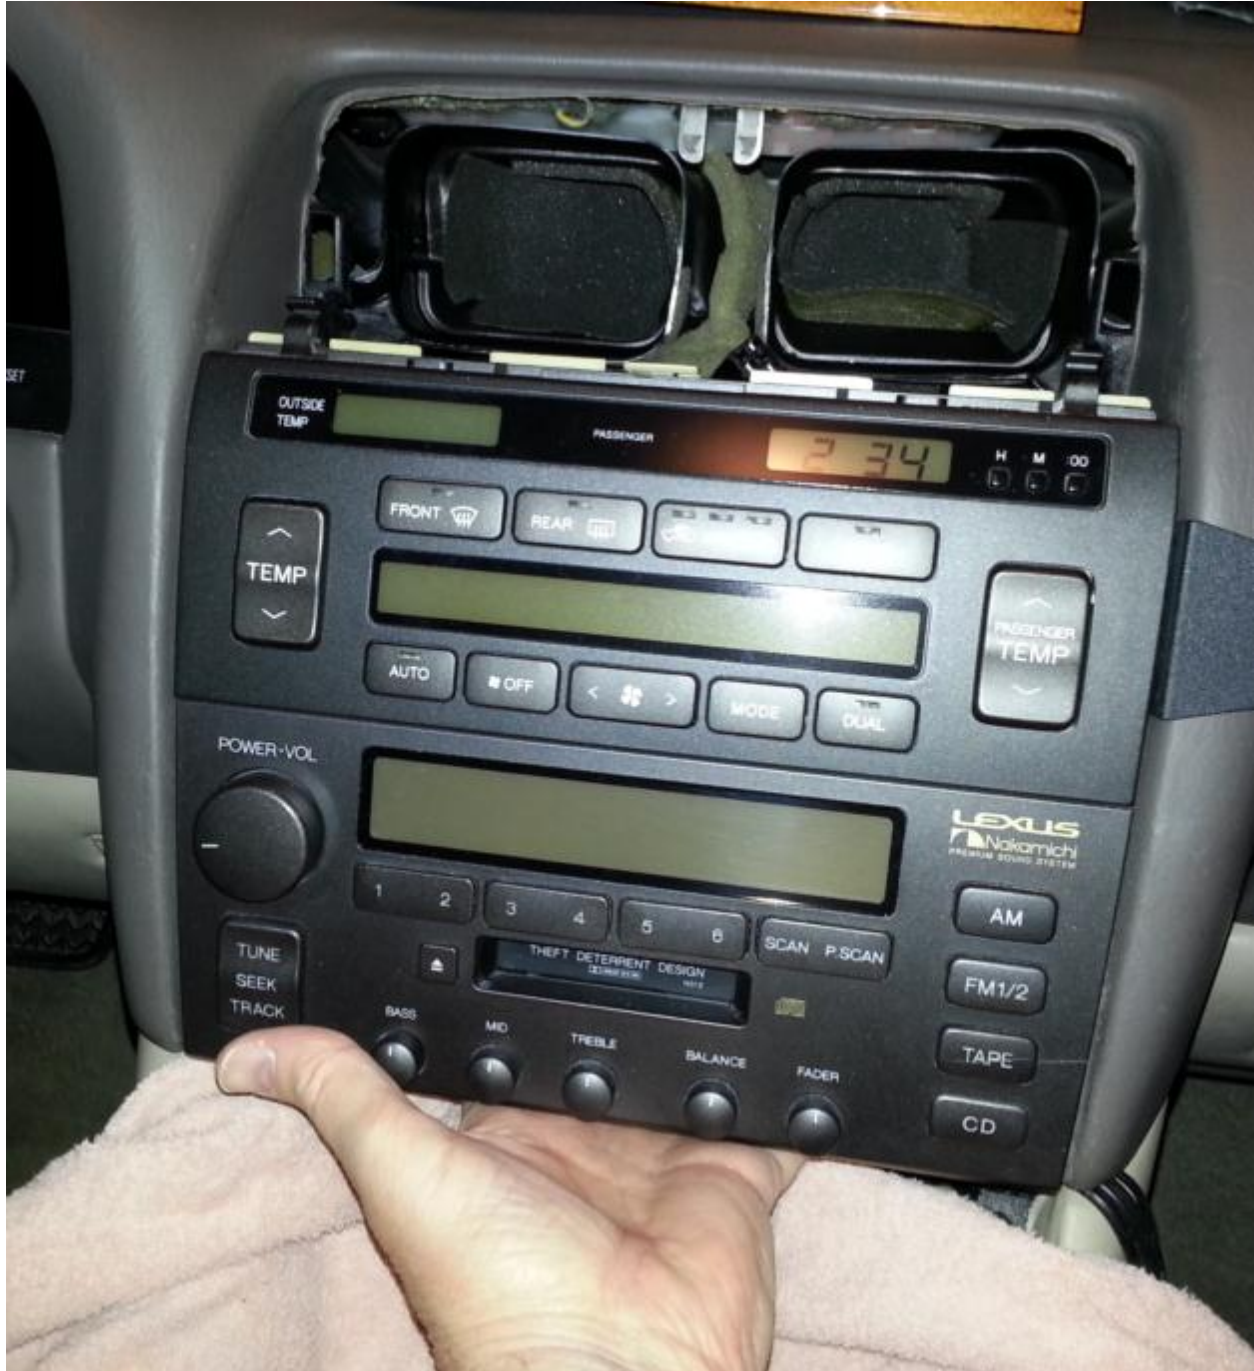
Use a towel to protect the vinyl on the console rails. Pull the radio/HVAC unit out and rest it on the towel.

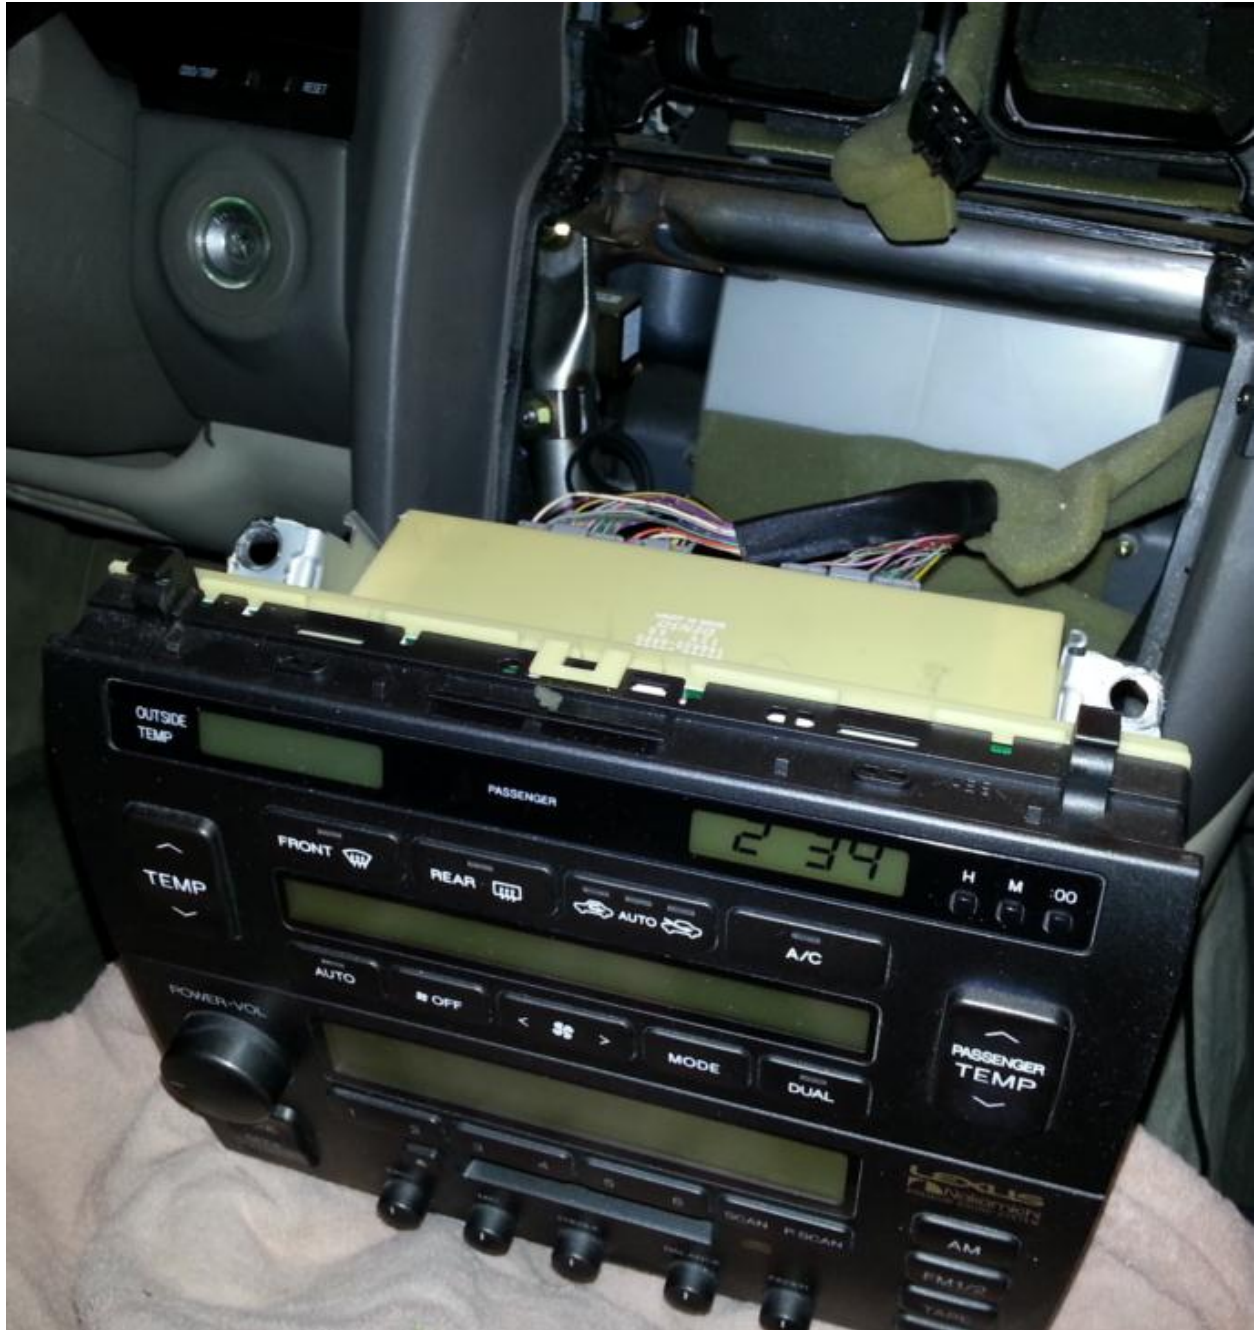
Unplug the radio and HVAC connectors from the radio/HVAC assembly.

Verify that all electrical connectors have been reconnected. This sounds simple but there are a lot of electrical connectors. Don't forget to plug in the two antenna leads.

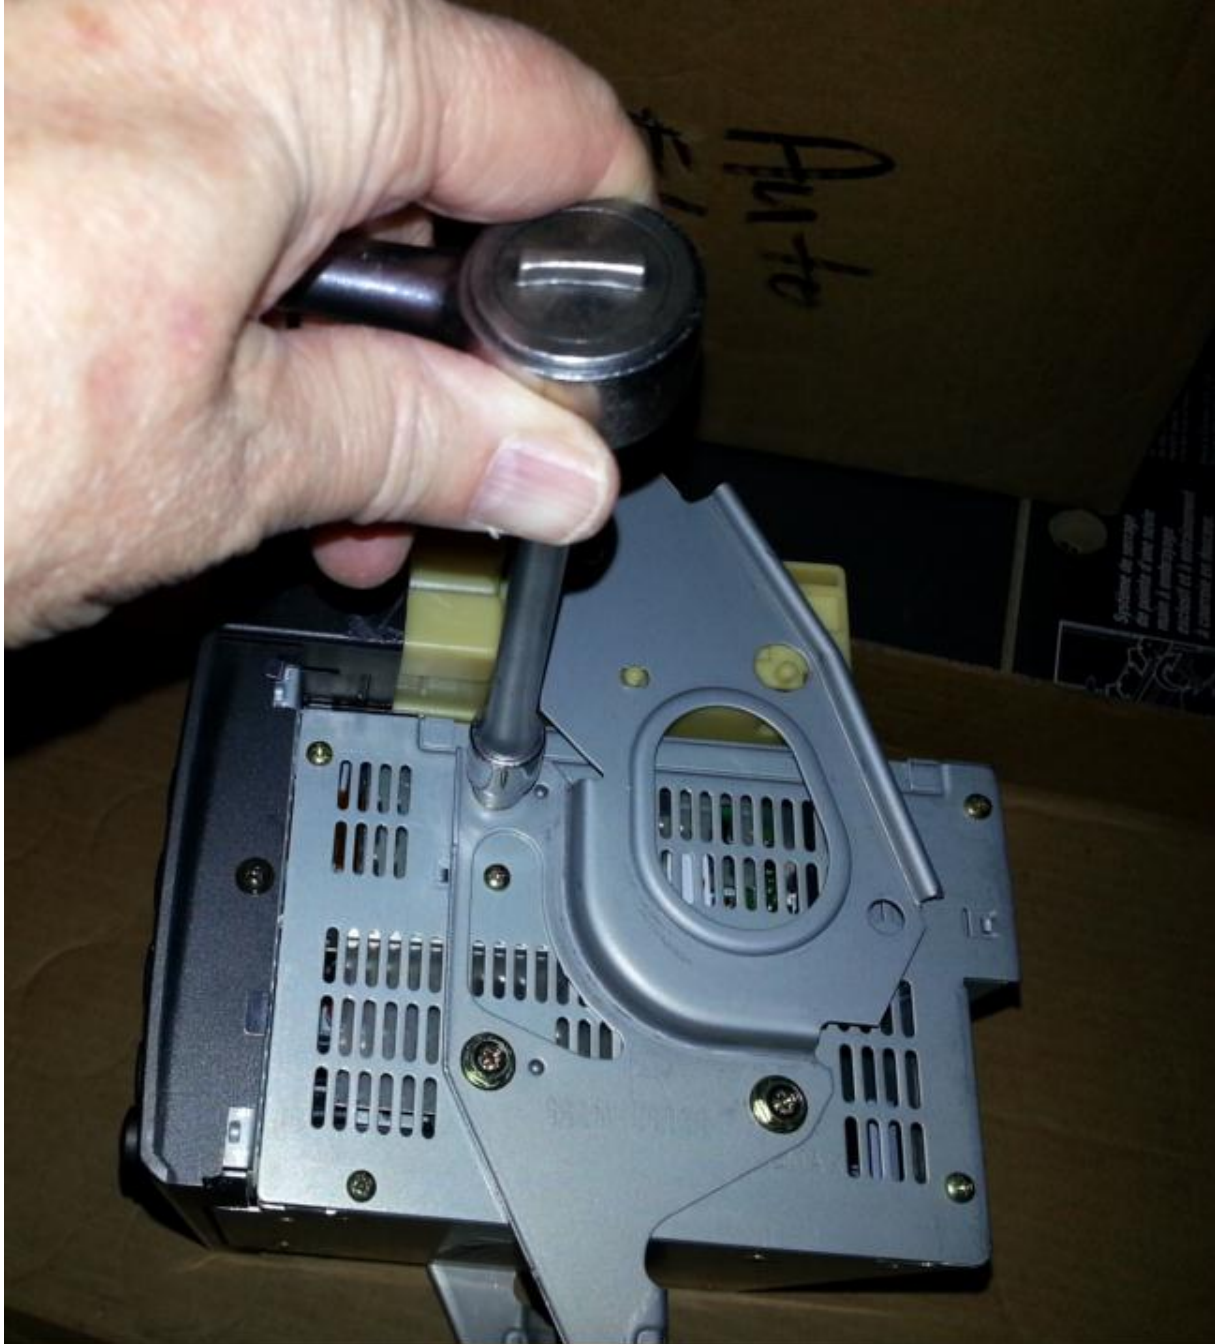
Place the radio/HVAC assembly on a workbench with a protective surface (e.g. cardboard). Remove the six screws that hold the radio head unit to the frame – three screws on each side.

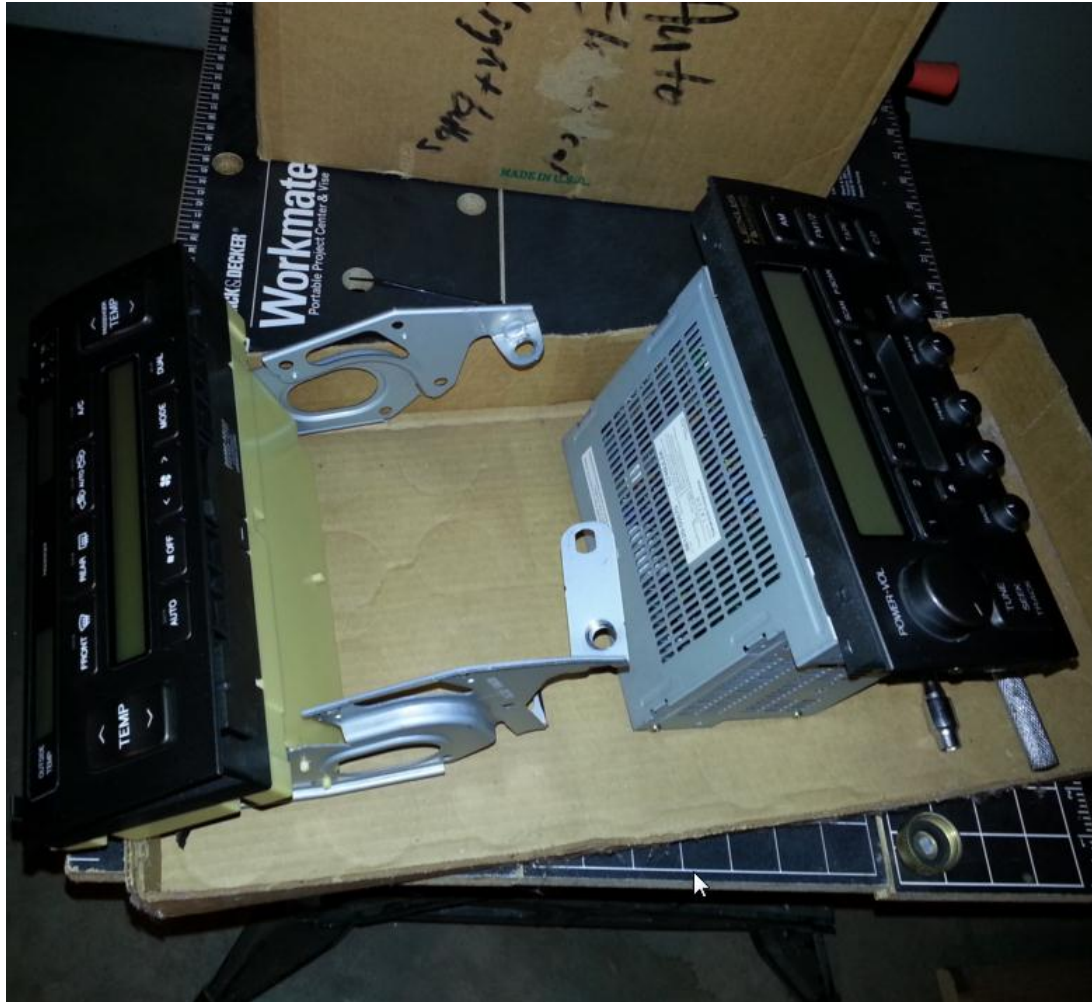
Separate the radio head unit from the frame.

Ensure that there is no or minimal gap between the HVAC assembly and radio head unit. A gap may make it difficult to reinstall the center vent assembly.
