I finished installing my new head unit. It took a bit longer than I expected as I ran into a couple of unanticipated challenges. I am documenting my experience here in hopes that it will help someone.

My project was to replace my OEM head unit in my 2001 LS430 (non-Nav, non-ML) with a modern unit that had features like Bluetooth, GPS, iPod interface and DVD. I am not a music aficionado so I was not overly concerned about sound quality; my OEM amp and speakers were working fine for me so I retained them. This means that I needed to install an interface unit to allow my new head unit to work with my OEM amp. Here are the parts I purchased and the cost (most of it purchased on eBay):

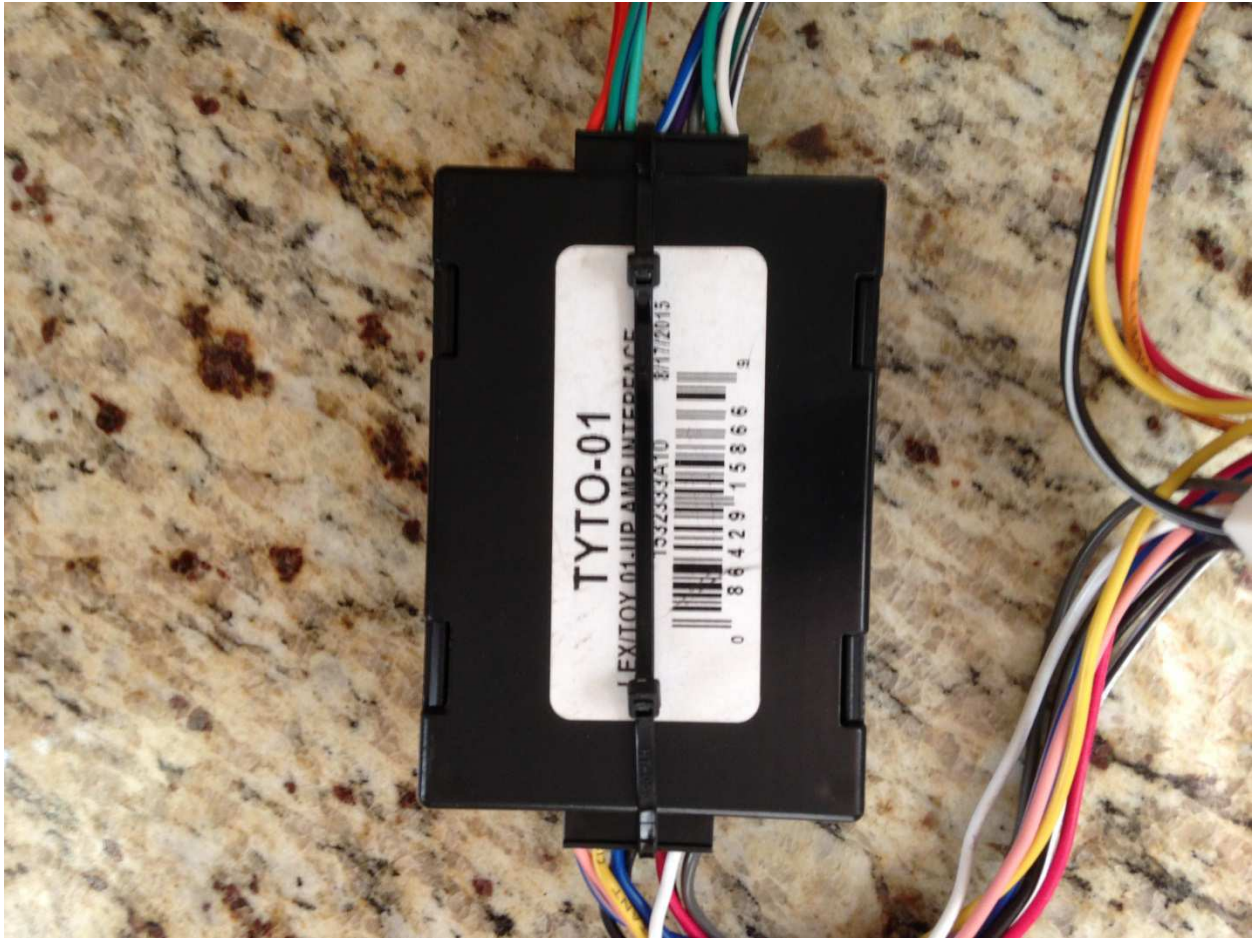
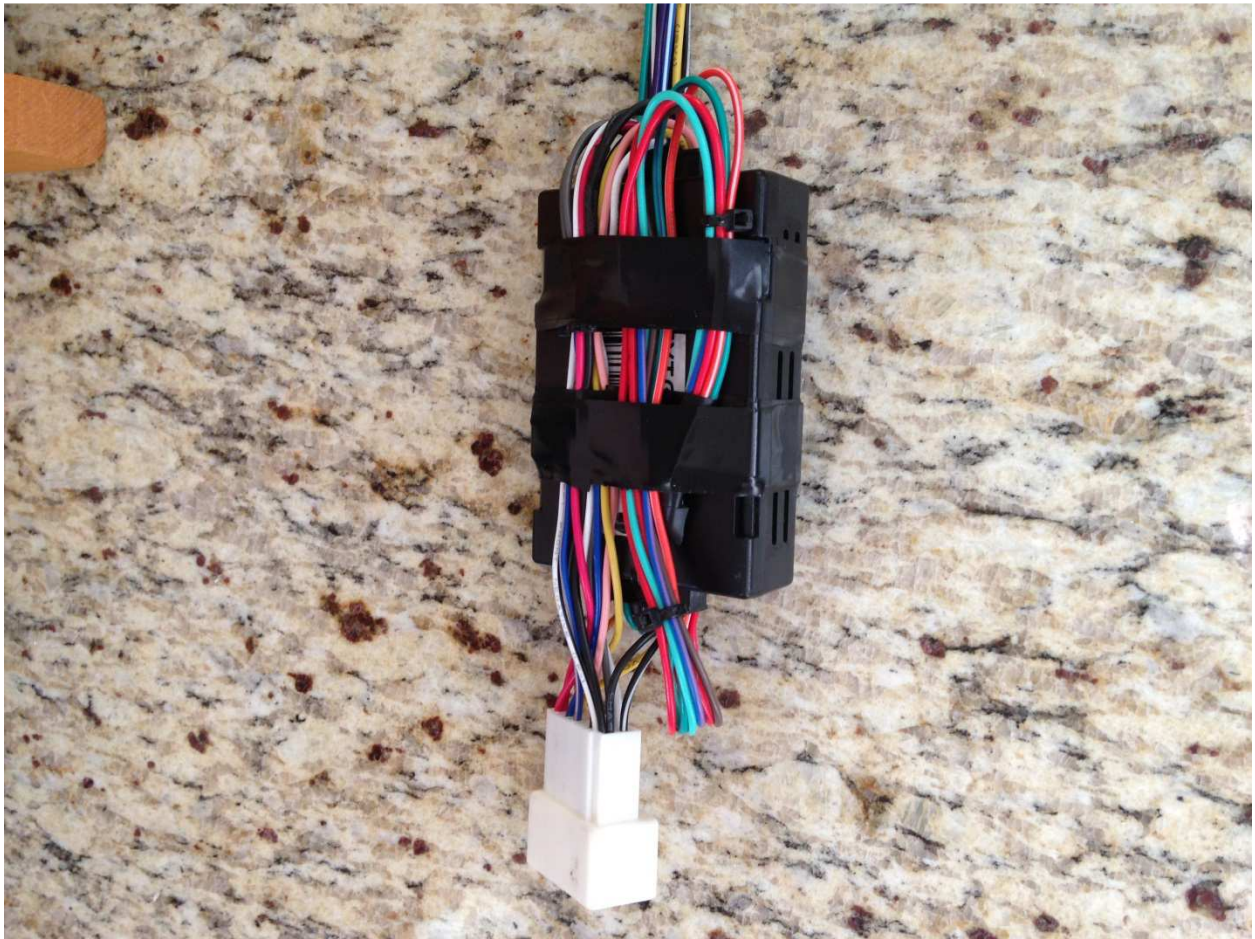
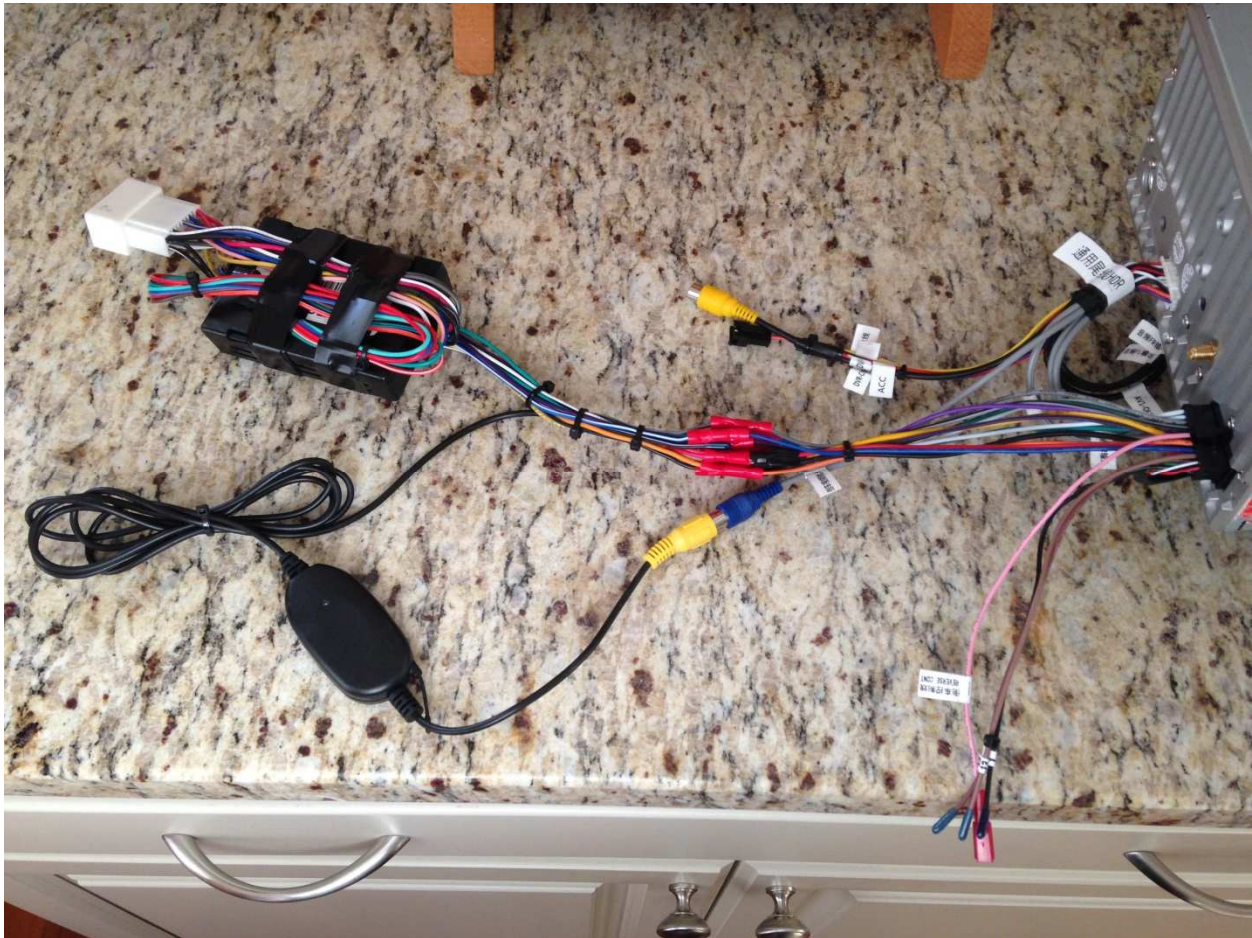
I did not perform this next step until I encountered an issue later in the installation but I am putting it here because this is where it belongs. It turns out that the TYTO-01 interface has an issue with its wiring connections being loose. I found this out at the end of the installation when I turned on the unit and got intermittent sound. When I wiggled the wires the unit sound would go on and off; this seemed to indicate that there was a loose wire and/or connection. I noticed that the contents of the TYTO-01 moved around when it was jiggled so I thought that maybe this was the issue. I contacted Metra support via e-mail and explained my situation; I was impressed that they responded in a couple of hours. They suggested that I secure the TYTO-01’s connectors with zip ties and then tape the wires to the side of the TYTO-01 to ensure that the connections are tight and the wires cannot move (see the three pictures below). Given how quickly the response came, I am betting that this has been a problem with this adapter. Nonetheless, I followed the instructions, reinstalled the radio and tested it. So far, the issue has gone away so I assume that this fix works.

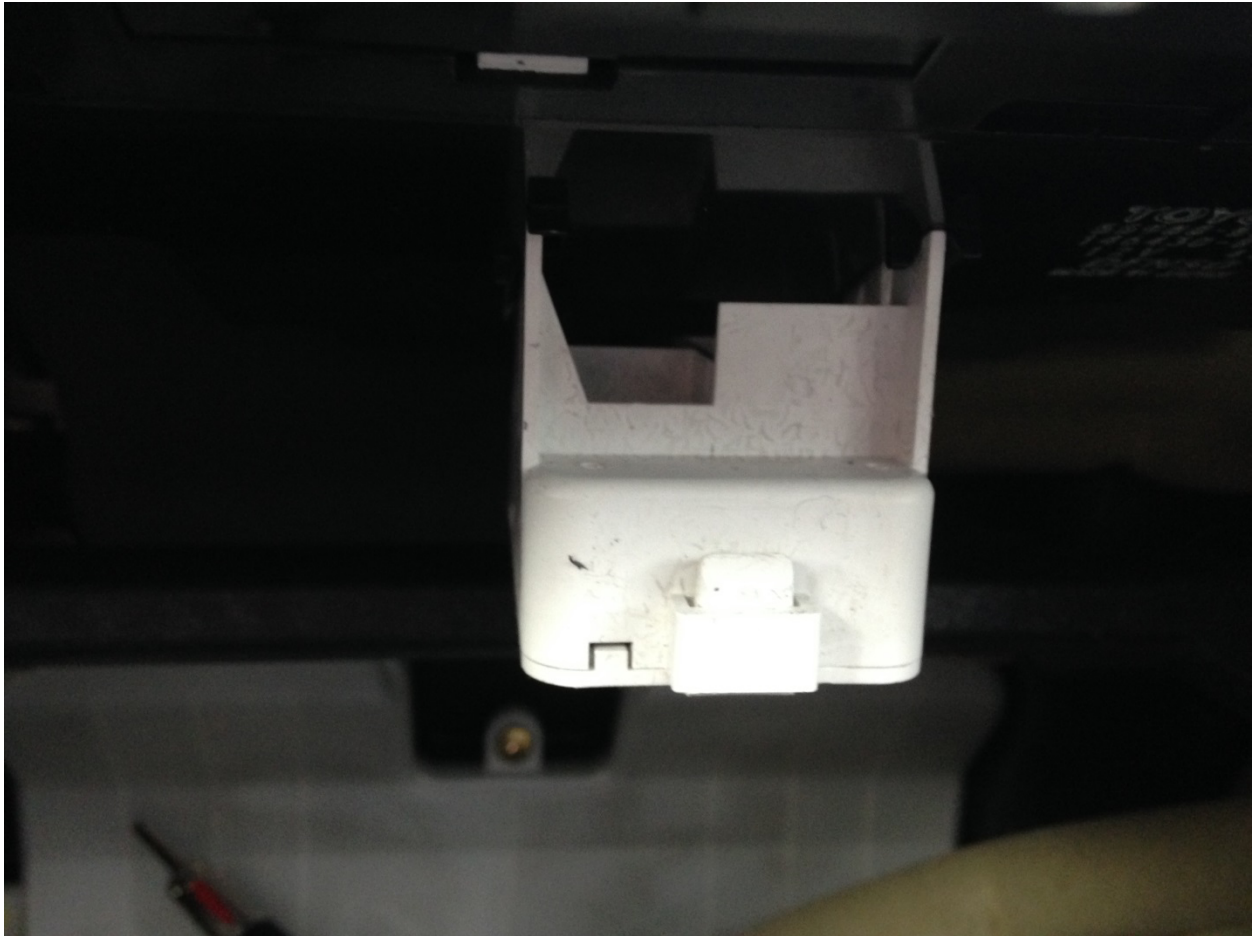
After removing the OEM unit I encountered two more challenges. First, there was a white box mounted on the top of the console opening behind the OEM unit which turned out to be the magnetic field sensor (see picture above). This sensor is what the compass uses to determine direction. I had to reposition the sensor because my new head unit needed that space. I was able to remove it from the top of the opening by squeezing on its mounting legs and sliding them out of the mounting slots. Be sure to reposition the sensor in the same orientation it was in when it was originally mounted! When I first repositioned the sensor I did not mount it in its original orientation; this caused the compass to give wrong directions!

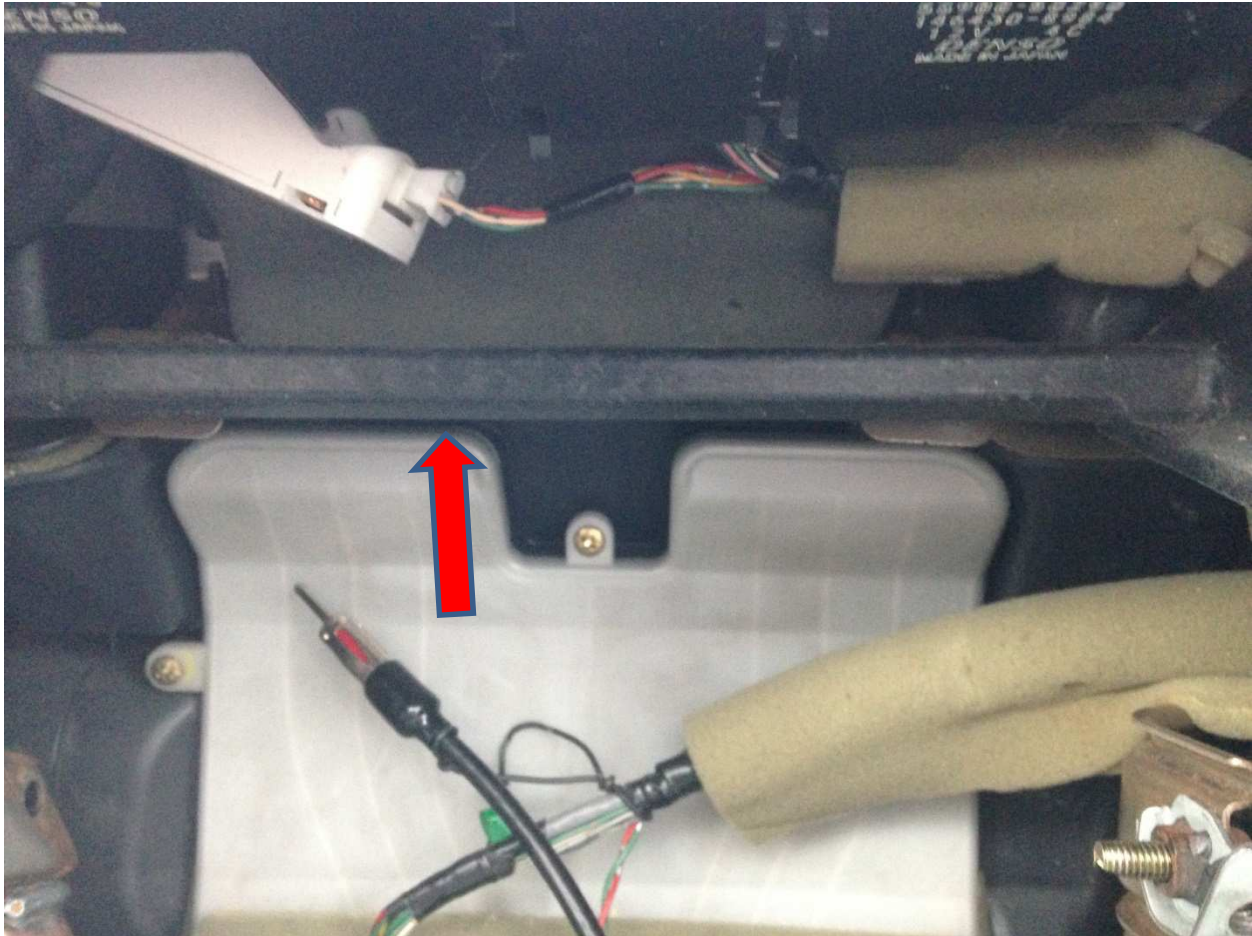
The next challenge was a plastic brace that is located at the top of the console opening (see picture below; red arrow pointing to brace). The brace is a part of the molding that the head unit mounts into. The brace is not an issue with the OEM unit because the top of the OEM unit does not extend very far into the top of the opening. However, the top of my new head unit extends much farther into the opening so the brace was interfering. The only solution I saw was to cut out the brace so I did it with a little hand saw. Before I cut the brace I questioned folks on the forum about this and no one said they had an issue with this brace when they installed their unit. I assume this means that the top of their units must not be as deep as mine so I probably should have purchased a better-fitting unit. Not only could I have avoided cutting the brace, I probably would not have had to reposition the magnetic field sensor.

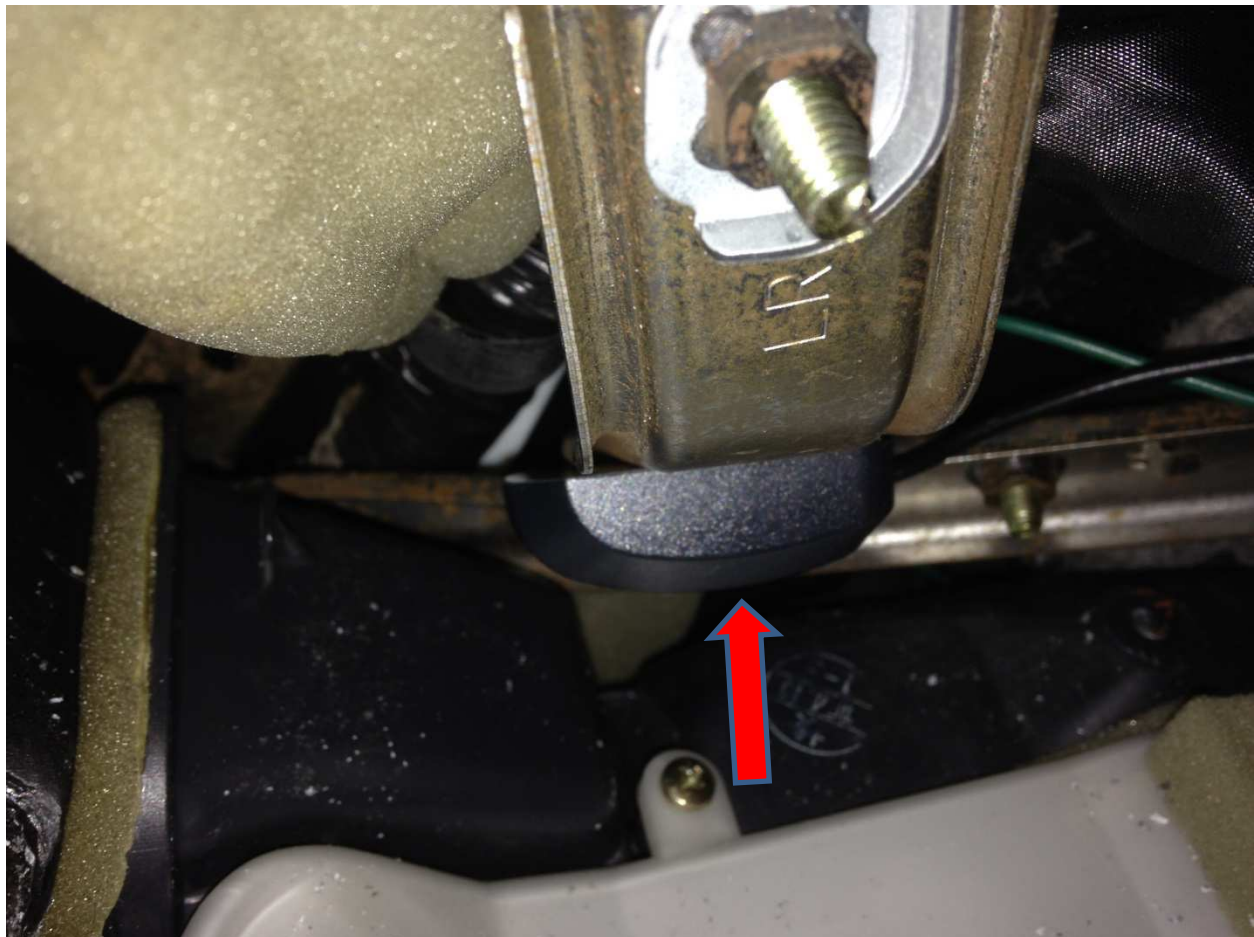
The next thing was to find a place to mount the GPS antenna. Ideally the GPS antenna would be out in the open to maximize reception. However, that means that I would have to find a path from inside the console to the outer part of the car but I did not want the GPS antenna exposed. I found a YouTube video where an expert installer said that the GPS antenna could be installed inside the console and still get good reception. I needed to mount the antenna on metal that was attached to the frame of the car; this would make the entire car part of the GPS antenna. The antenna has a magnet in the base which made it simple to mount it. There is a metal brace on the left side of the console opening; I attached the GPS antenna to it (see picture below, red arrow pointing to antenna).

Now that all of the console connections were made, I was ready to connect the new head unit and test it. I connected the TYTO-01 to the car's radio harness and attached the radio and GPS antenna cables to the head unit. I turned on the accessory power and... success! The radio powered up and seemed to function properly. I also got a fairly strong GPS signal so installing the antenna inside the console worked out OK.

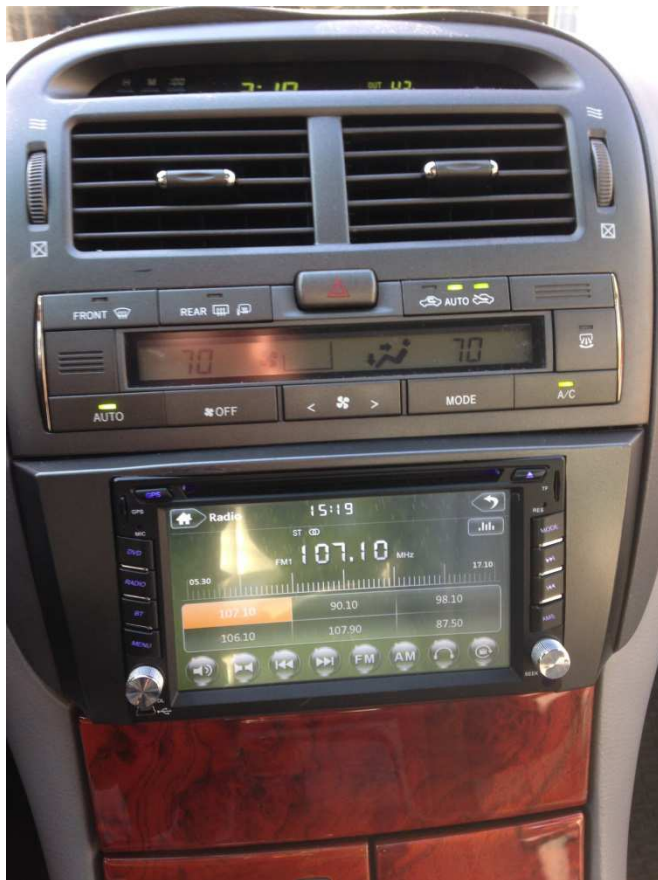
Despite the unexpected challenges I faced, I was able to make the adjustments and ended up with a good install:

Now I was ready to fasten the unit in place. It was here that I encountered my final challenge – there was a 2-3mm gap between the trim's mounting holes and the mounts. After spending a significant amount of time diagnosing the issue, it appears that my new head unit is a little too tall. It is hitting against the ceiling of the console opening which is not allowing the dash kit to sit properly on the mounts. I added a rubber grommet on each side of the mounts to take up the extra space. Given my initial issue with the opening of the dash kit, my suggestion is to make sure that your unit stays within the 173mm x 98mm dimensions and everything will fit perfectly.
