HVAC Evaporator Drain Hose Clogged Due to Insect Intrusion

Service Category Vehicle Interior

Section Heating/Air Conditioning

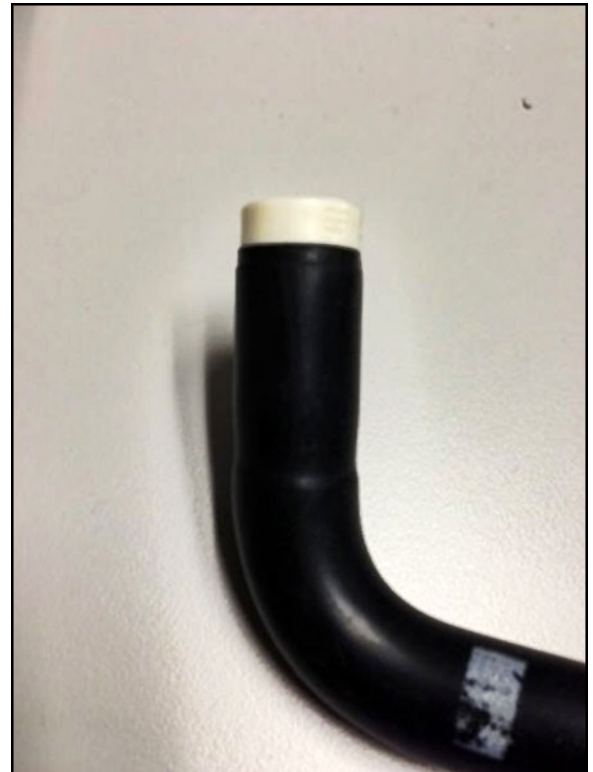
1. Follow the instructions provided in the Safety Requirements for Handling the ARINIX® Tip (Connector, Water Hose) section of this bulletin.
2. Locate the HVAC Evaporator Drain Hose.
3. Following the vehicle specific Repair Manual, remove the HVAC Evaporator Drain Hose.
4. Put on all necessary PPE and install the ARINIX® Tip (Connector, Water Hose) into the NEW HVAC Evaporator Drain Hose listed in the Parts Information section of this bulletin.
5. When installing the ARINIX® Tip, verify it is fully seated in the HVAC Evaporator Drain Hose as shown in Figure 1.
6. Following the vehicle specific Repair Manual, install the HVAC Evaporator Drain Hose.

1. Follow the instructions provided in the Safety Requirements for Handling the ARINIX® Tip (Connector, Water Hose) section of this bulletin.
2. Locate the HVAC Evaporator Drain Hose.
3. Following the vehicle specific Repair Manual, remove the HVAC Evaporator Drain Hose.
4. Put on all necessary PPE and install the ARINIX® Tip into the original HVAC Evaporator Drain Hose listed in the Parts Information section of this bulletin.
5. When installing the ARINIX® Tip, verify it is fully seated in the HVAC Evaporator Drain Hose as shown in Figure 1.
6. Following the vehicle specific Repair Manual, install the HVAC Evaporator Drain Hose.
