Side Markers Bulb (#3) and Lamp Assembly Replacement

Front White Marker (#5 & #7, Parking or Clearance Light), Bulb Replacement.

This page shows How2 get to the side markers (front and rear) and the small white marker in the front headlight assembly.

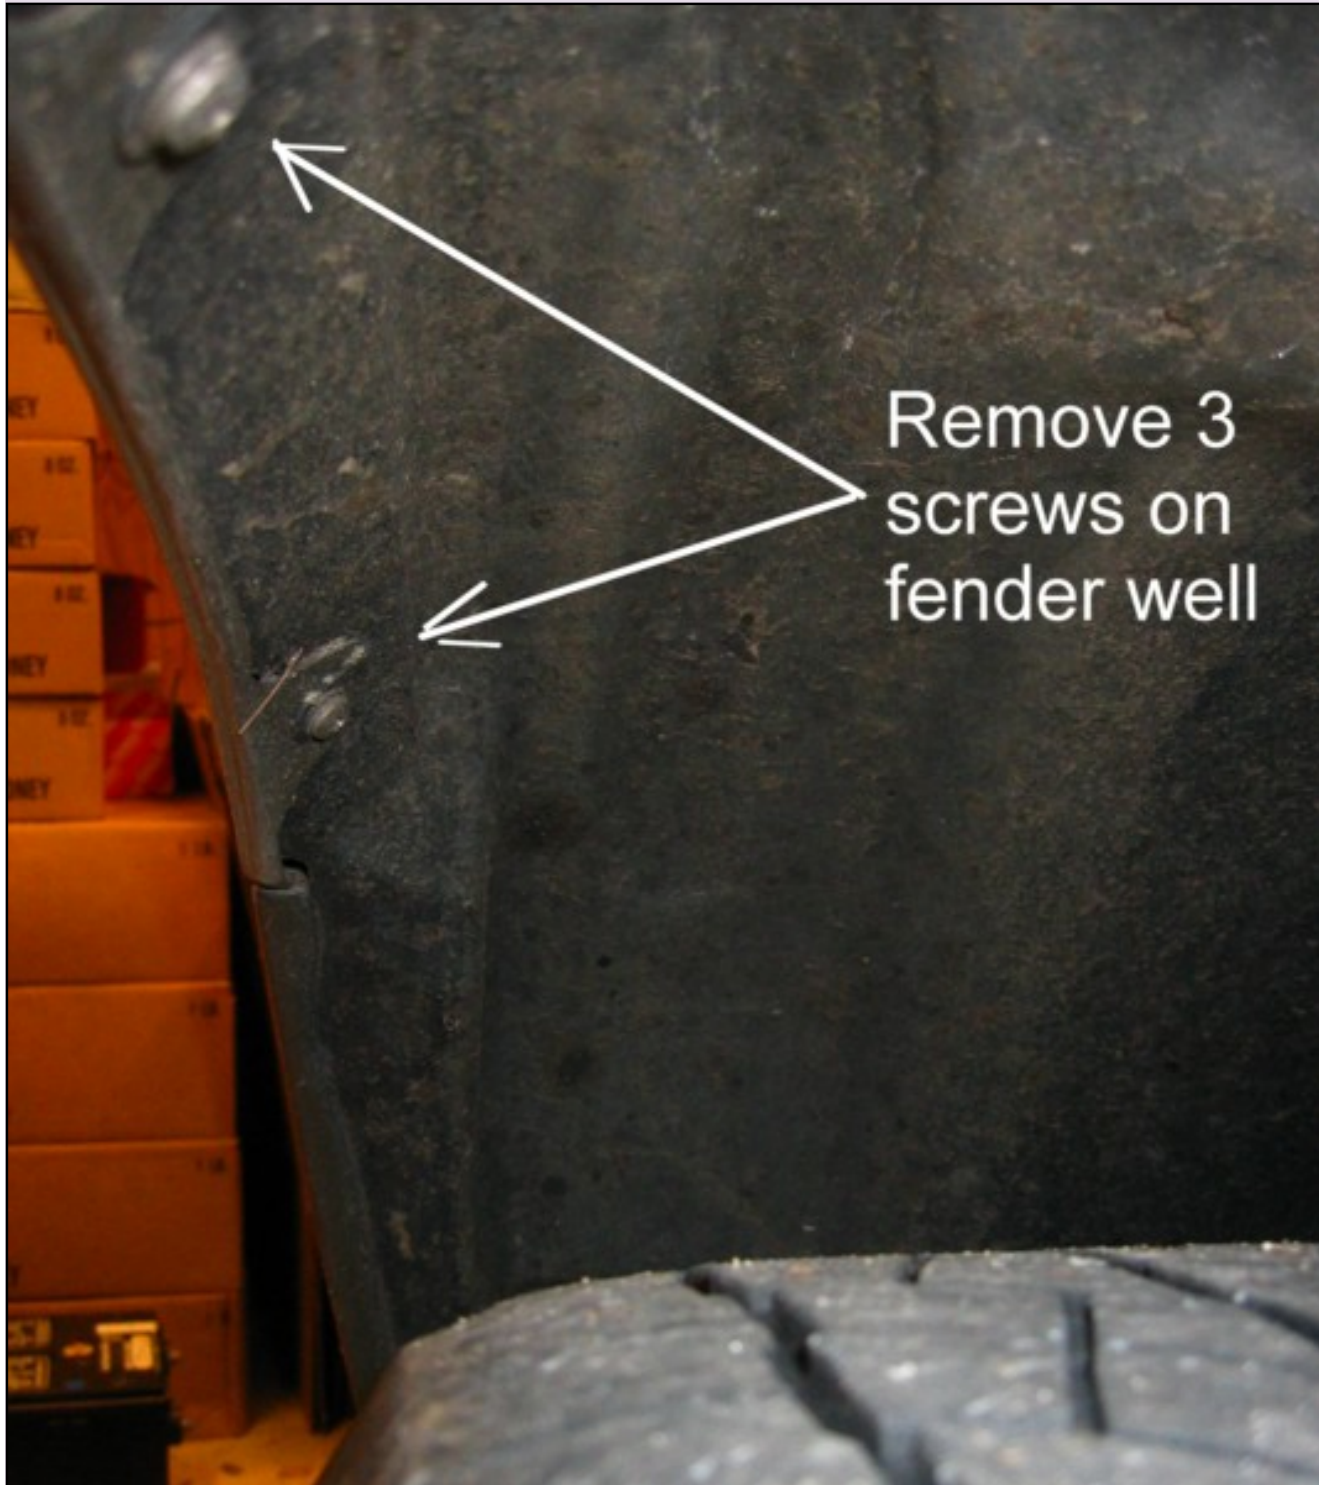
The pics show the drivers side front. One must remove most of the fender inner plastic liner

(cowling). First remove at least 3 Philips head screws along the lip of the inside fender well starting at the lower front (first 2 are shown in the pic).

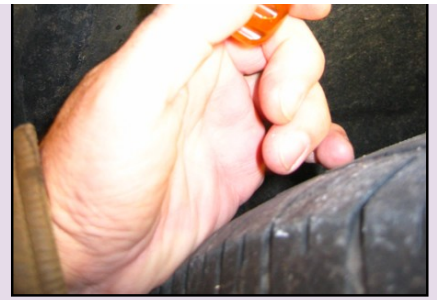
In front of the wheel, on the inside edge there is one bolt to remove (below). There is one more bolt along the inside edge above the tire near the spring (strut), not shown.

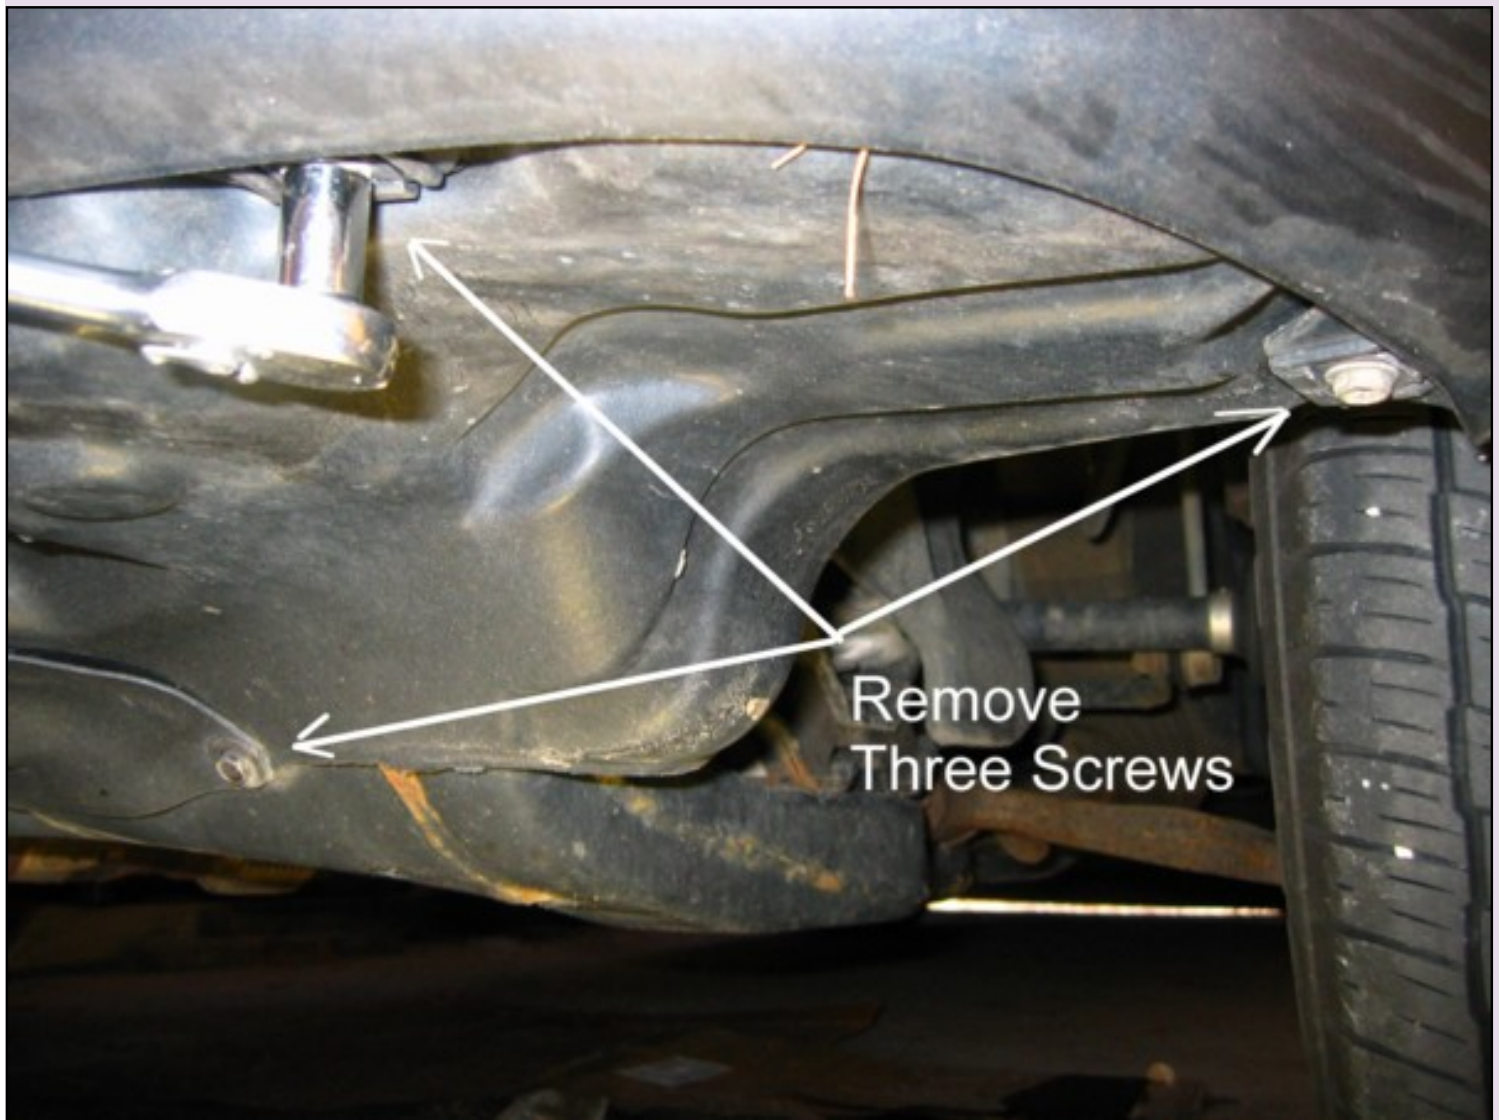
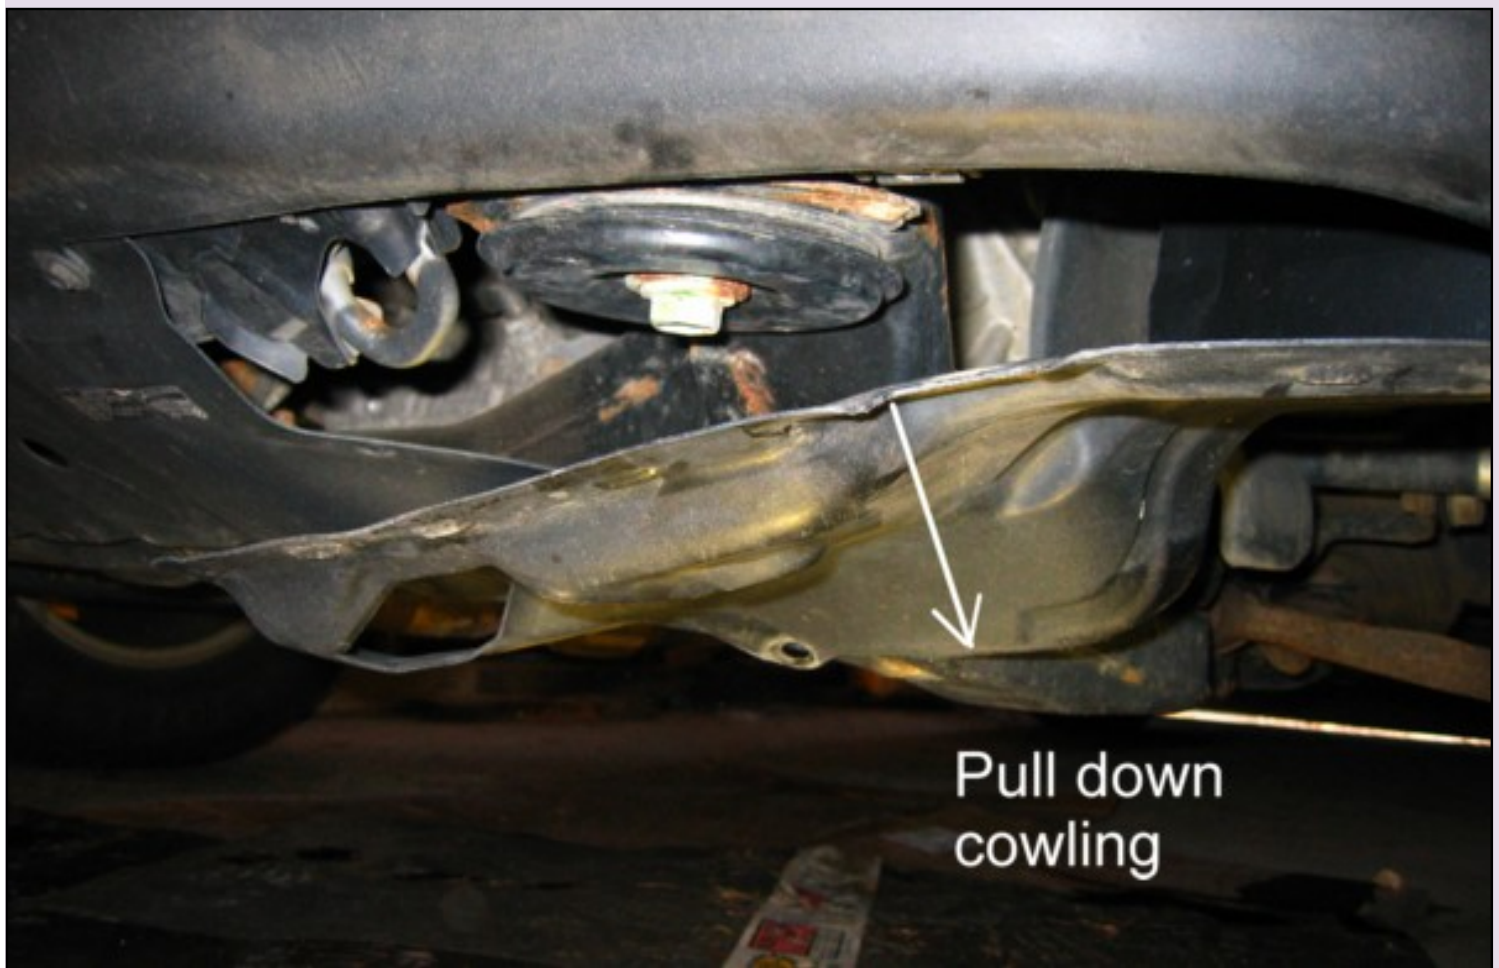
There are 3 more bolts to remove at the bottom front. Looking under the front, there are 3 bolts to be removed that hold the cowling in place.

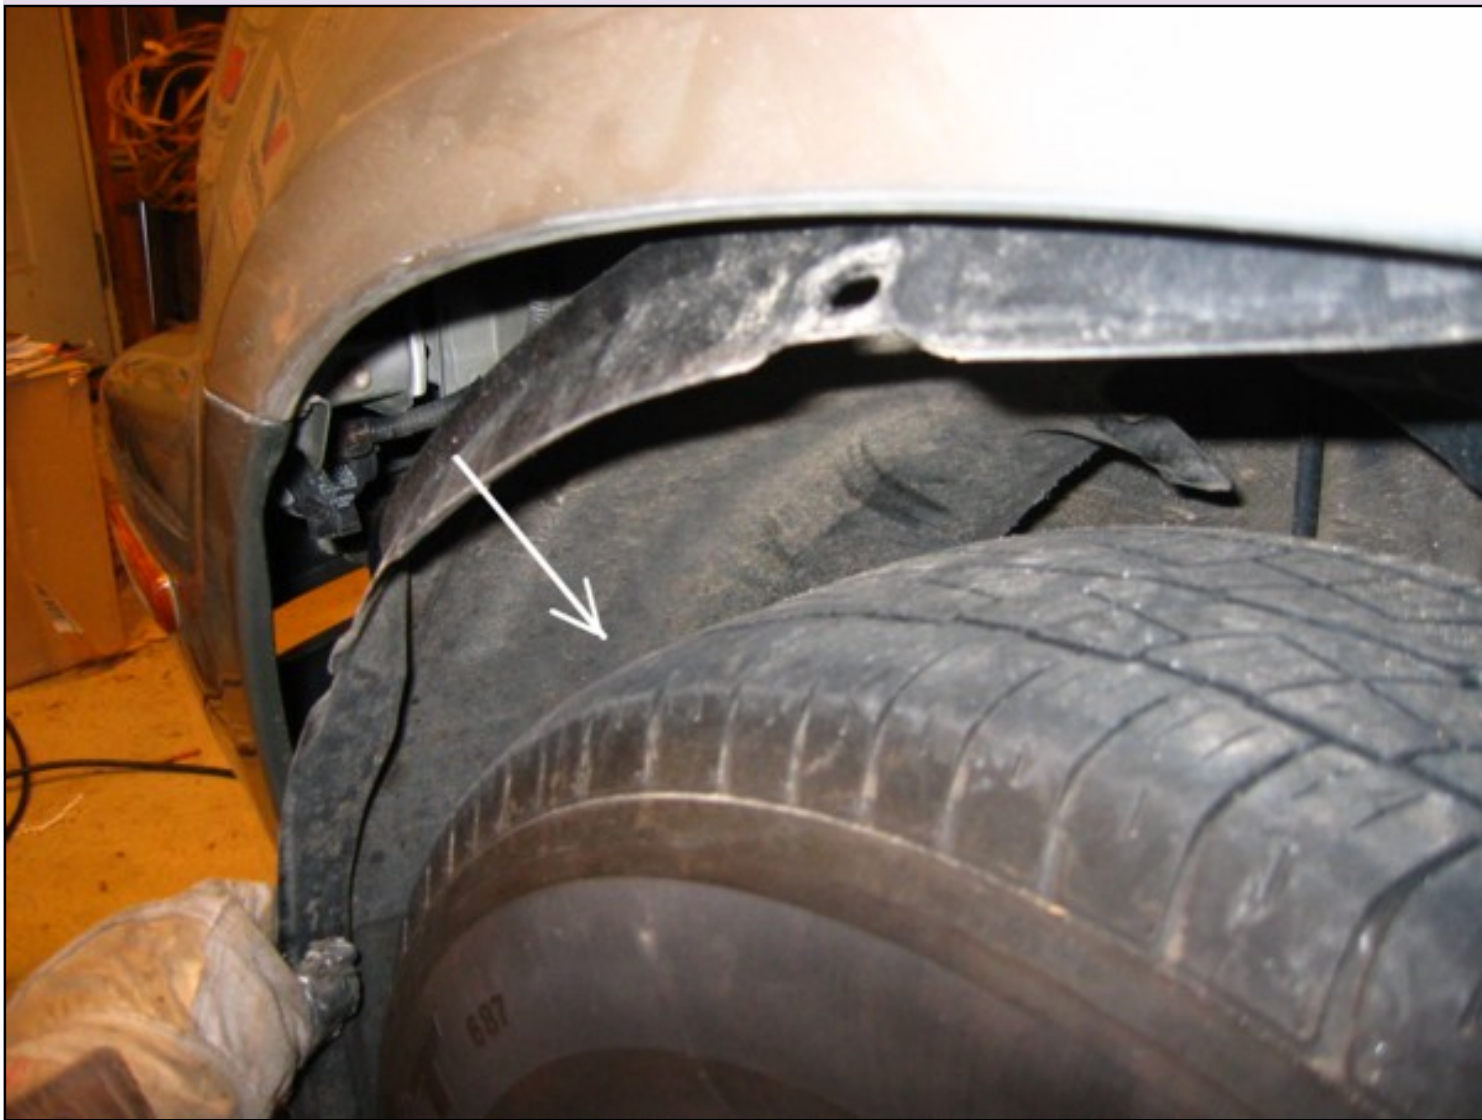
Once you pull down the front liner portion, work out most of the wheel well liner to get inside the front bumper.

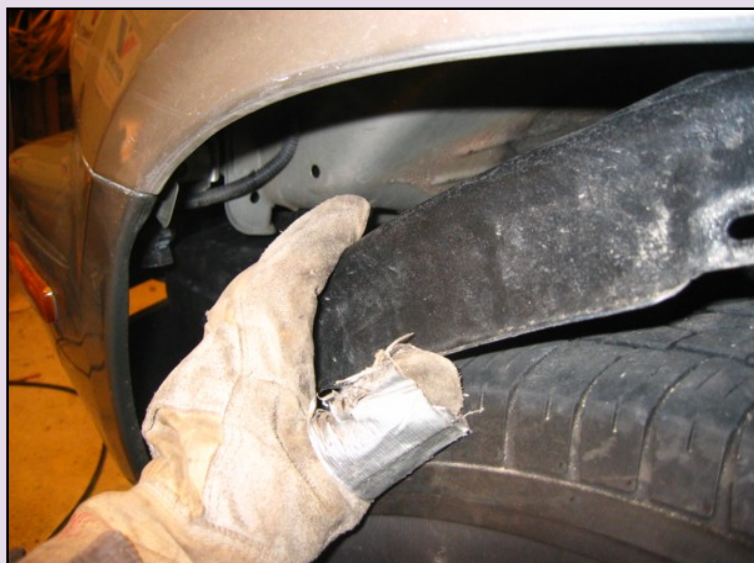
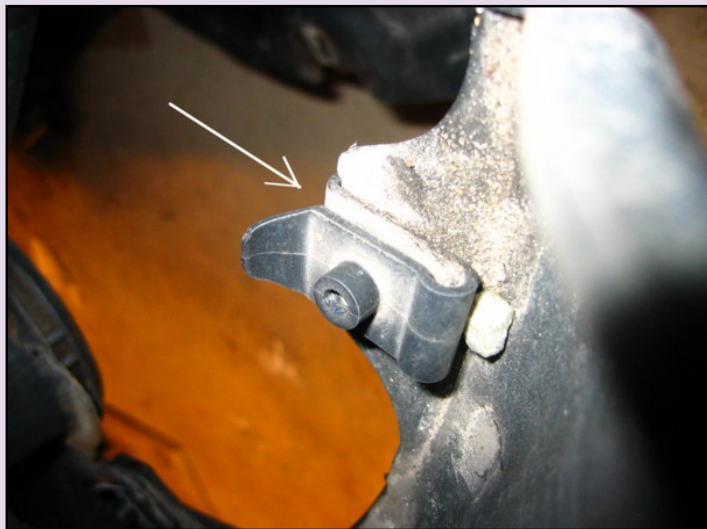
pic shows the type of clips that hold the plastic liner in place. After the screws/bolts are removed, the liner is removed from between the inside of the "C" clip.

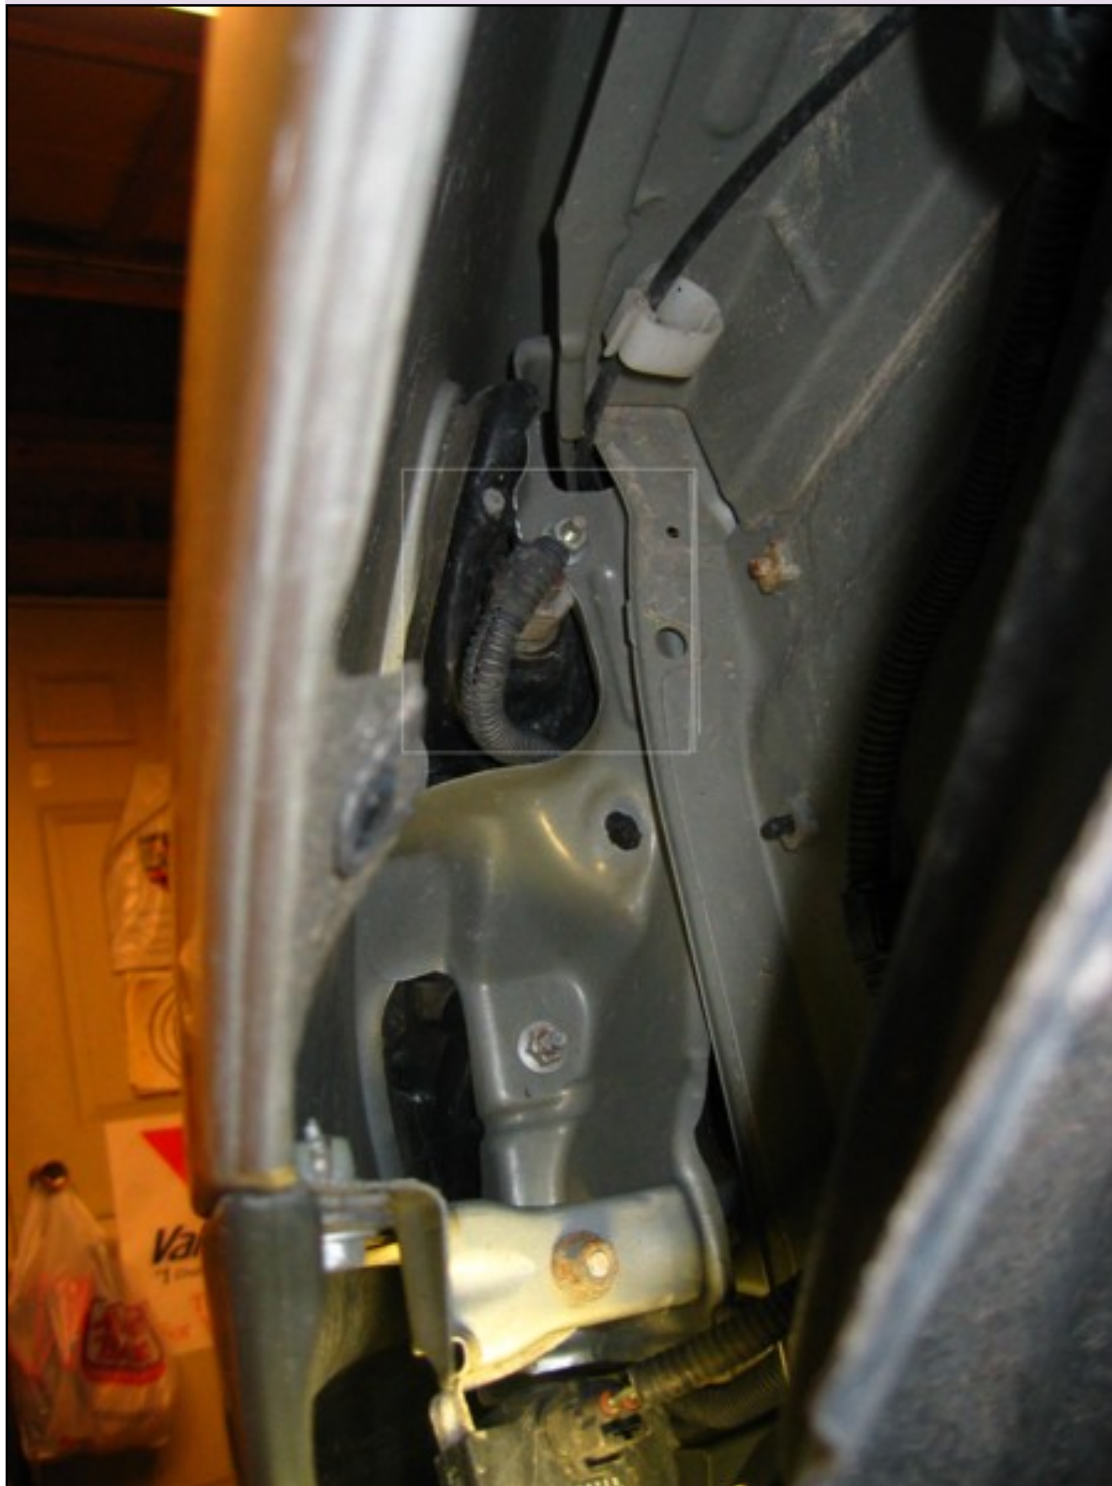
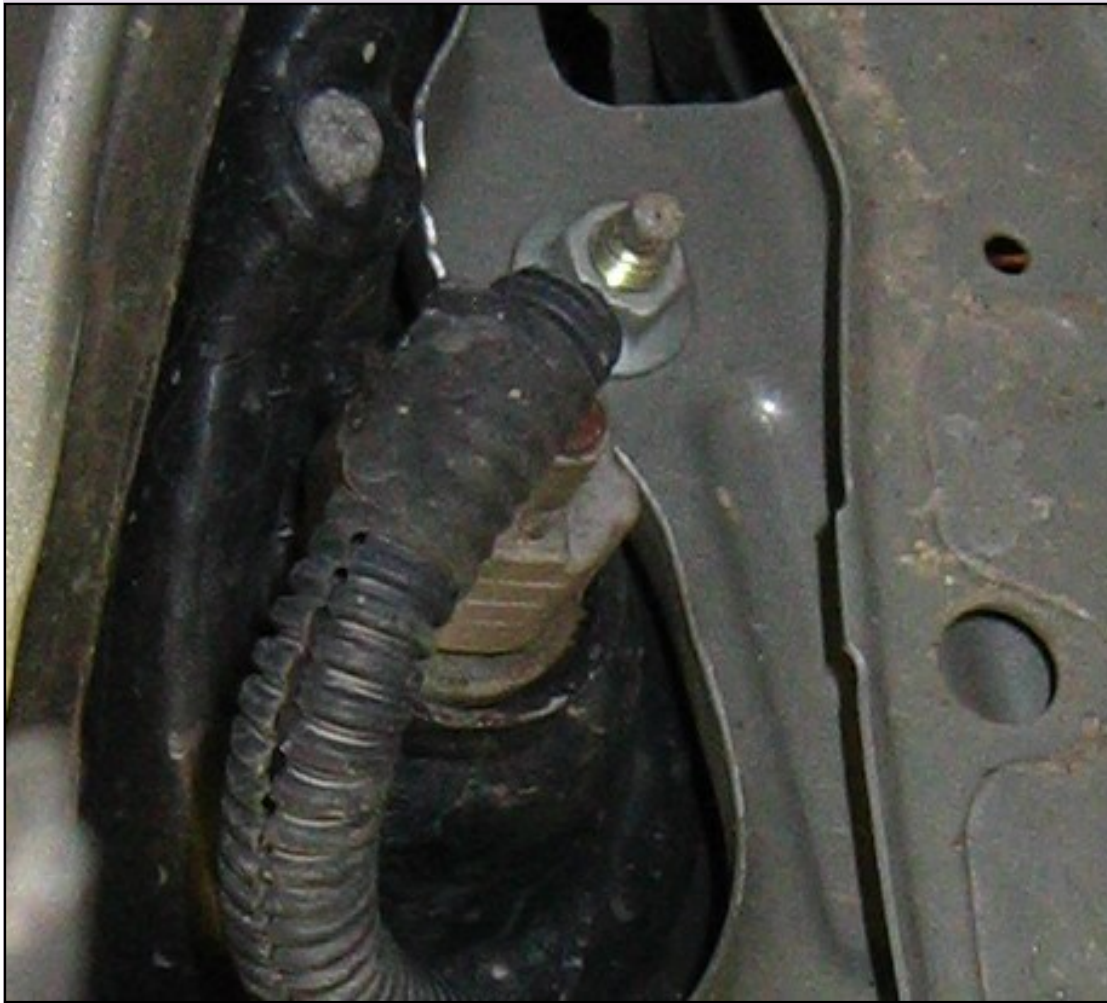
Looking in and up toward the front you will see the small white lamp socket that is part of the front headlight assembly. This is the typical way to replace this bulb. Look at the faint white box in the pic below. An enlargement is shown in the next pic. This is the parking or Clearance marker in the front headlight assembly.

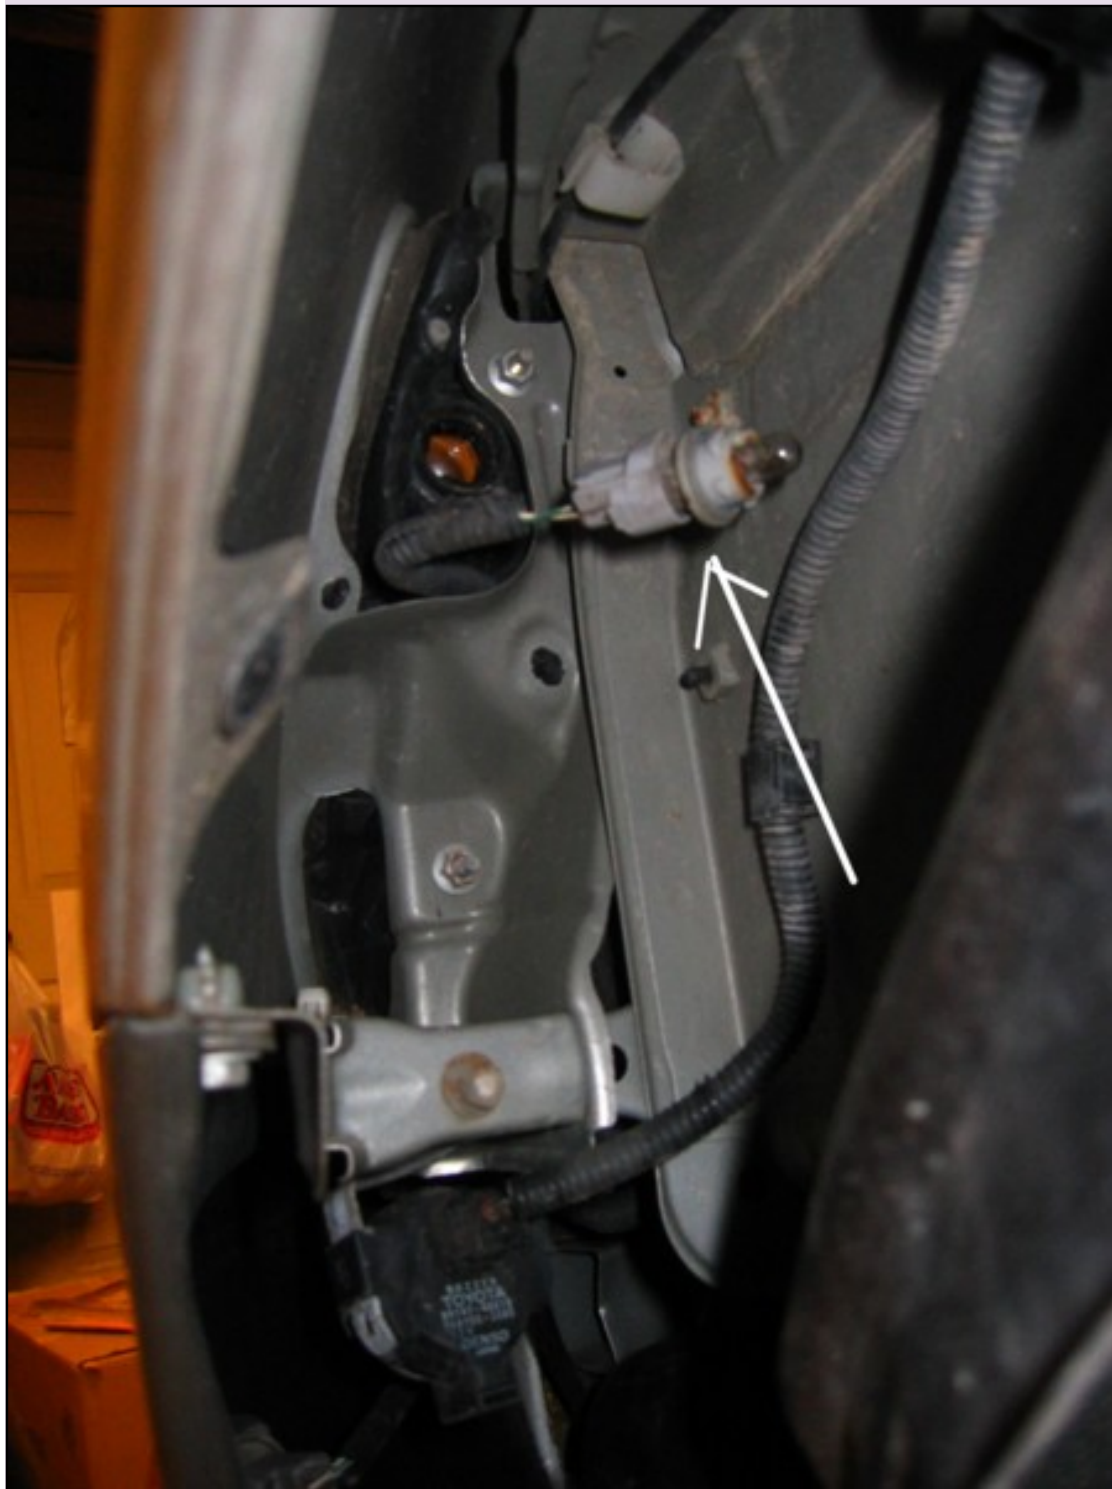
You can replace the white lamp in the front headlight assembly by turning 1/8 turn CCW and pulling it out. Then pull the bulb straight out of the socket. Once I replace a bulb, I typically turn on the light to make sure it works before reassembly.

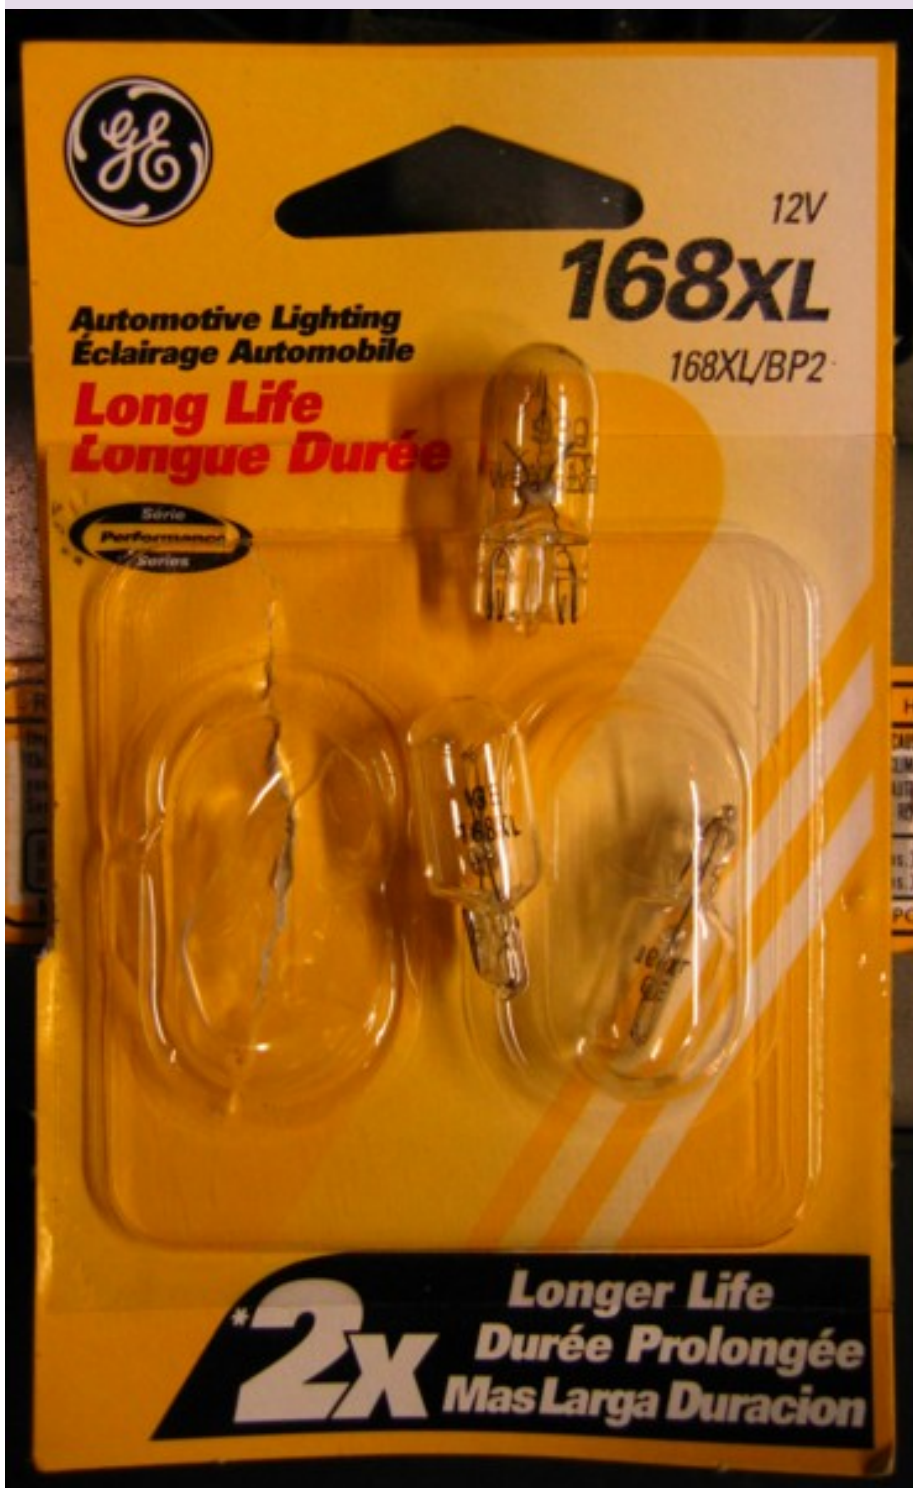
Find some bulbs like these. This package claims to be double-life. That's nice. They are 5 watt lamps. [Specs for 168 vs 194.](#) Long Life are worth looking for because of the work required to get to change them.

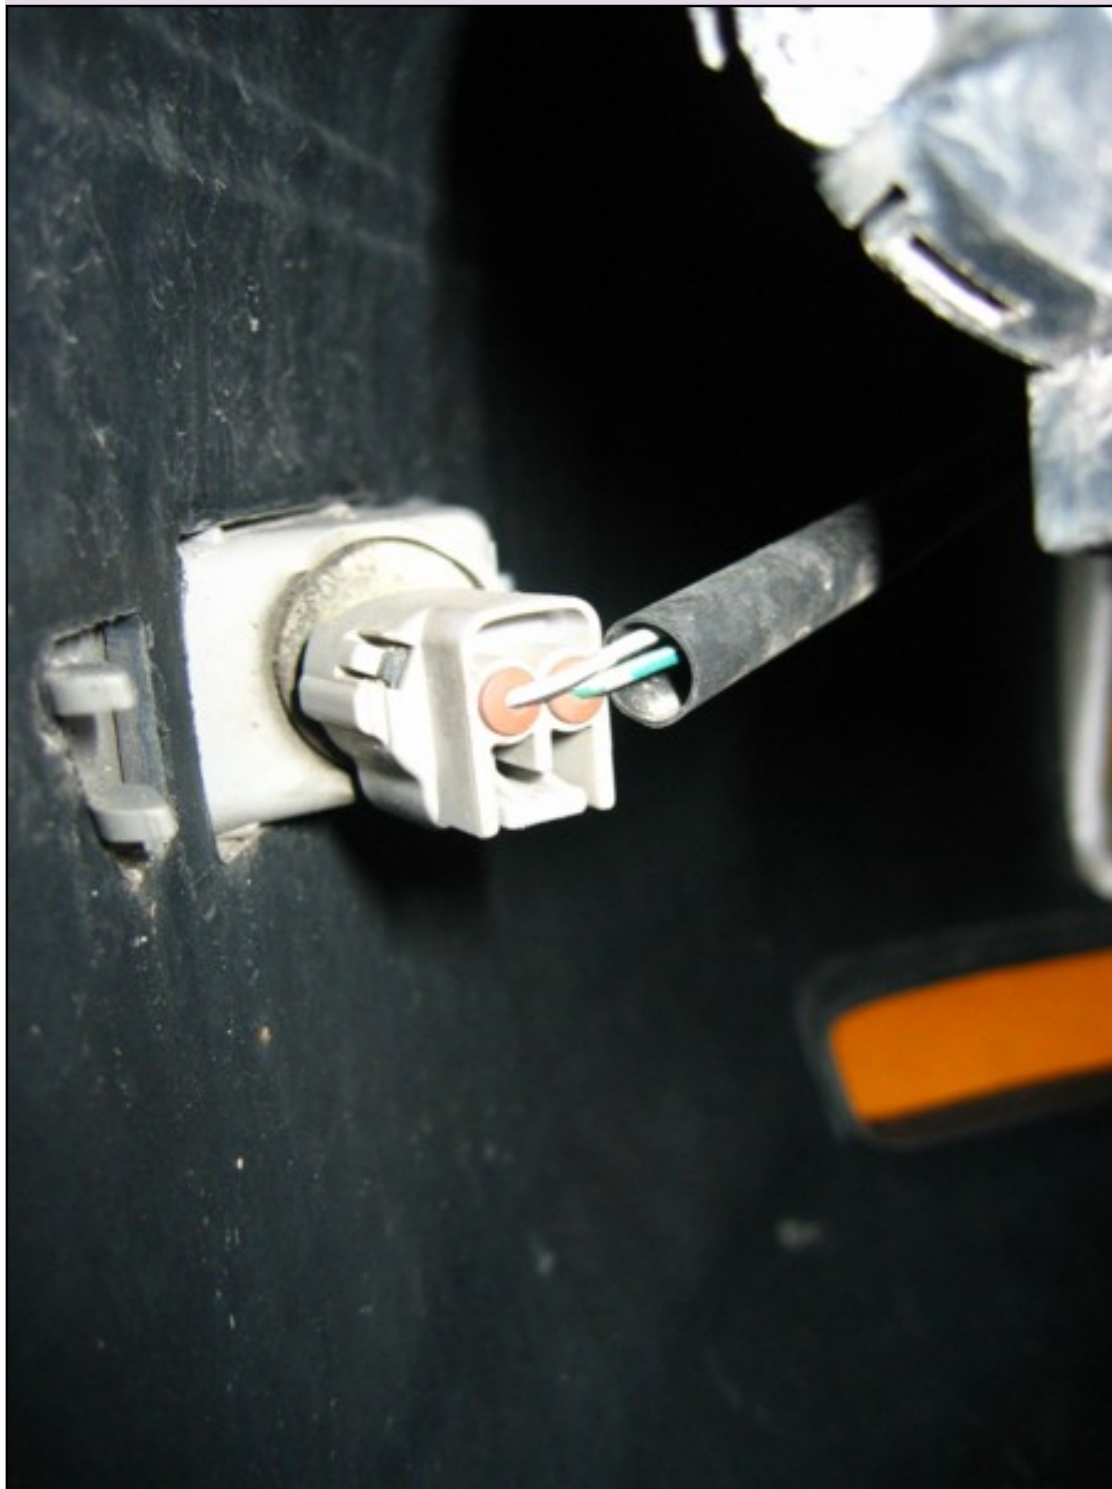
Looking below at the inside of the bumper cover, you will see the back of the side marker assembly and the socket for that lamp. This one also is removed by turning 1/8 turn CCW and pulling out. The one on my vehicle actually collected water inside of the assembly. Since the bulb/socket was wet inside (and we use a lot of salt up here in the NE), the contacts in the socket were eaten away. I have a new socket on order now. Replace the bulb, test and reinsert in the assembly.

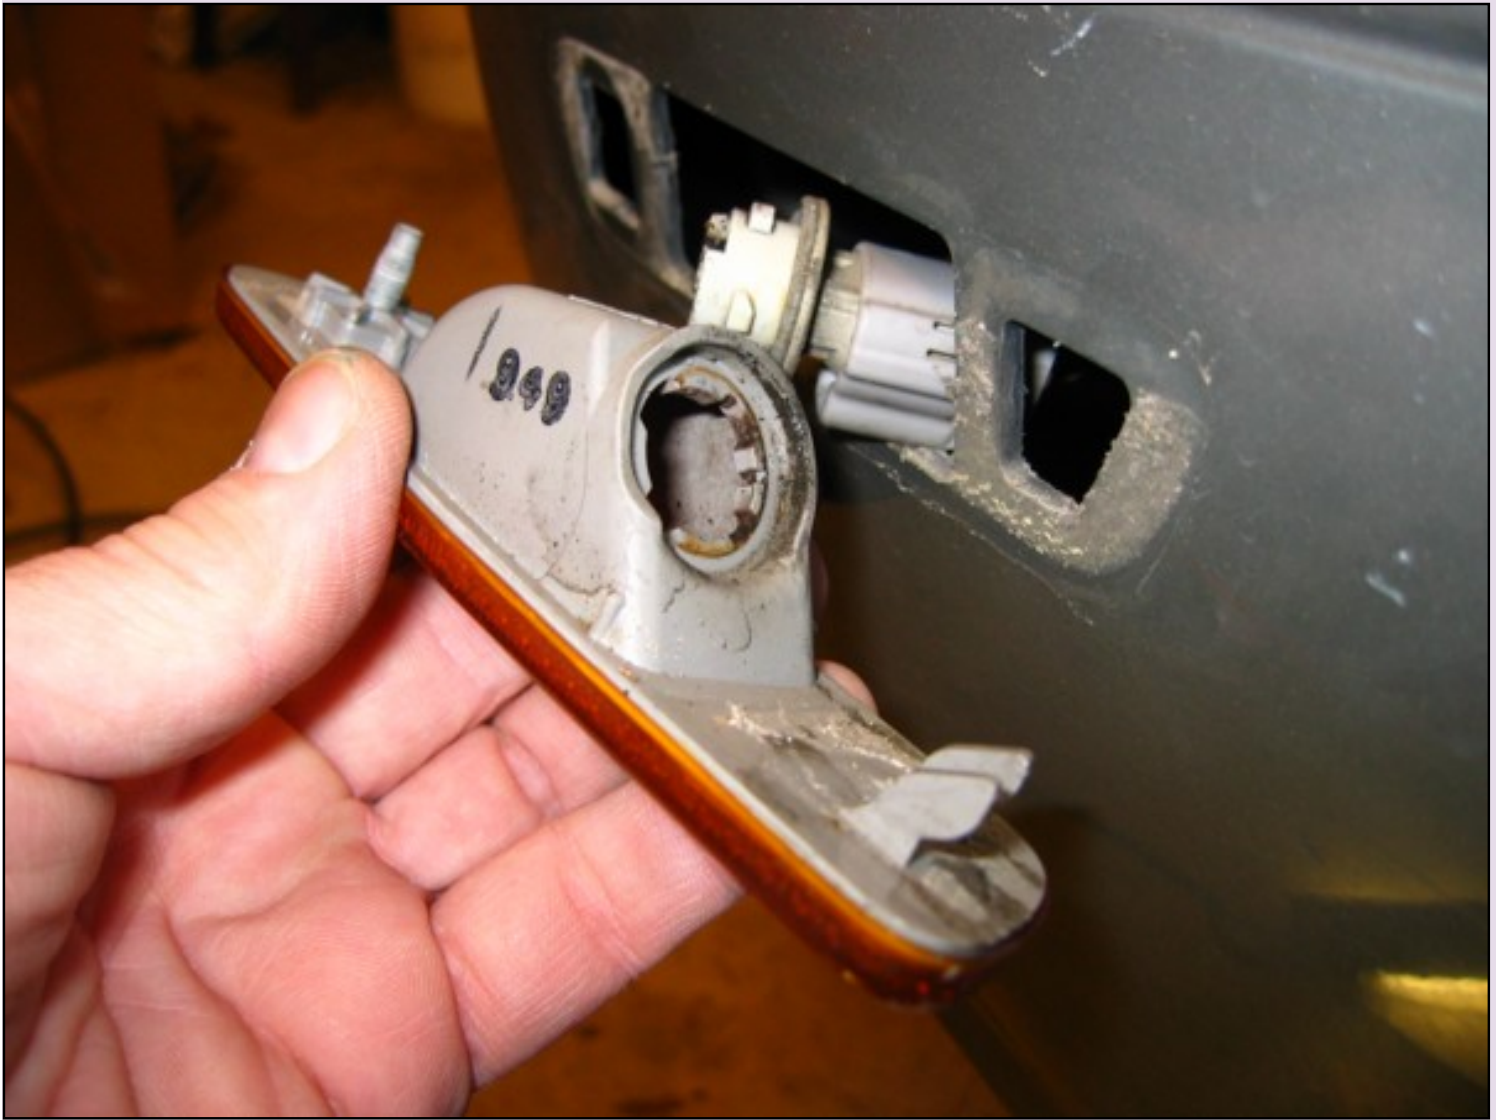
If you wish to remove the entire assembly and replace with some new Crystal Clear style assemblies, just reach inside and use a ratchet to undo the nut at the front of the assembly.

In this case the assembly was filled with water! The connector was also ruined - contacts eaten away. A lot of salt is used up here in the NE and everything rusts (if you noticed the undercarriage pics). I've ordered the crystal clear assemblies to replace and update from [ProCarParts](#) - \$36/pair + shipping (Dec 2003).

TIPS: SteveH at Club Lexus suggested drilling small drain holes in the bottom of each assembly to allow the water to drain. This is easy to do and the assemblies do not have to be removed. CK6Speed also from Club Lexus suggested adding additional sealant on the plastic seams (silicone) but requires removal (perhaps I'll do that on the new assemblies before installation).

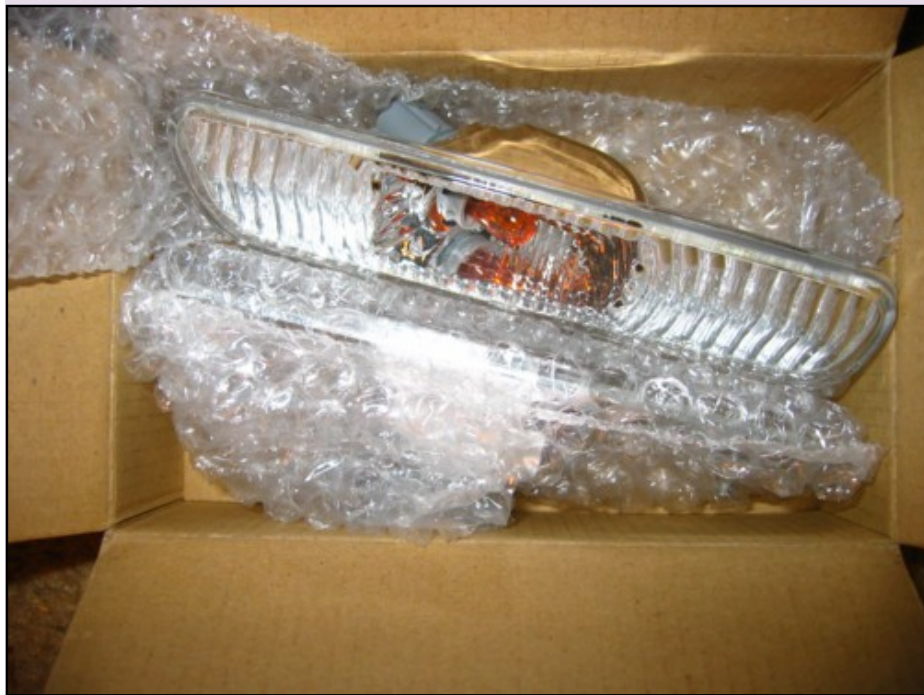
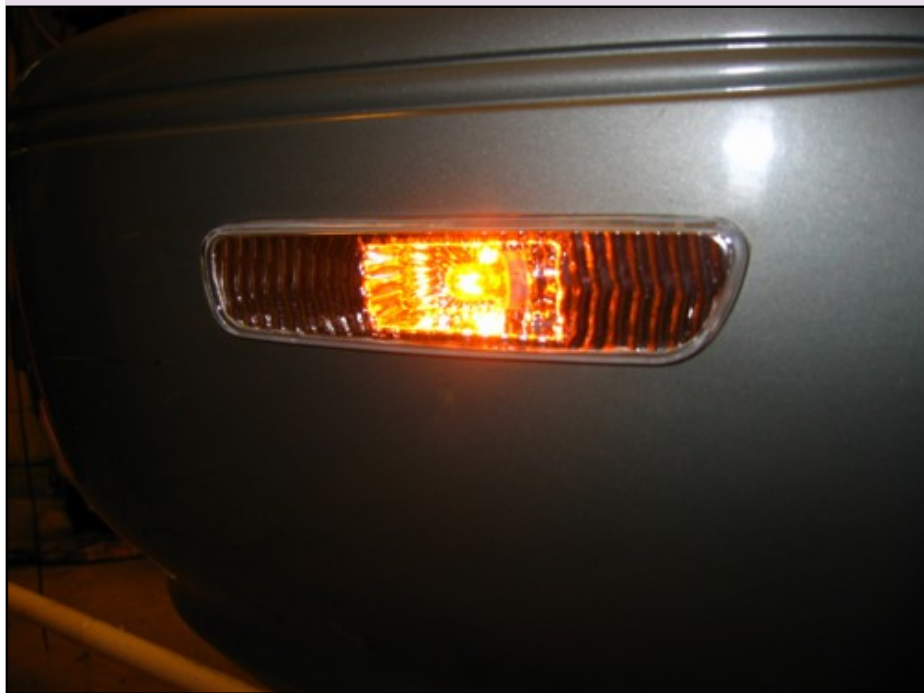
Delivery came today: New clear markers from ProCarParts: Packaging and installed. The new assemblies came with new bulb sockets and amber bulbs. Now that I'm getting good at removing the wheel well liner, it took under an hour to install the new unit.

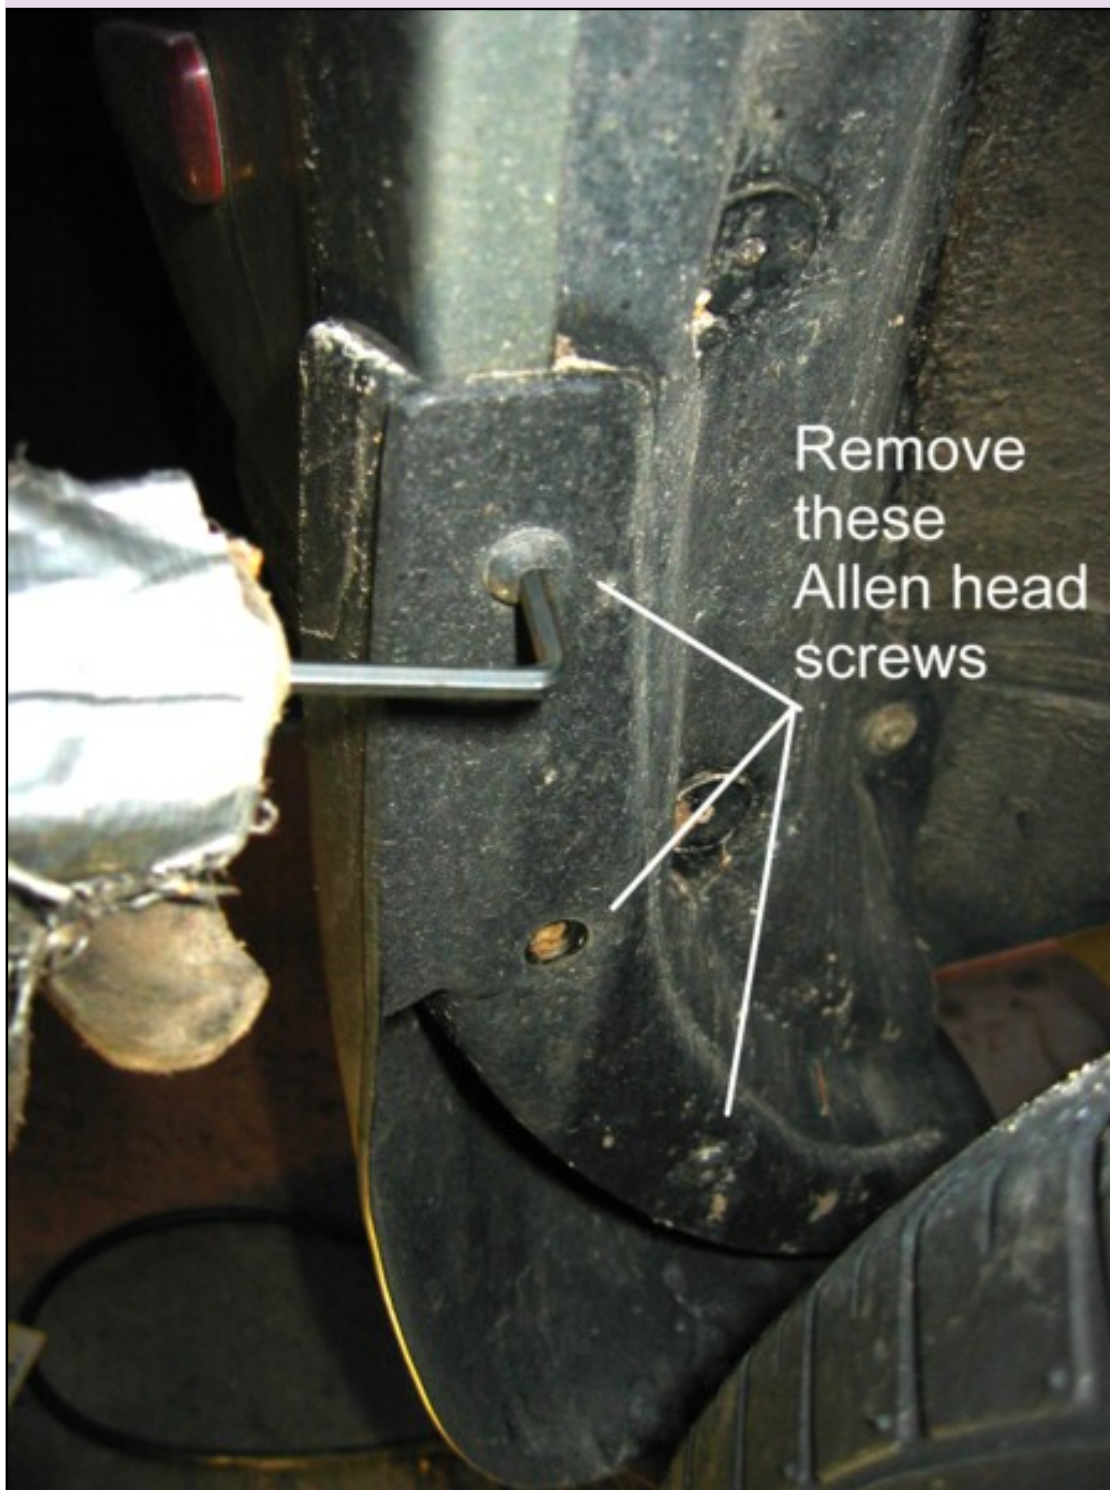
Several pieces must be removed. First the mud flap has to be taken off. These are removed with an Allen wrench. Then remove the mud flap.

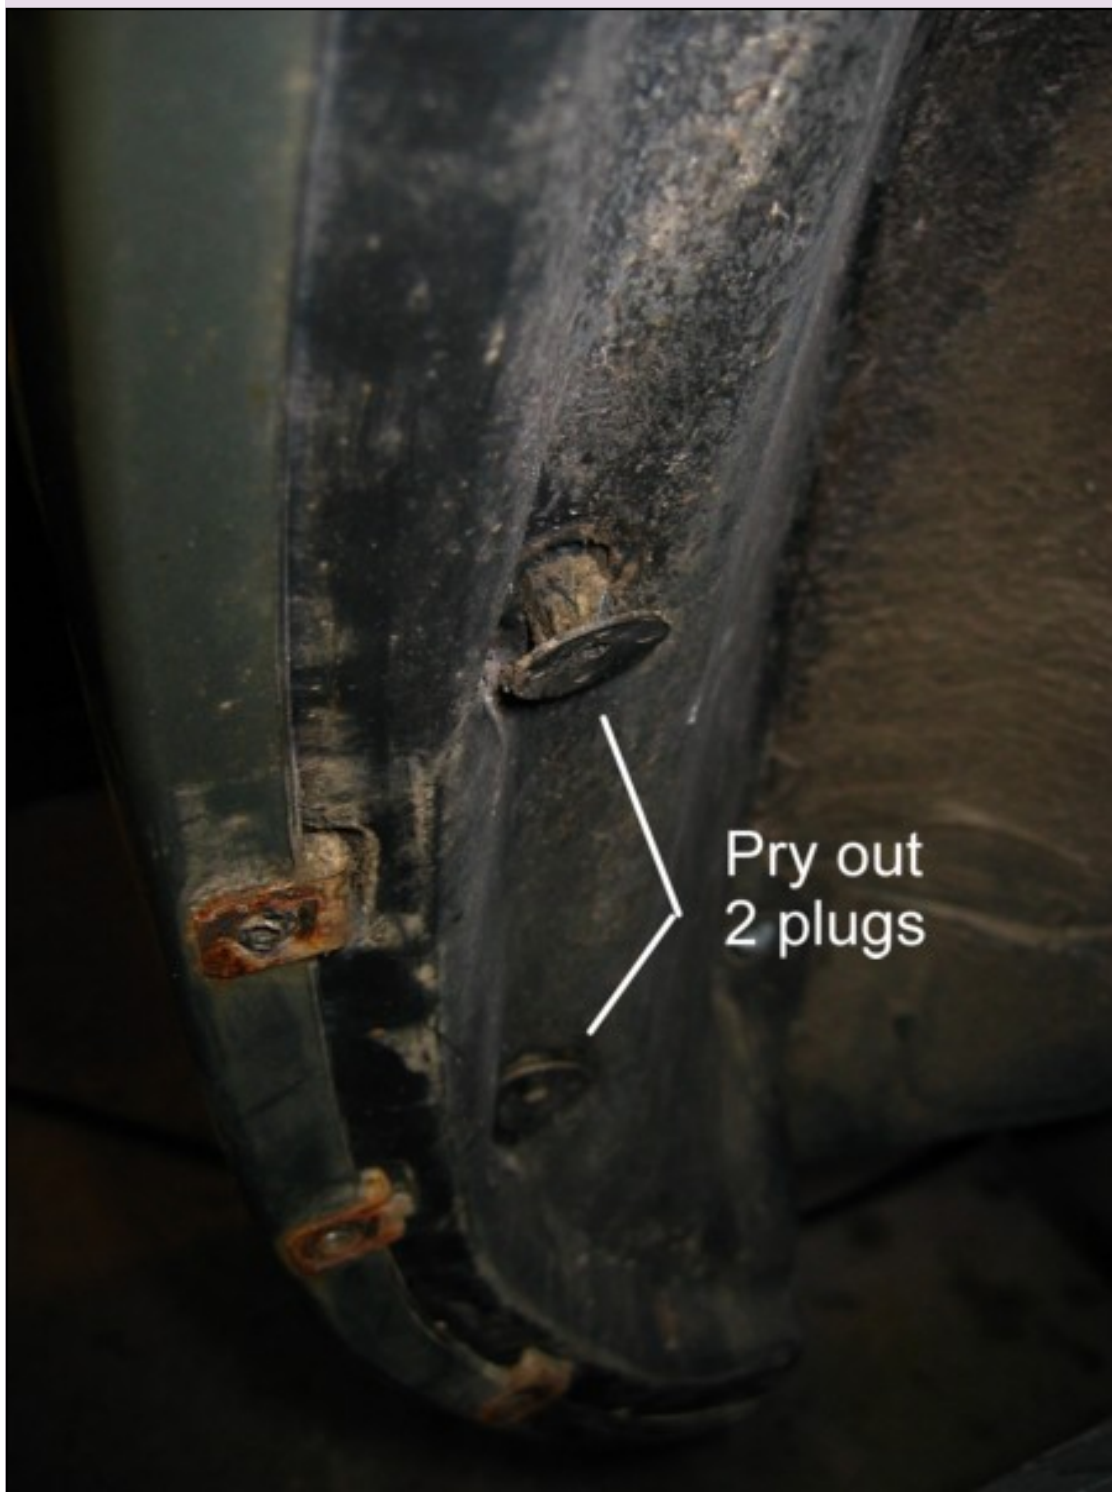
Next pry out the 2 plastic plugs in the inner plastic shield. These are difficult to pry out. Try not to break them, although mine almost came apart. If you break them, you may not need them for reassembly anyway. You have to remove one Philips screw (under the word "screws" in the above pic and behind the number "2" in the pic below).
