Side Markers Bulb (#3) and Lamp Assembly Replacement

Front White Marker (#5 & #7, Parking or Clearance Light), Bulb Replacement.

This page shows How2 get to the side markers (front and rear) and the small white marker in the front headlight assembly.

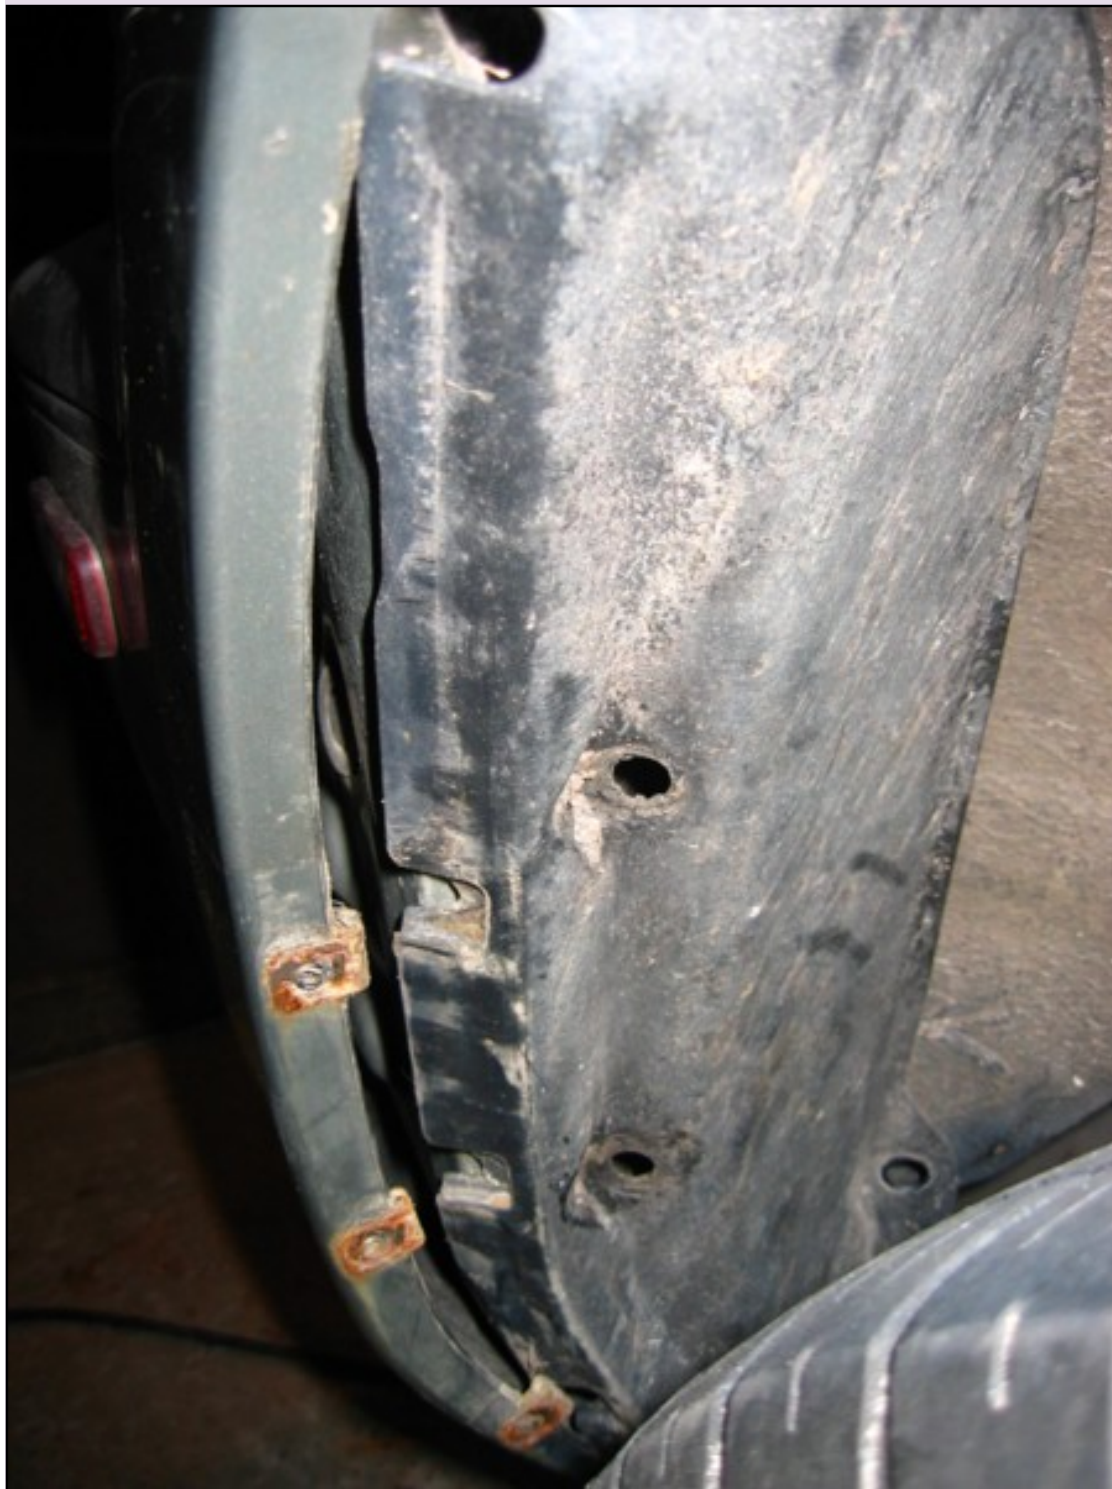
Once the 2 plugs are out, you can pull out the shield as below.

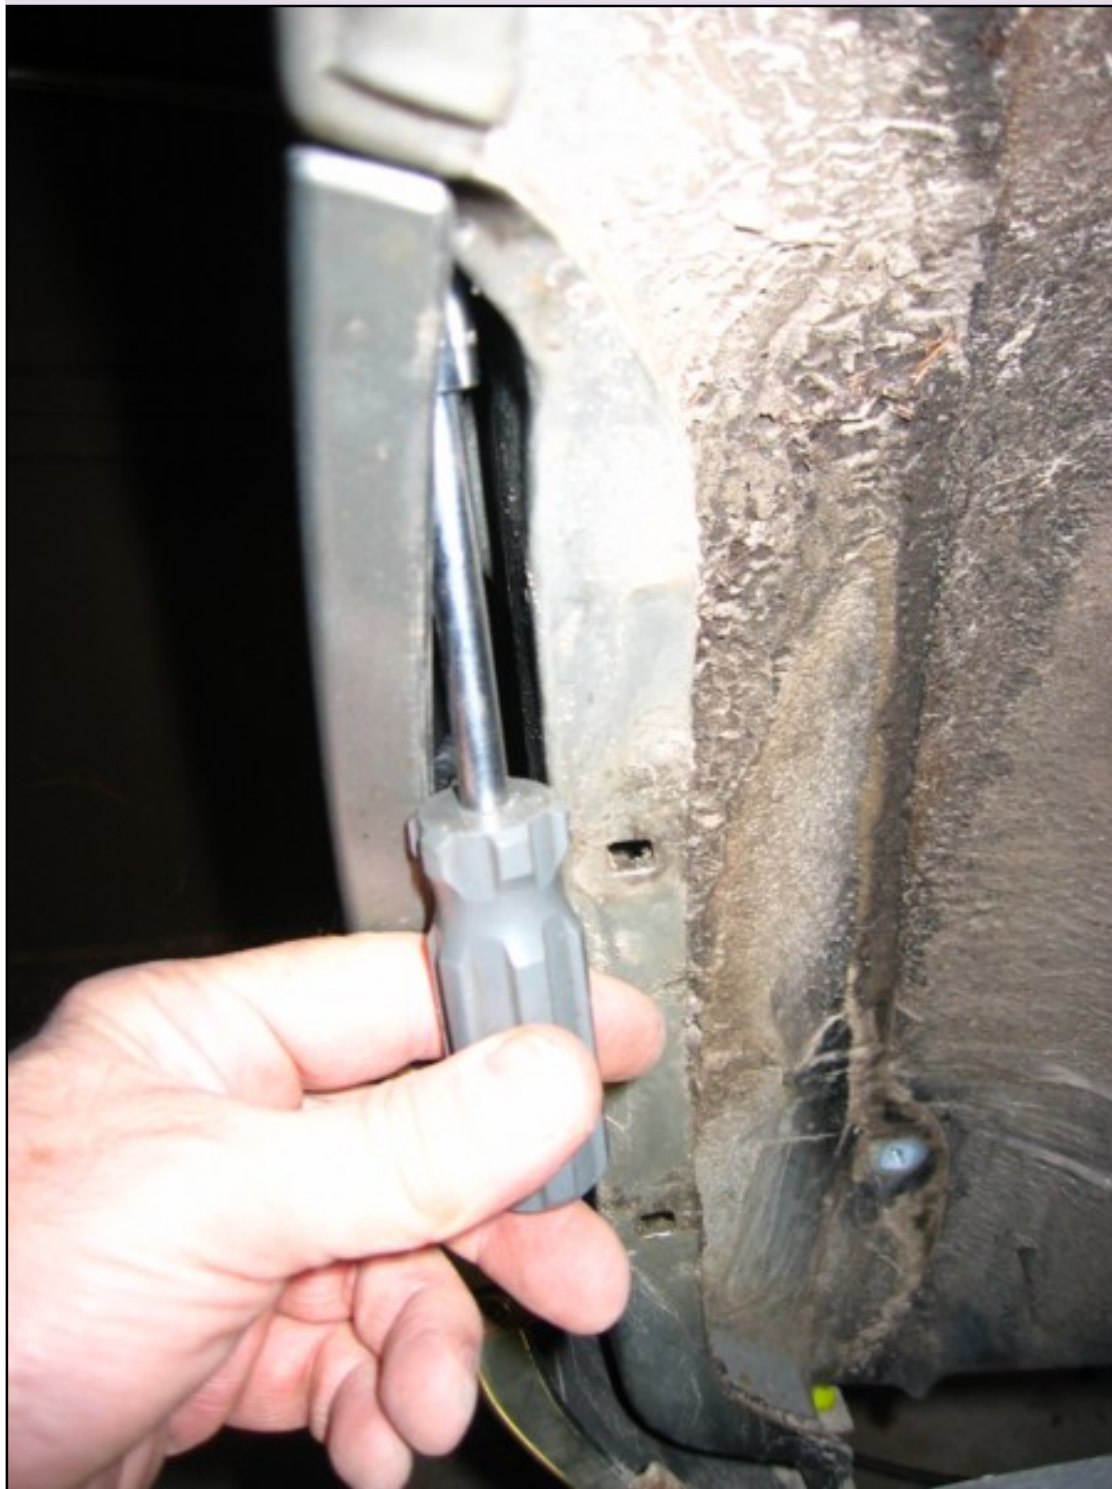
Once the inner shield is removed, there are 2 screws that must come out. The first is shown below at the front of the bumper cover below.

The best way to get to this bolt is with a long #3 Phillips screwdriver or nut driver (10mm) or a socket on a socket wrench with extension.

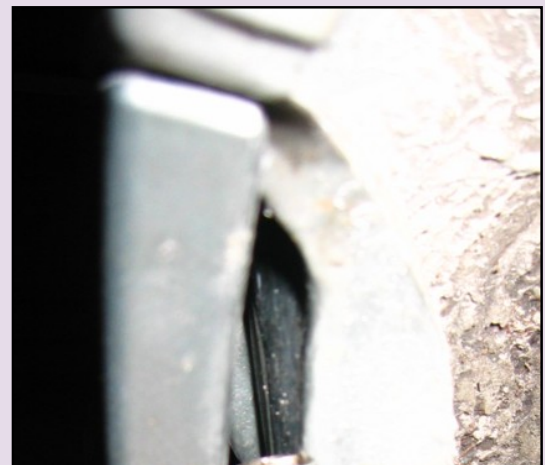
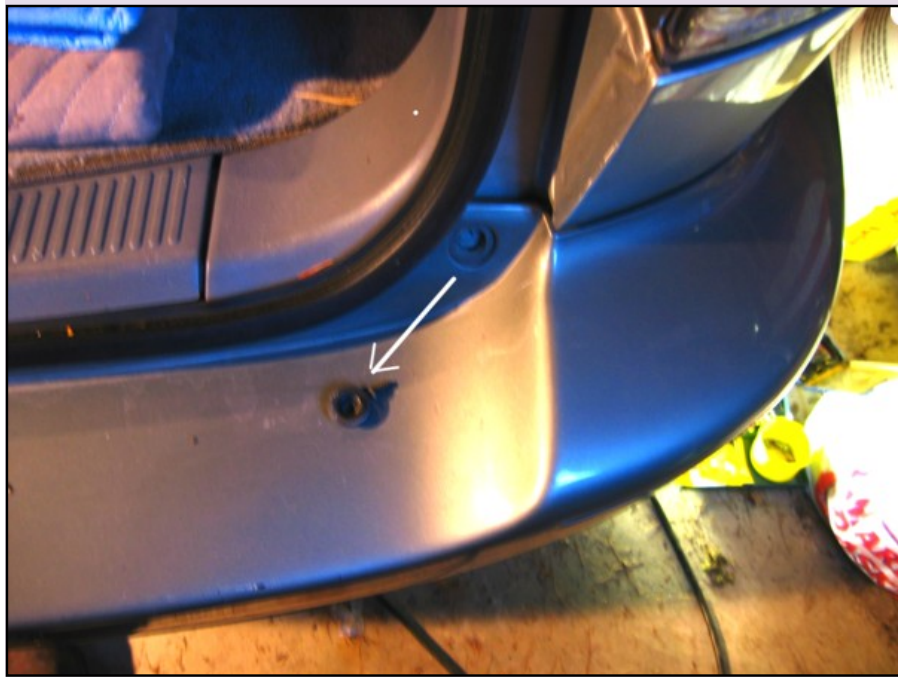
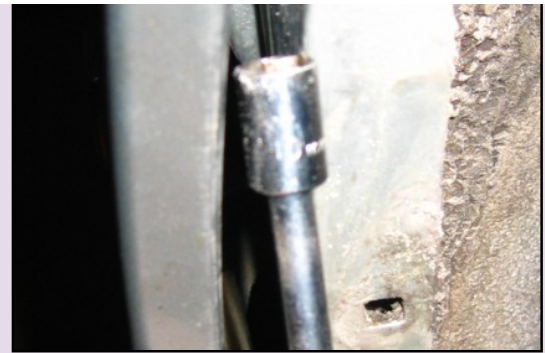
The second bolt is in the top of the rear bumper. Open the hatch back and remove the Philips screw and washer.

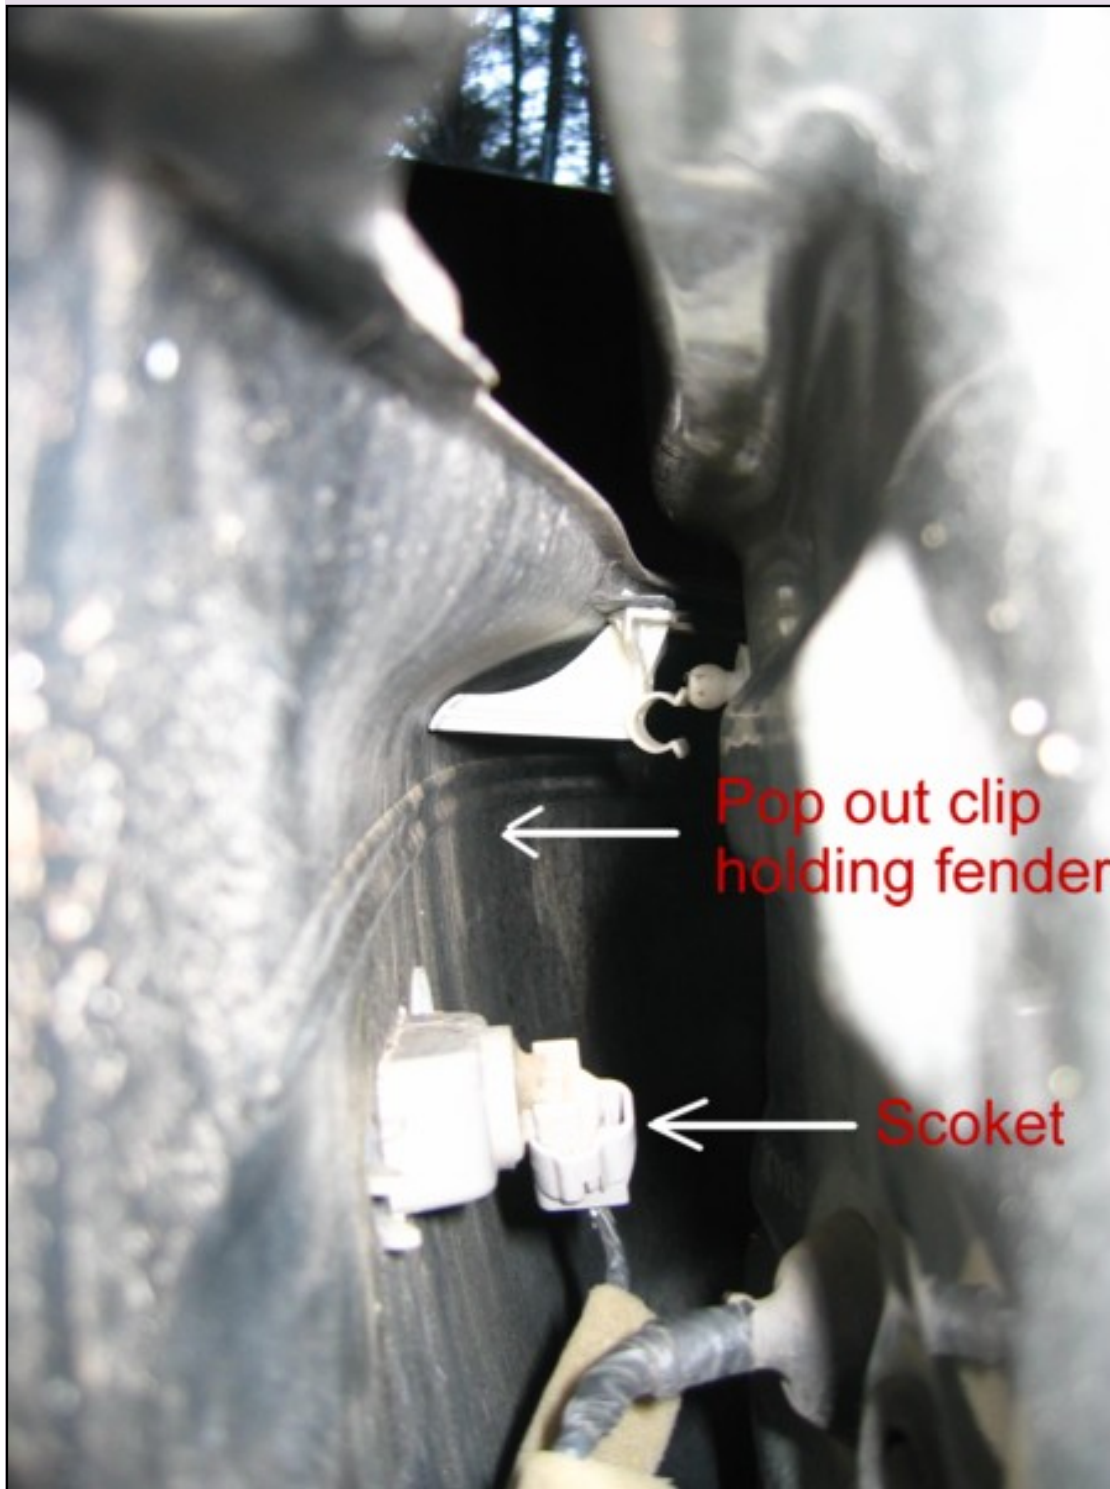
Once these bolts/screws are out, you can pull out the plastic bumper cover and you will be able to pop apart the "C" clip at the inside back corner (white plastic ball and "C" clip). The side marker lamp socket is accessible and the socket may be removed by turning 1/8 turn CCW.

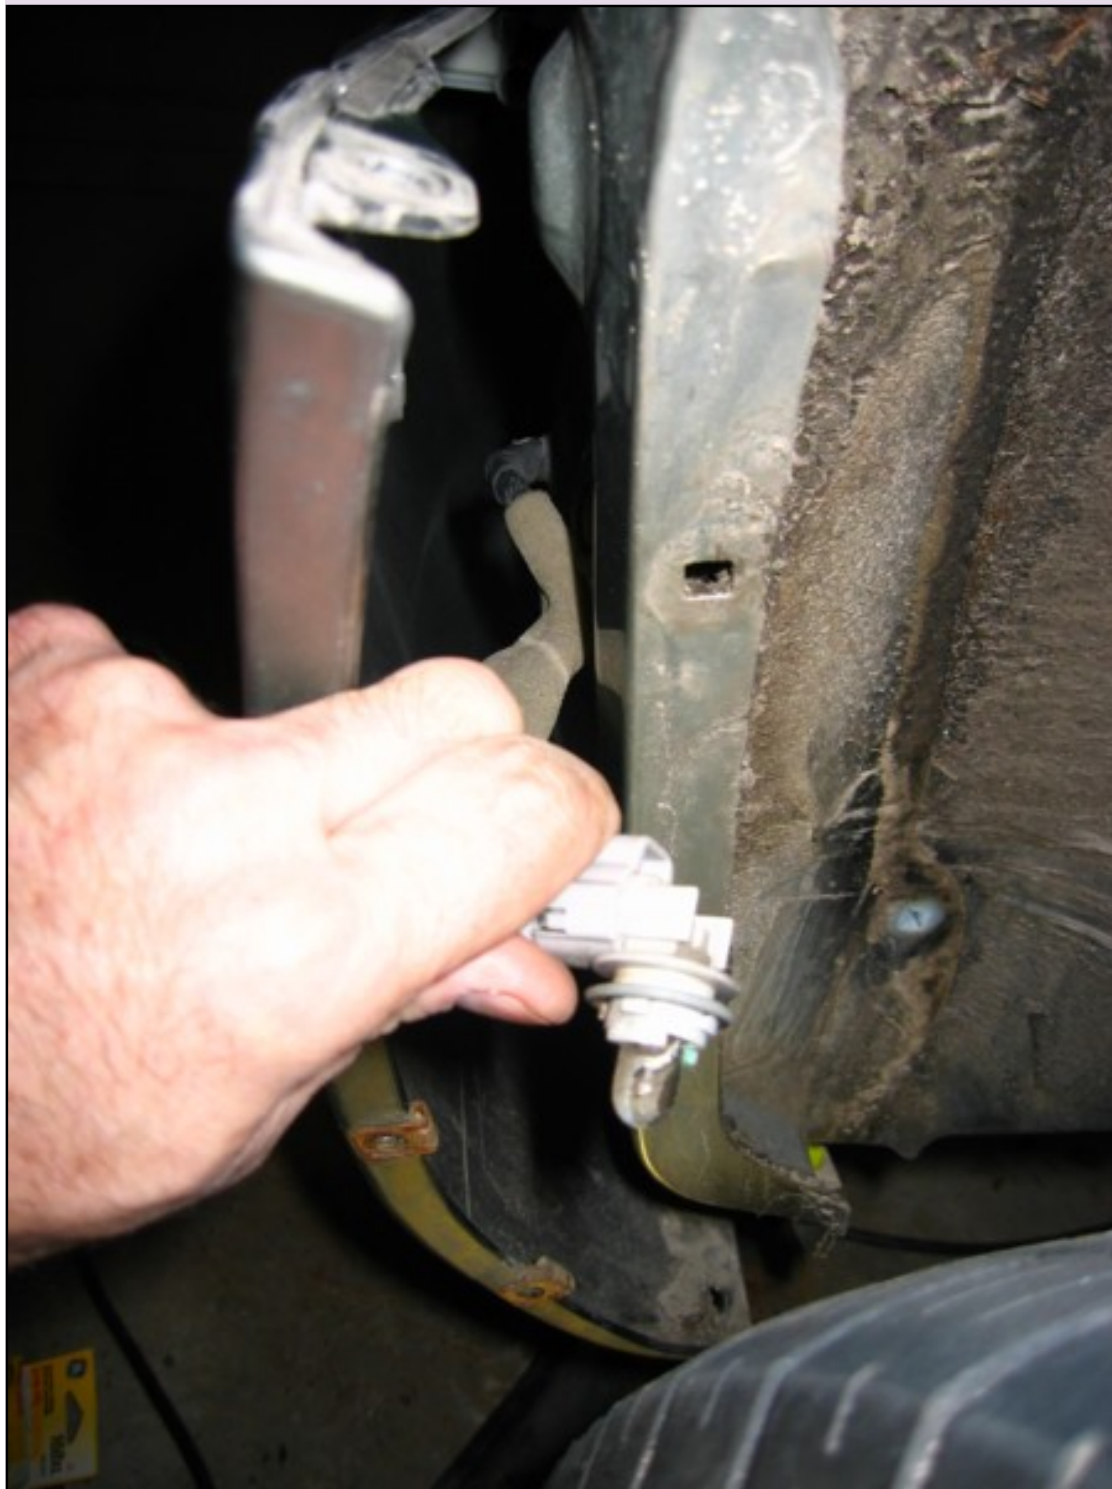
Pull out the socket to replace the bulb.

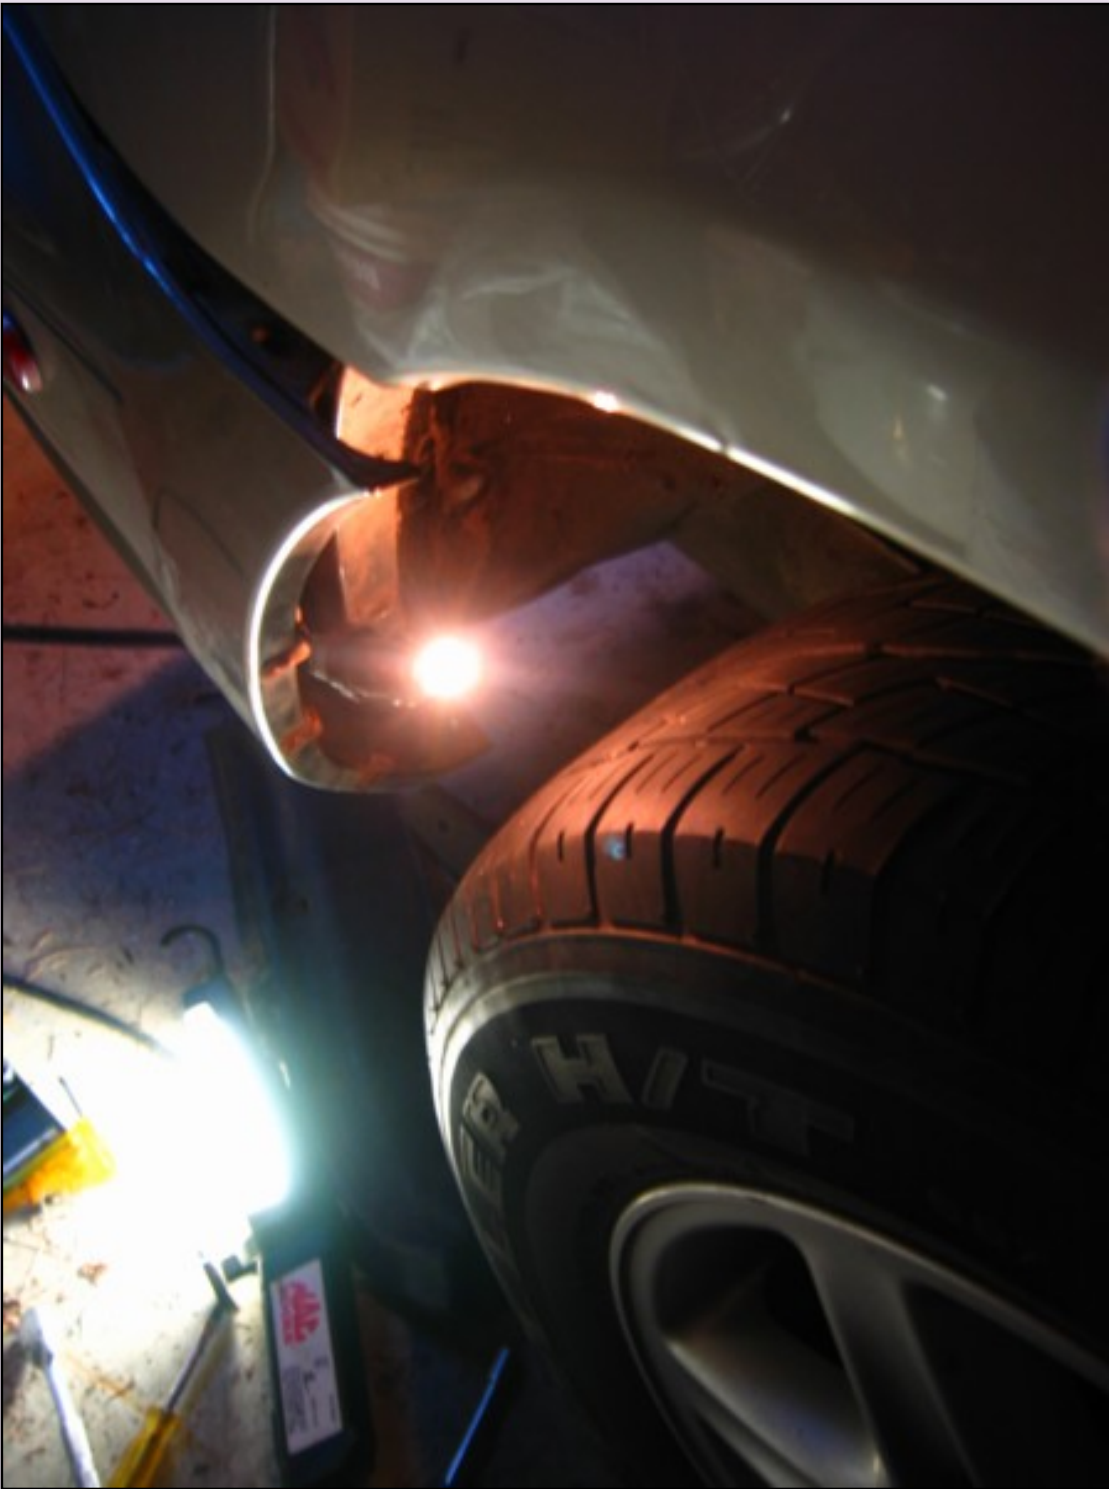
Replace the lamp and test before reassembly.
