**Subject: Special Service Campaign (SSC) 9LB
Certain 2006 - 2007 GS and IS Vehicles
Rear Brake Caliper Inspection**

Special Service Campaign (SSC) 9LB - Q&A
 Certain 2006 - 2007 GS and IS vehicles
 Rear Brake Caliper Inspection

TECHNICAL INSTRUCTIONS
FOR
SPECIAL SERVICE CAMPAIGN 9LB
REAR BRAKE CALIPER INSPECTION AND RUST REMOVAL
2006-2007 IS 250/350
2006-2007 GS 300/350/430/450h

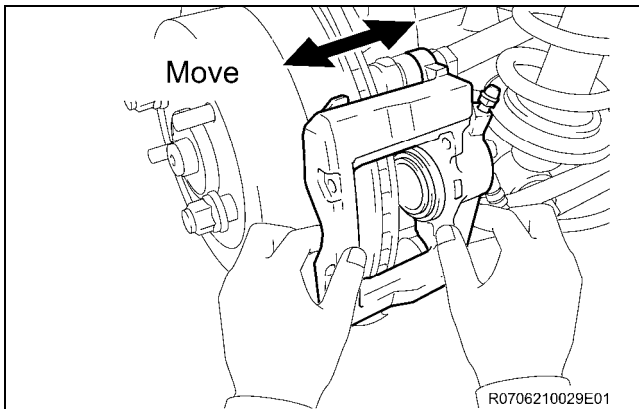
3. INSPECT REAR DISC BRAKE CALIPER ASSEMBLY SLIDE

- a) Move the brake caliper in the direction of the arrows. Compare the results with the chart below.
- b) Perform the same operation on the RH side.

Results	Procedures
Brake cylinder slides	Remove the rear disc brake cylinder assembly and assess the amount of rust. (Page 8)
Brake cylinder does not slide	In the rare instance the Brake Cylinder will not slide, refer to TIS and replace the rear disc brake cylinder assembly for that side only. If the either brake caliper does not move, replace the brake pads on both sides. Please keep all replaced parts for possible Warranty Parts Recovery and Inspection.

- Perform slide inspection to both the **LEFT AND RIGHT REAR DISC BRAKE CALIPER ASSEMBLIES** and compare the results with the chart above.

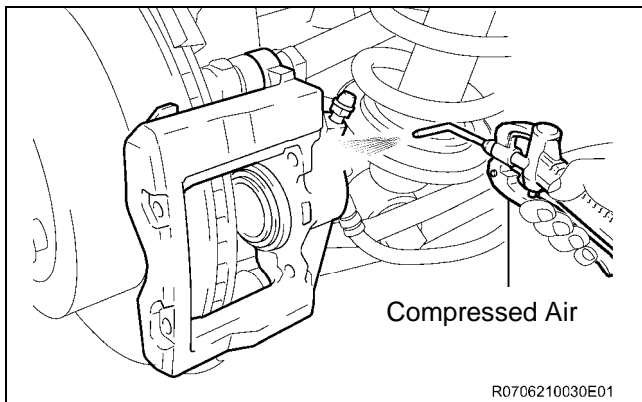
1. DISCONNECT REAR DISC BRAKE CYLINDER ASSEMBLY

- a) Using compressed air, clean the brake cylinder.

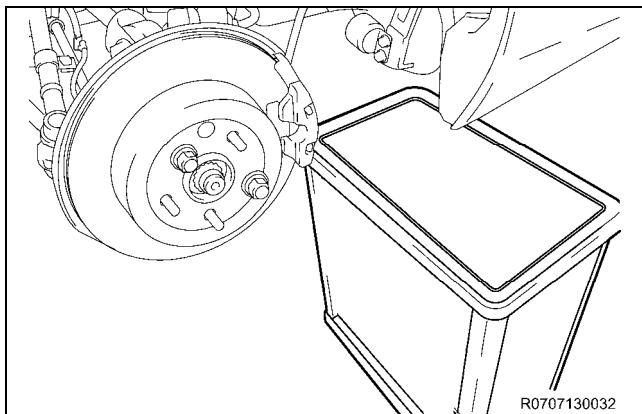
- c) Prepare a tool cart or equivalent.

Prior to removing the rear caliper it is necessary to prepare a cart that the caliper can be rested on. This is done to prevent stress from being applied to the brake hose. Do not bend, twist, or pull the flexible brake line.

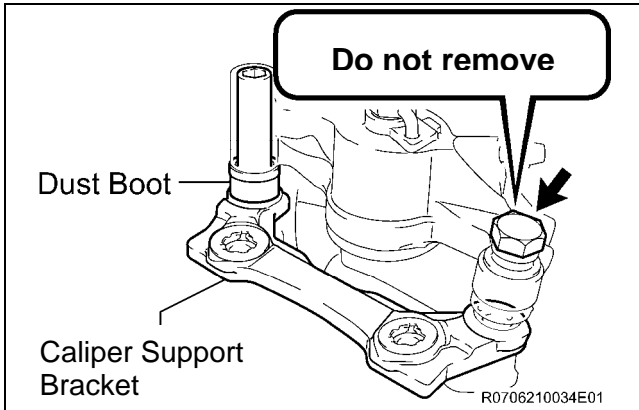
2. REMOVE CALIPER SUPPORT BRACKET

a) Disconnect the No. 1 slide pin, and remove the caliper support bracket with the dust boot.

Do not remove the No. 1 slide pin from the brake caliper.

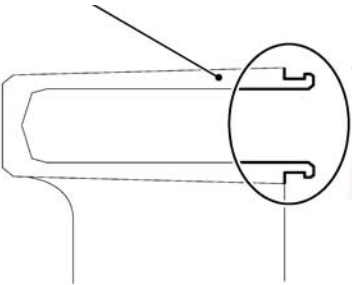
Brake Caliper Slide

If rust extends within A, then remove rust.

If rust extends into B, then replace.

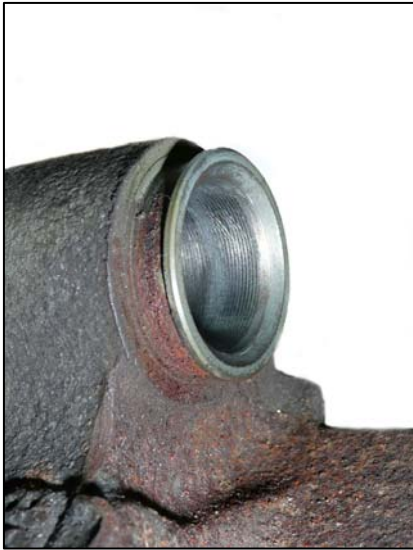
Rust only in section A:

Results	Procedures
There is rust only in section A and none in section B	<ul style="list-style-type: none"> ▪ REMOVE REAR DISC BRAKE CALIPER RUST (Page 11) ▪ REPLACE REAR DISC BRAKE BUSH DUST BOOT (Page 13)
No rust in either section A or B	<ul style="list-style-type: none"> ▪ REPLACE REAR DISC BRAKE BUSH DUST BOOT (Page 13)
Rust extends from section A to B	<ul style="list-style-type: none"> ▪ REPLACE REAR DISC BRAKE CALIPER (Please keep all parts for possible parts return and inspection) ▪ REFER TO TIS

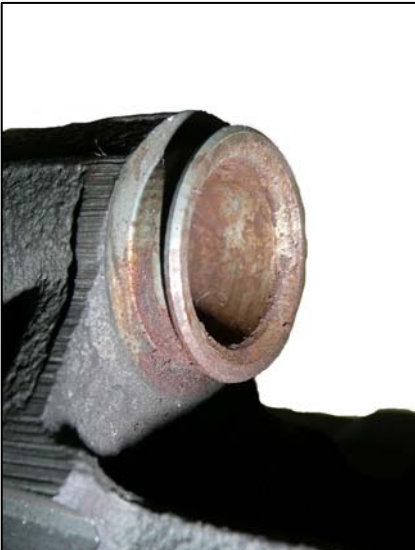
Rust extends from section A to B:

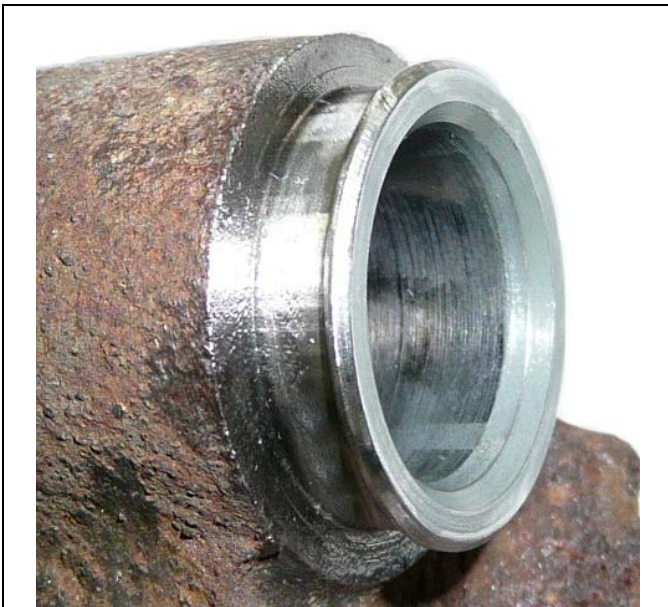
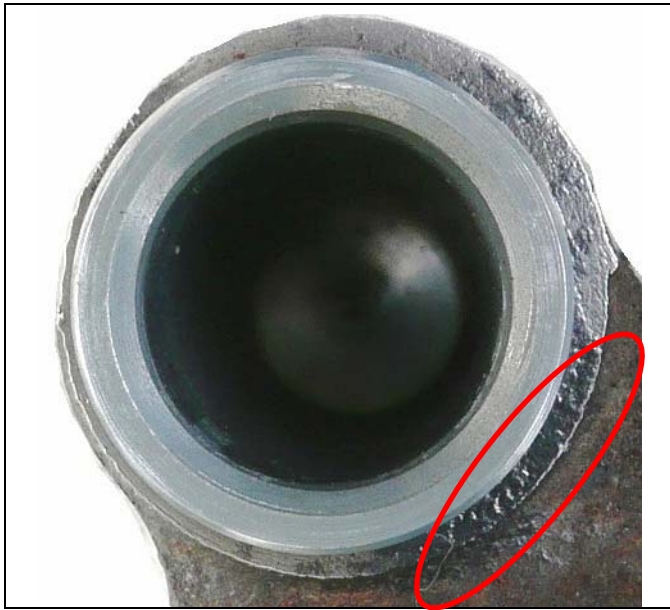
REMOVE RUST UNTIL RESULTS MATCH EXAMPLE PICTURES BELOW.

- **Specks appear after rust has been removed. This is normal; no further action necessary.**

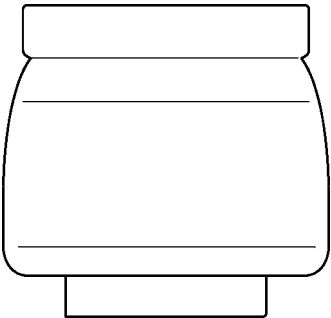
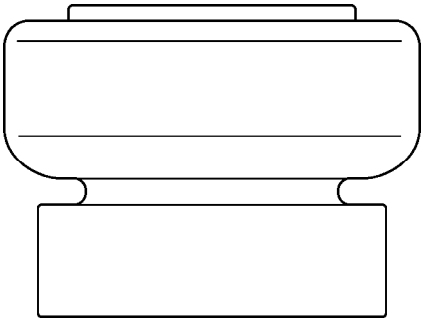
for Size M9: See pg. 15 (04007-49230)	for Size M12: See pg. 17 (04007-49330)
Shape

Slide Pin Color	<p>No. 2 Slide pin is <u>green</u></p>

</div>	<p>No. 2 Slide pin is <u>silver</u></p>

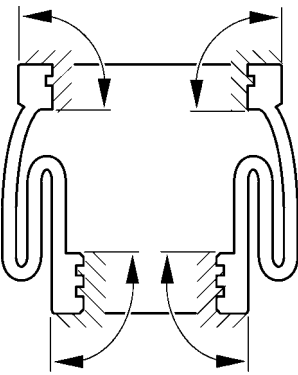
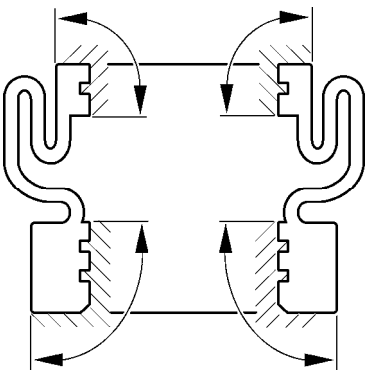
</div>
Lithium soap base glycol grease coating area

Direction to install	<p style="text-align: center;">↑</p> <p style="text-align: center;">Brake Caliper Side</p>

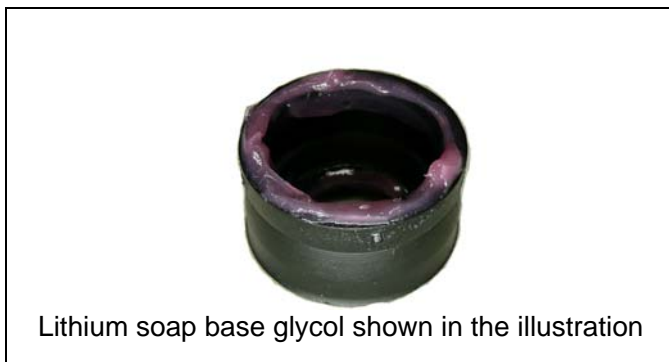
b) Apply Toyota White Grease or lithium soap base glycol grease to the **NEW** dust boot.

c) Install the dust boot to the brake cylinder.

- Be sure the dust boot is installed in the proper direction.
- Verify that the dust boot is installed firmly against the brake caliper groove.

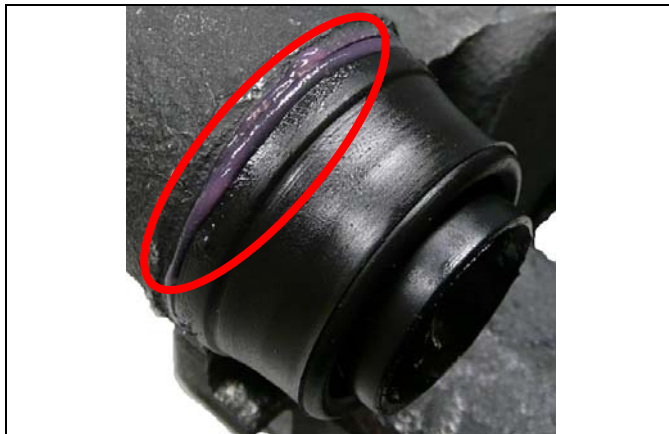
- e) Verify that Toyota White Grease or lithium soap base glycol grease extrudes from between the brake caliper and the dust boot.

The extrusion of the lithium soap base glycol grease will aid against water, rust and wear particles from entering.

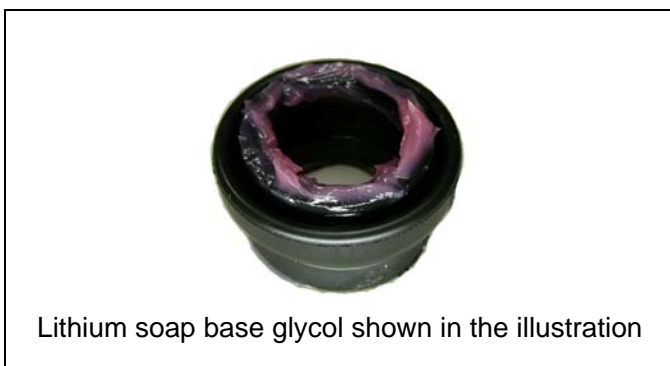
b) Apply Toyota White Grease or lithium soap base glycol grease to the **NEW** dust boot.

c) Install the dust boot to the brake cylinder.

- Be sure the dust boot is installed in the proper direction.
- Verify that the dust boot is installed firmly against the brake caliper groove.

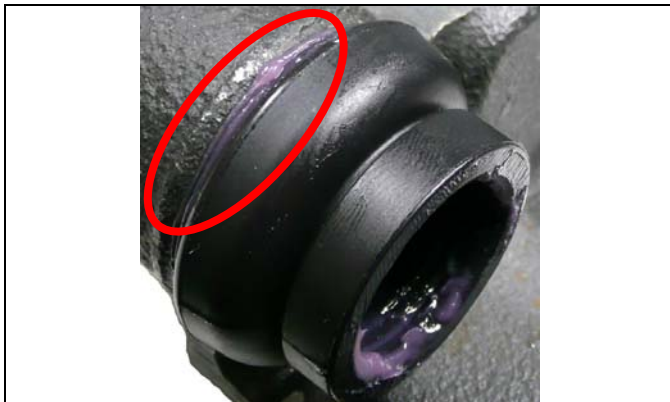
e) Verify that lithium soap base glycol grease extrudes from between the brake caliper and the dust boot.

The extrusion of the lithium soap base glycol grease will aid against water, rust and wear particles from entering.
