F-Sport Front Sway Bar Thump Noise

Service Category Suspension

Section Front Suspension

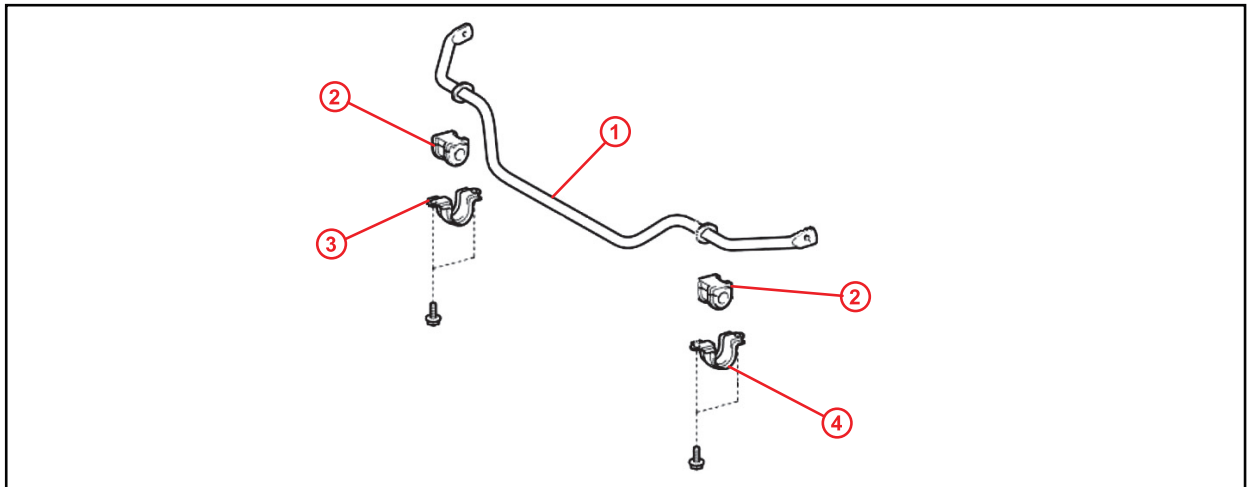
Figure 1.

1	Front Stabilizer Bar
2	Front Stabilizer Bar Bushing

3	Front No. 2 Stabilizer Bracket RH
4	Front No. 2 Stabilizer Bracket LH

The revised bushings are identified with a “ZD” marking, and the original bushings are identified with an “AB” marking.

1. Replace the sway bar bushings.
